Subject: Oak Tree Report for the Proposed Senior Apartments, Calabasas Development,  
4803 El Canon Avenue Project Site – LSA Project No. JCT0602

Oak Tree Survey

*Senior Apartments  
4803 El Canon Ave  
Oak Tree Survey  
Tree Photos*

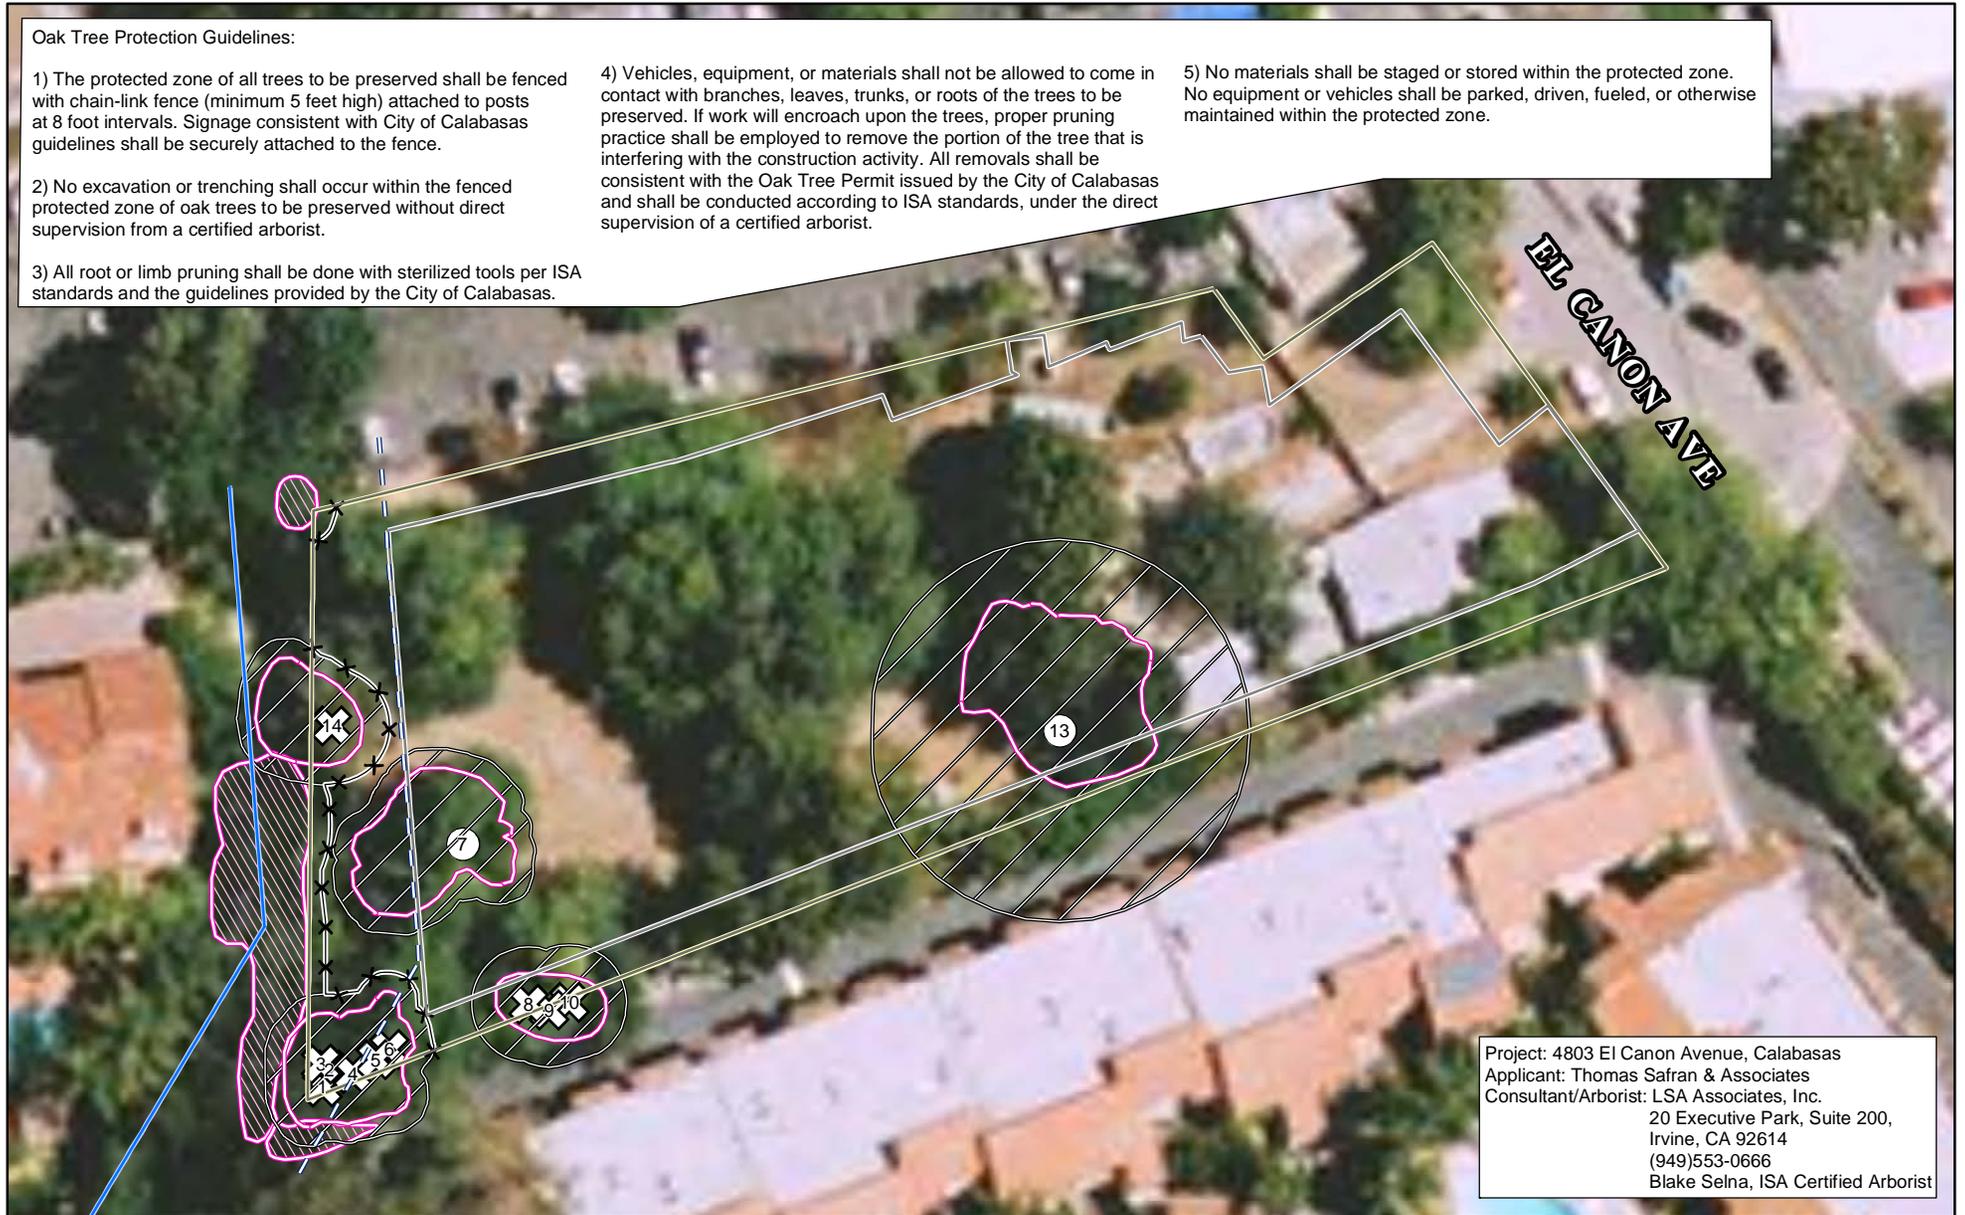
FIGURE 2

A total of 14 coast live oak trees were inventoried and evaluated. Figure 2 shows the location of the qualifying, inventoried trees within the proposed project limits as well as the location and canopy of oak trees on adjacent property. Tree number 11 is not shown on the exhibits because it does not satisfy the size criterion for coverage under the ordinance. Tree number 12 is not shown because it was toppled by heavy winds after the initial data collection was completed for this report. On Figures 2 and 2a, the trunk locations, represented by the numbered icons, are displayed in the actual location within the canopy. Figure 2 shows the aerial photograph, the property boundary, creek setback, and the tree locations at a scale of 1"=50'. Figure 2a shows the location of proposed improvements and the tree locations at a scale of 1"=20'. The measured dripline (pink) and the protected zone (green hatching) are also displayed. The trunk locations were verified using the civil survey data provided by the Mollenhauer Group. The canopy data were collected by LSA using a Trimble GeoXH GPS unit as well as physical measurements taken during the field visit. Data were post-processed to sub-meter accuracy. Figures 3–7 show photographs of the trees. Because of intertwined canopies and limited vantage points, the individual trees were difficult to photograph in some cases.

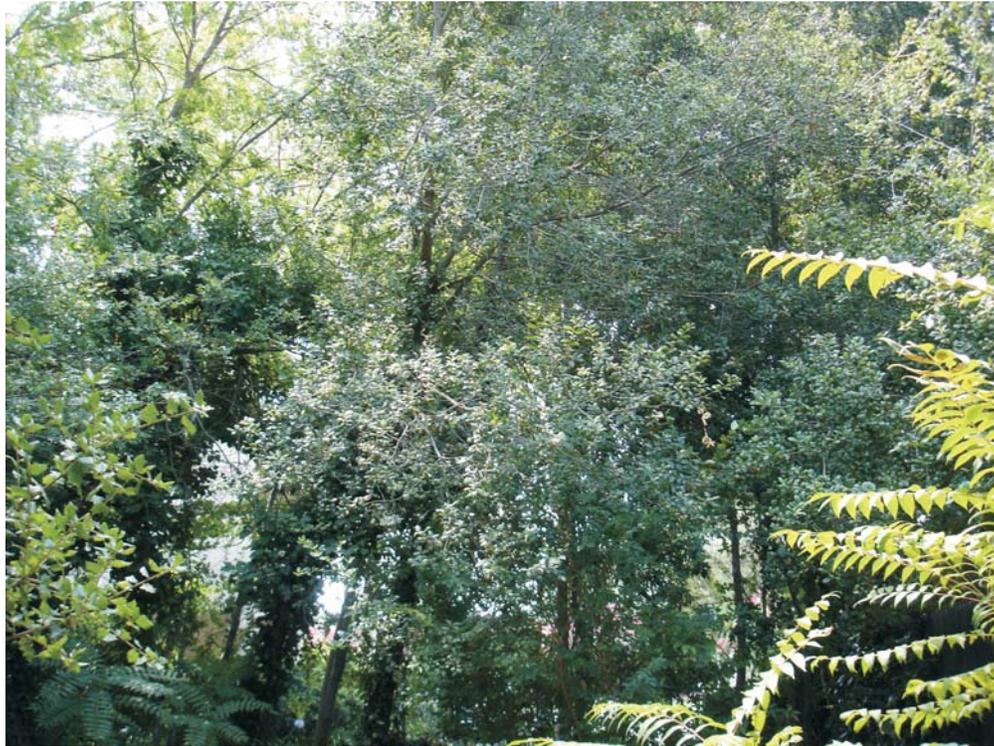
All of the oak trees were healthy and vigorous at the time of the survey and did not exhibit signs of infestation or disease. Trees 1 through 6 and 8 through 10 have ivy growing on them, which can be detrimental to the health and structural integrity of the trees if it goes unchecked. All of the oak trees except number 13 have relatively poor growth form due to other adjacent trees and/or structures on the site (e.g., chain-link fence, outbuildings).

Photo 1 - Trunks and canopy of trees 1 - 6 from approximately 25 feet north.

In addition to the mitigation measures for retained trees listed above, all ivy should be removed from retained trees by a qualified landscape contractor. Ivy removal must be done carefully, taking great care to avoid damaging oak bark or branches. Use of a selective herbicide may be possible; a qualified pest control advisor should be consulted regarding any pesticide.

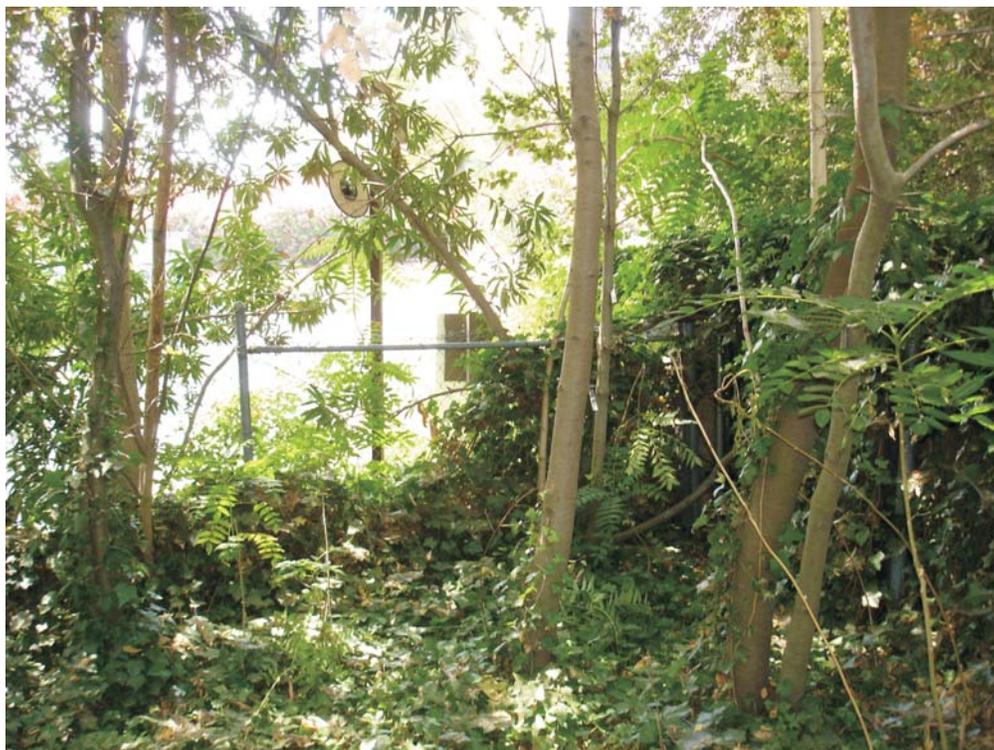
Photo 2 - Trunks of trees 1 - 4 from approximately 20 feet north of the trees.

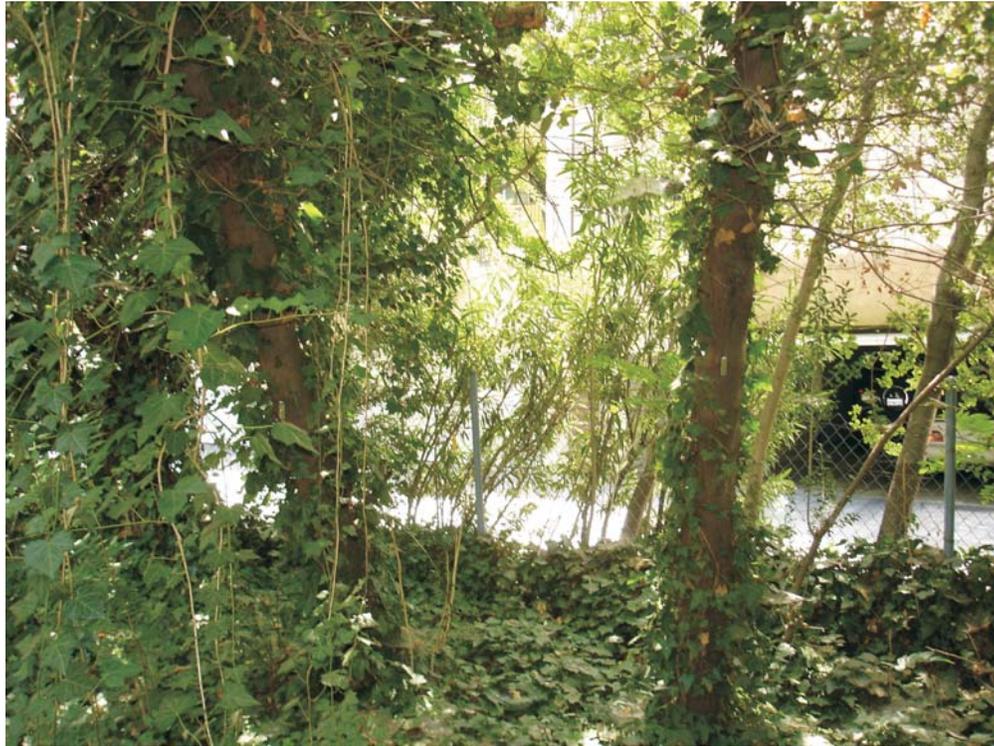
Photo 3 - Trunks of trees 5 and 6 from approximately 15 feet north.

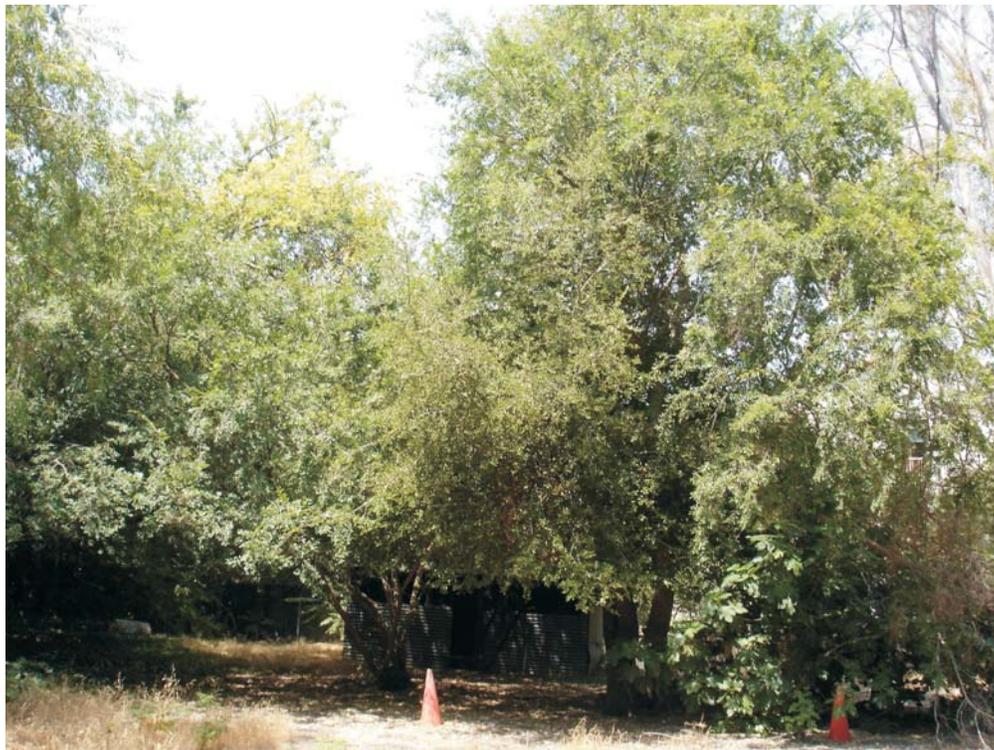
Based on the grading plans, it appears that two of the qualifying oaks (Nos. 7 and 13) will be removed for the construction of the proposed building and/or underground parking garage. Because tree number 11 has a DBH of 1.5 inches, no permit or mitigation is required for that particular tree. Because tree number 12 was toppled by heavy winds, no permit or mitigation is required for that tree. The trees to be removed are outside of the likely CDFG jurisdictional limits.

Photo 4 - Tree 7 from 45 feet east of the tree.

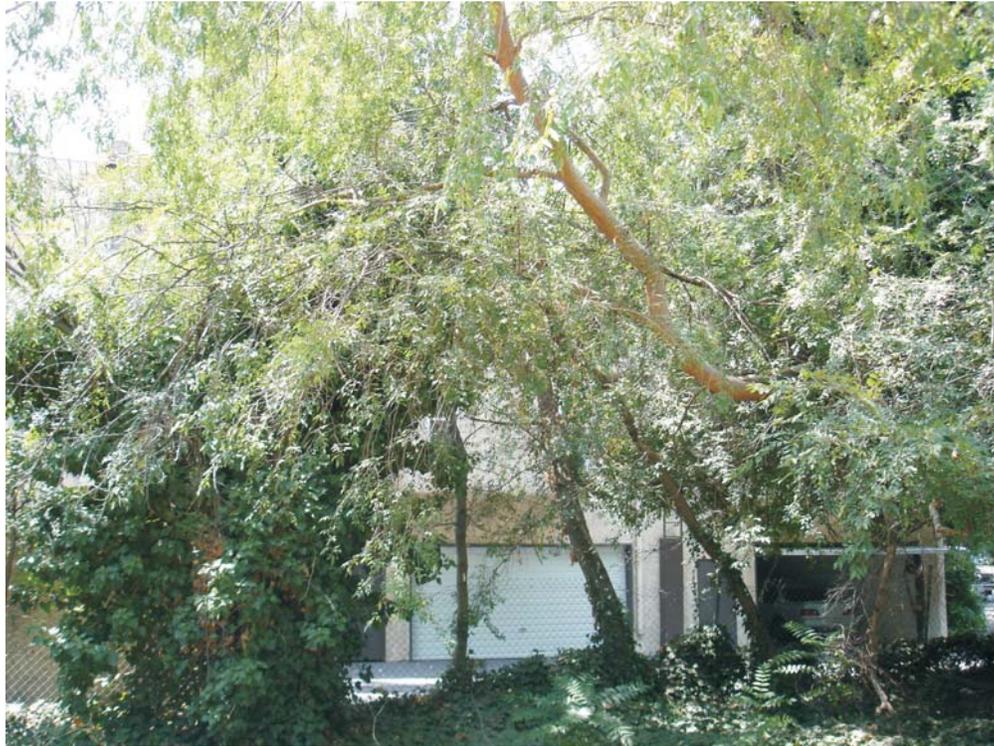
Trees 8, 9, and 10 will be encroached upon by the excavation of the underground parking garage. The trees are heavily lopsided to the south and east, away from the project site. Impacts to the roots on the northwest side of the trees will weaken the support structure of the trees, creating an unsafe condition, and may lead to windthrow. Personal injury or property damage could result from such tree failure. The approval of the project requires the retention of trees 8, 9, and 10; therefore, significant tree protection and stabilization measures will be required, such as guying and/or staking. Such stabilization measures are not included in the scope of this report. Careful removal of roots (per ISA standards) within the grading limits and restriction of above-ground activities (per mitigation measures, below) within the protected zone are recommended for the long-term health of the trees.

Photo 5 - Trees 8 - 10 from approximately 35 feet north of the trees.

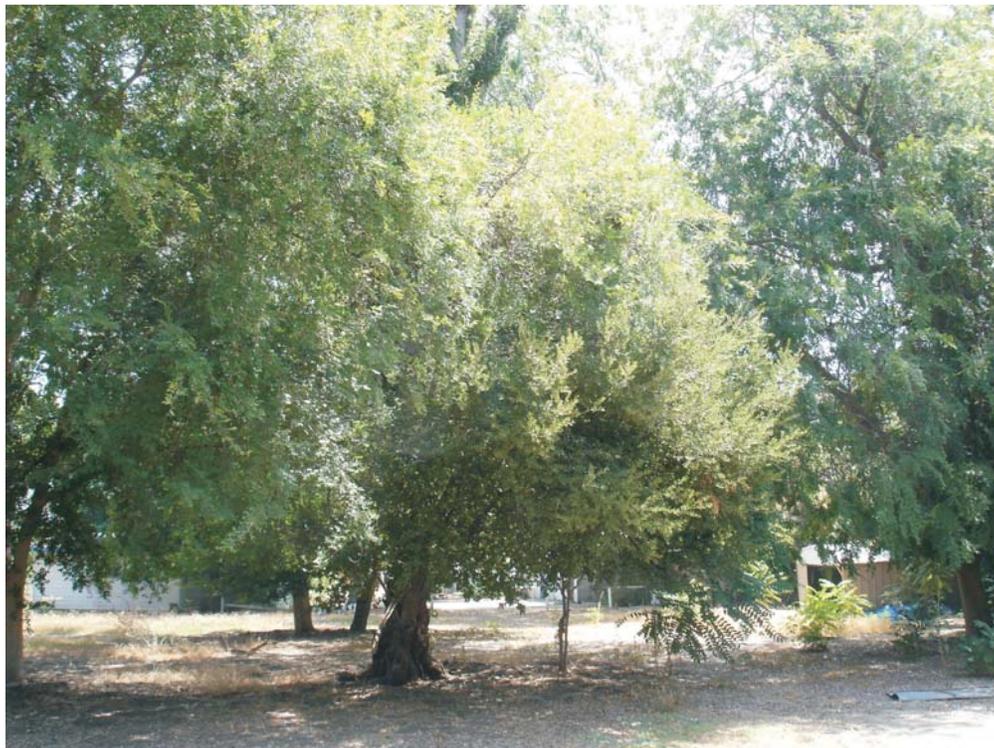
Photo 6 - Tree 12 from 60 feet west of the tree.

Tree Number	
1	
2	
3	
4	
5	
6	
7	Canopy very unevenly distributed to the west and southwest. Growth form is poor due to adjacent ornamental trees and a chicken coop. Canopy 40–85% dense.
8	Trunk adjacent to chainlink fence. Leaning badly. Trunk forms an approximately 60 degree angle with the ground. Majority of canopy is overhanging adjacent to the parking lot to the south and east. North and west quadrant lack canopy. 50–80% shade on south and east.
9	Trunk adjacent to chainlink fence. Majority of canopy is overhanging adjacent to the parking lot to the south and east. North half lacks canopy. 40–60% shade on south half.
10	Adjacent to chainlink fence. Fence is wired to the tree. Canopy is leaning far to the east of the trunk. East half of canopy 50–75% shaded.
11	Less than 2 inch DBH.
12	Since the initial data collection for this report, tree 12 failed in heavy winds and will not require permits or mitigation.

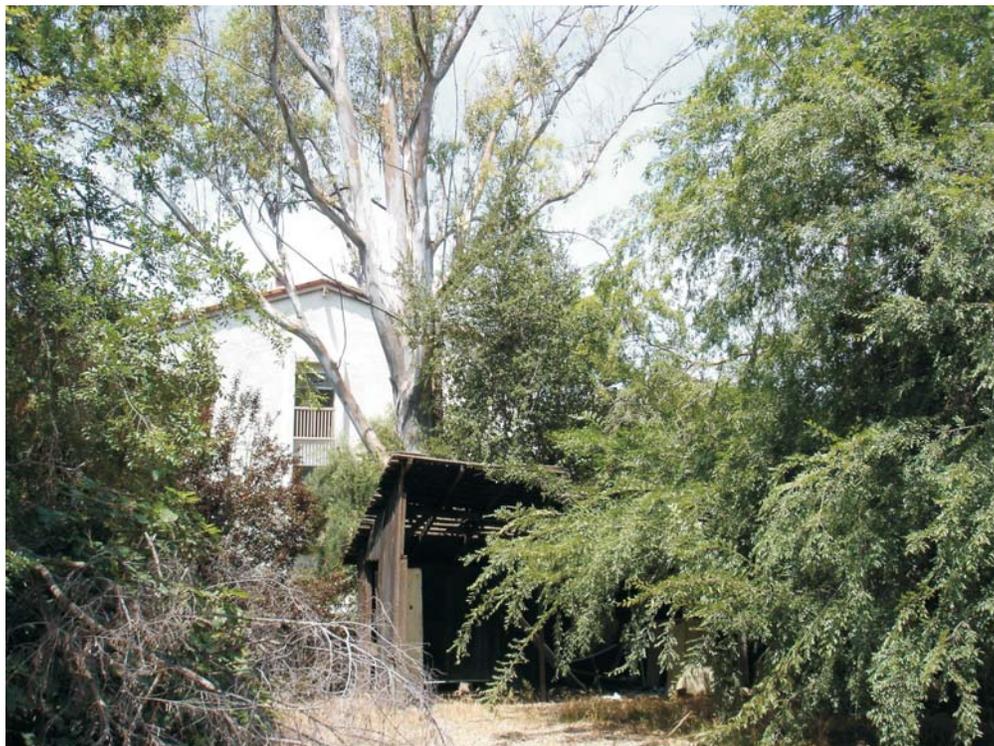
Photo 7 - Tree 14 from 50 feet east of the tree.

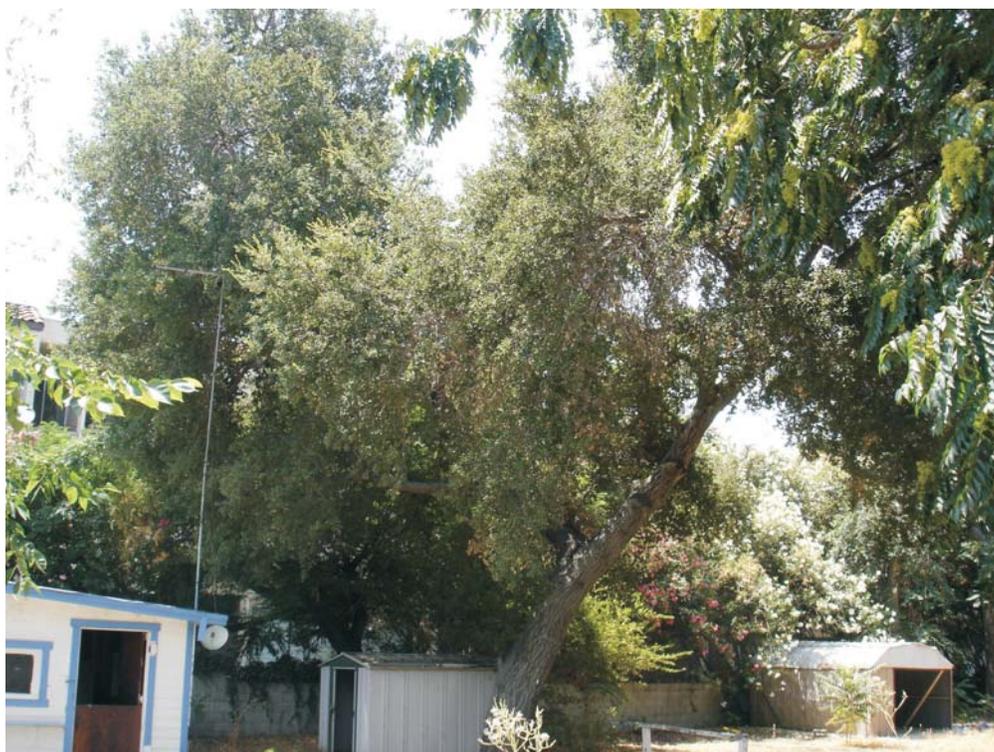
Photo 9 - Tree 13 from 60 feet northeast of the tree.

13	Very large spreading oak. Canopy density: N-70, NE-80, E-80, SE-80, S-45, SW-45, W-40, NW-70.
14	Between existing shed and fence. Canopy density: approximately 50%.

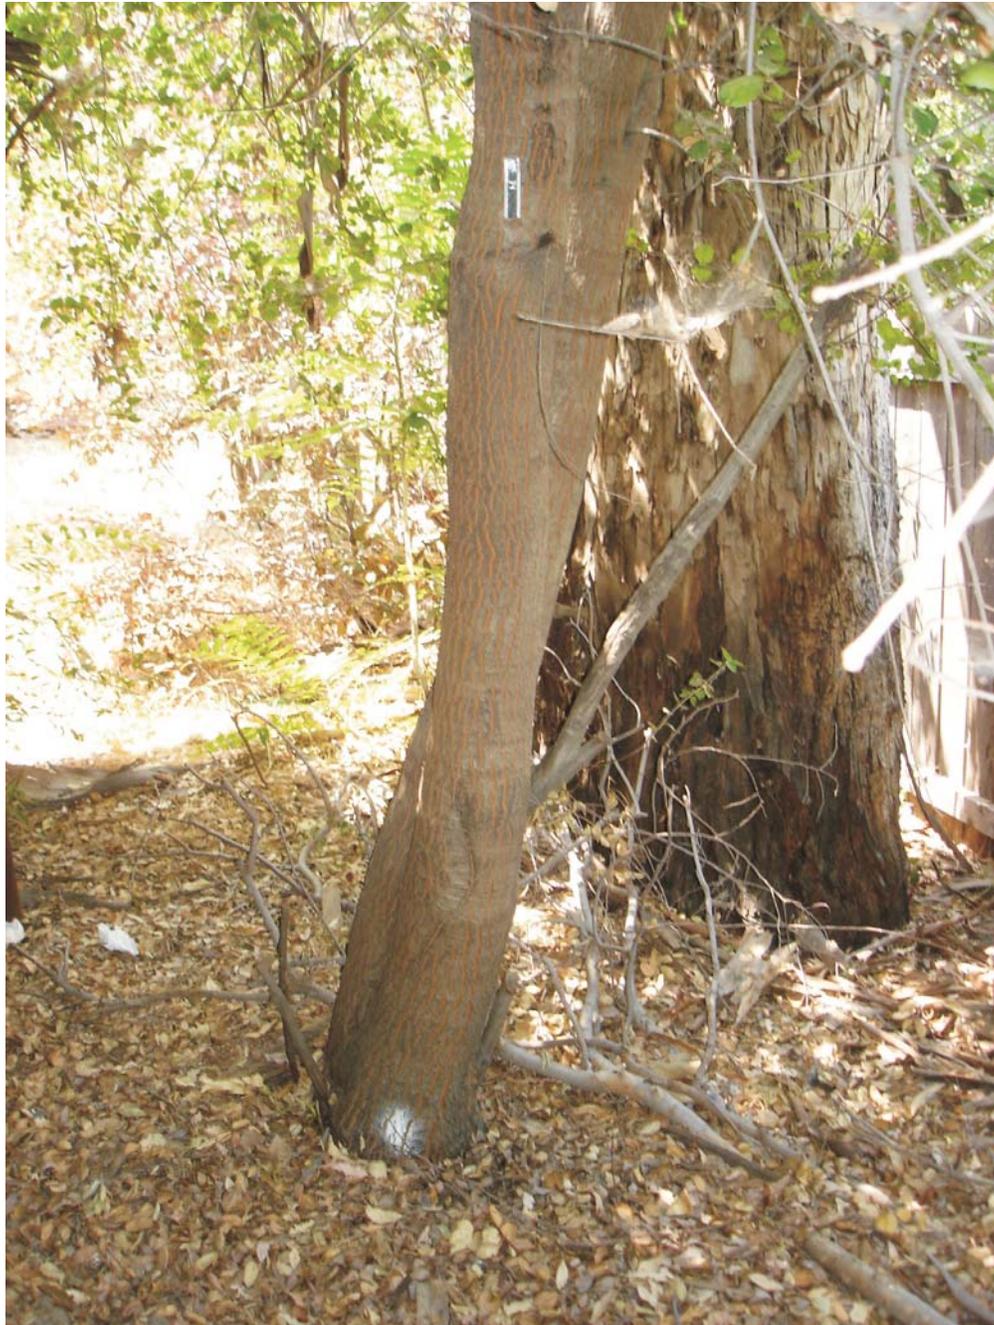
Photo 8 - The trunk of tree 14 from 8 feet north of the tree.
