## EXHIBIT G

September 21, 2016

**Subject: Oak Trees at 23604 Dry Canyon Cold Creek Road, Calabasas, California 91302**

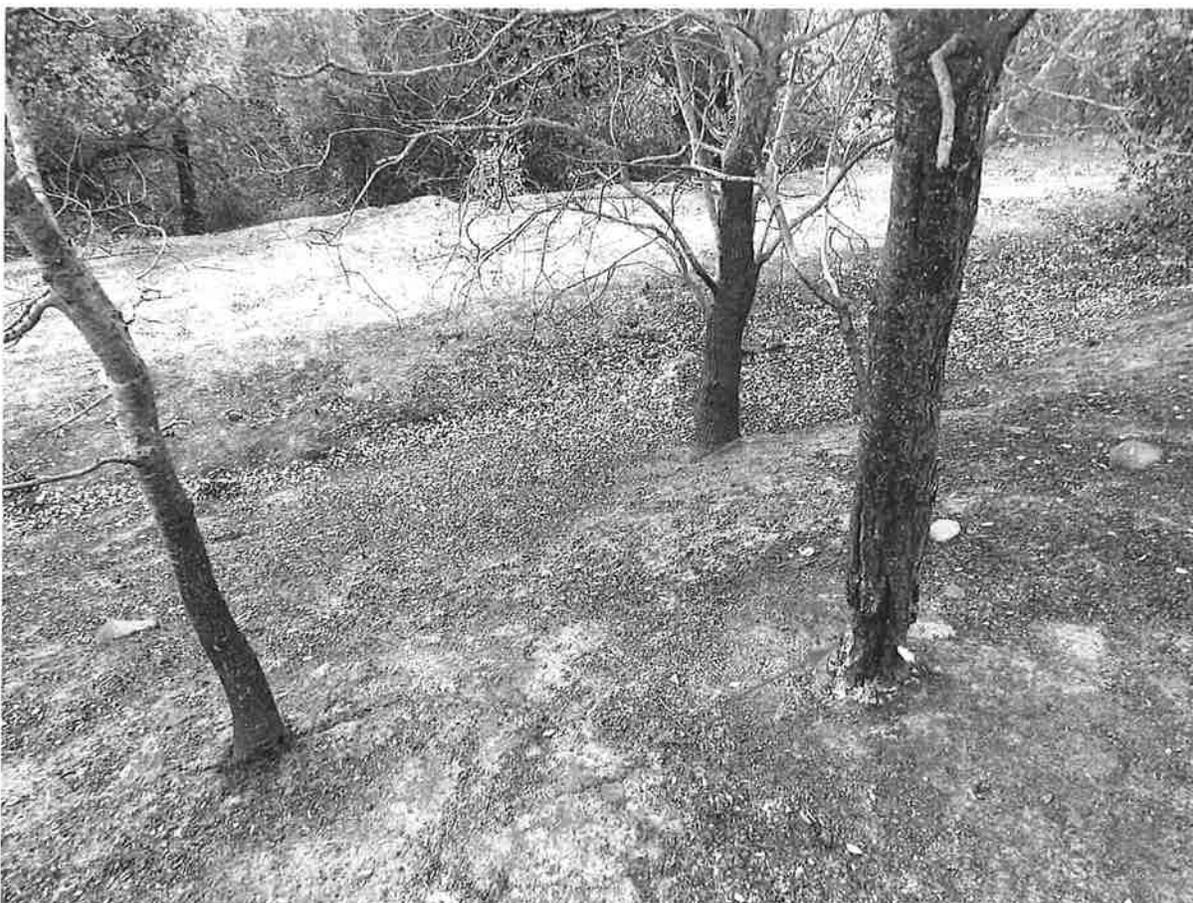
Three small coast live oaks, four inches dbH to five inches dbH, located just west of the existing dirt trail on the easterly portion of the site, had been severely damaged. No tags could be located on any of the trees in this general area. Two of the trees' lower trunks were completely girdled by the fire. In the same general location, a third tree sustained severe damage to its lower trunk. Based on its general location and photos taken at the time of the inventory, we tentatively identified this tree as tree #65. Two small scrub oaks in the same general vicinity may also have been top-killed by the fire.

**Girdled trunk of small coast live oak, existing dirt trail in middle ground**

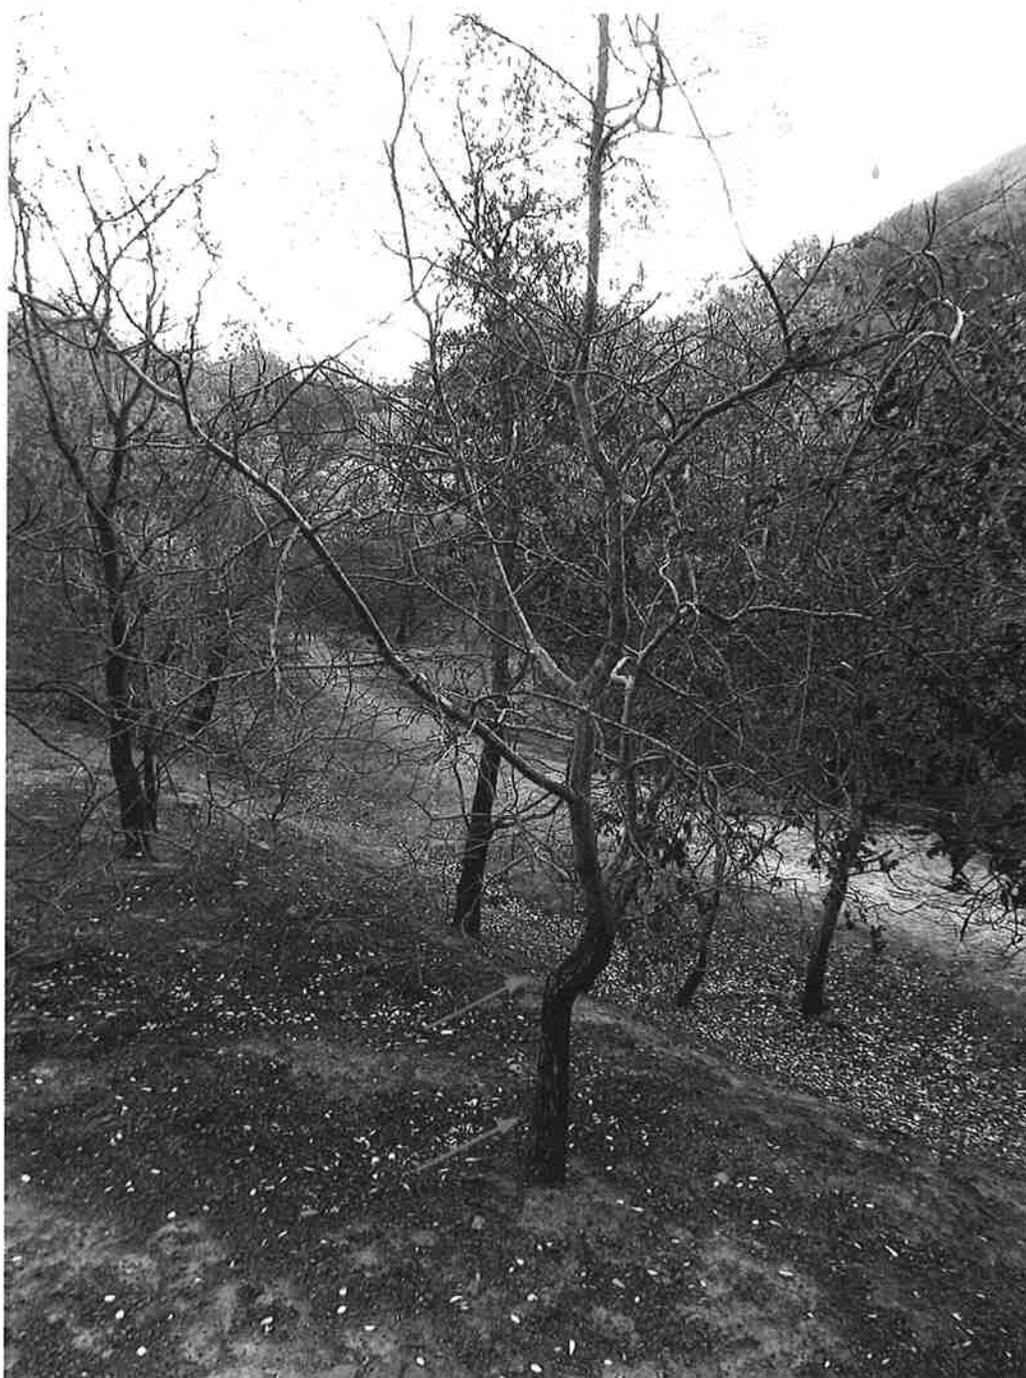
**Severely damaged coast live oak, tentatively identified as tree #65**

A copy of this report should be presented to the City of Calabasas as justification for the required permit to allow pruning and removal of the specific trees discussed above. Reference and record photographs are attached and should also be provided to the City as part of the permit application.
