CITY *of* CALABASAS

LAS VIRGENES CREEK
POLLUTION SOURCE INVESTIGATION

By: Matt Horns
Intern, City of Calabasas Environmental Services Division
May 2007

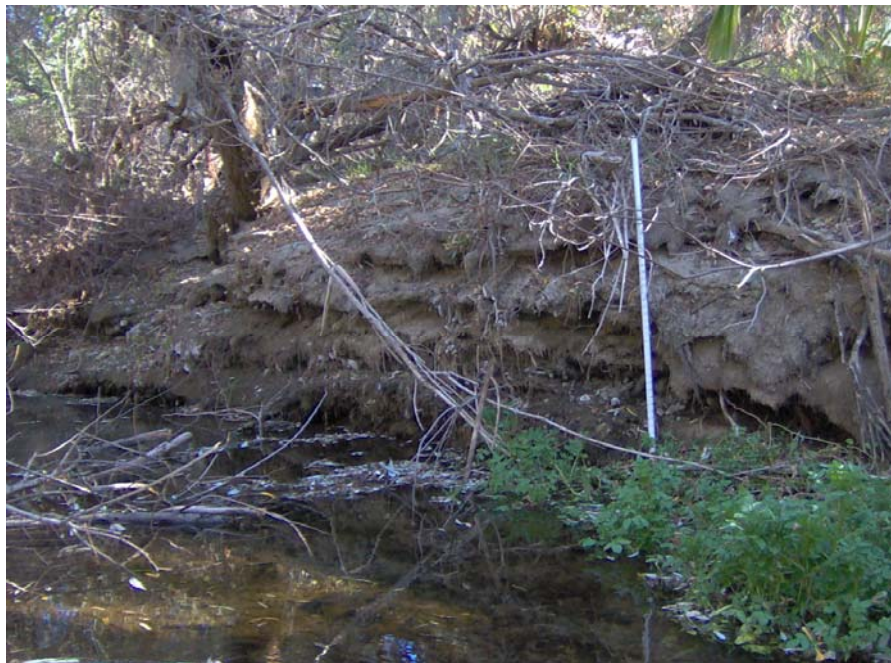
Image 1: East bank at Station LVH

Las Virgenes Creek's erosion/sedimentation processes are quite complex, as exhibited by the photo above of the stream bank at Station LVG. The light-colored horizontal bands are a succession of sandy sediment layers that are strengthened against erosion by root systems that developed soon after the sediment layers were deposited. This series of sediment layers represent a time period during which sediment was accumulating in the channel and the stream bed elevation was rising.

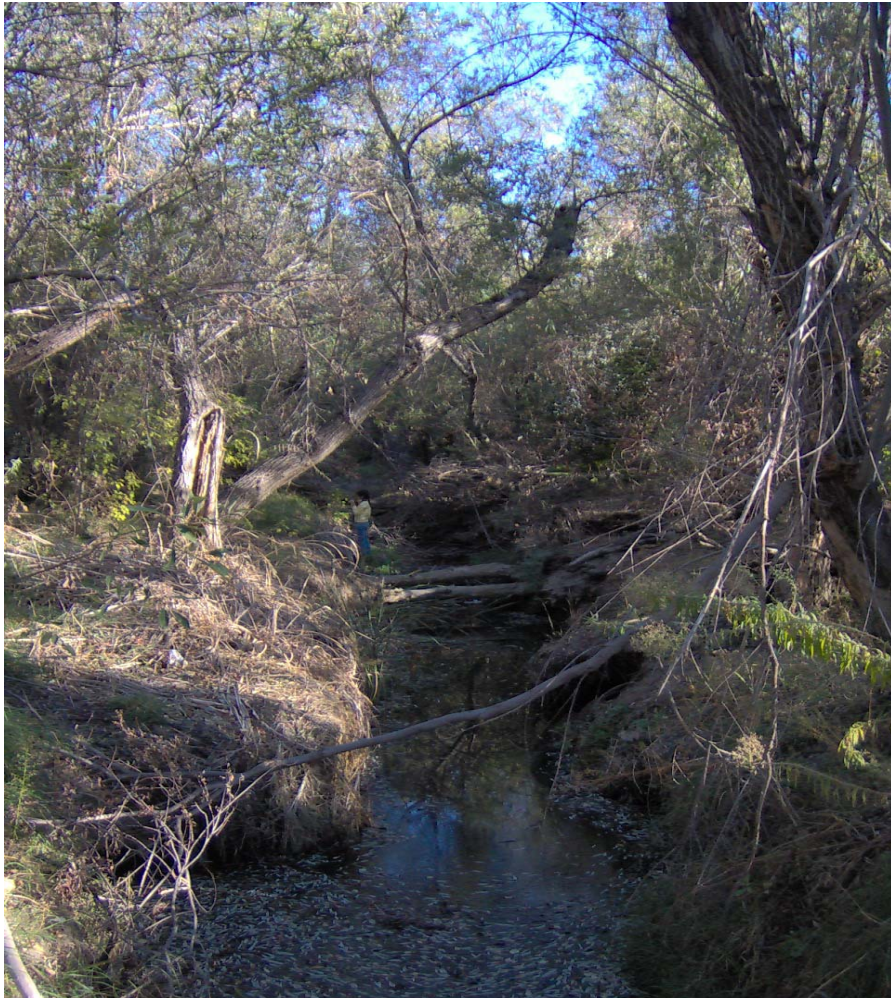
Image 2

The photo above is looking downstream at the same location as Image 1. Willow roots that originally grew in the stream bed are now elevated several feet above the thalweg. These exposed tree roots demonstrate that the stream is now downcutting. That is, sediment is now being flushed out of the channel and the stream bed elevation is declining.

urban development. Soil grading associated with urban construction typically generates large amounts of sediments that are stored in the channel. When construction is completed, graded areas that have experienced erosion are replaced by pavement and homes. These impervious surfaces increase storm water runoff and reduce sediment input. Subsequent storm runoff events tend to deliver increased amounts of water and reduced amounts of sediment to the stream channel, which results in stream downcutting through sediment stored in the channel.

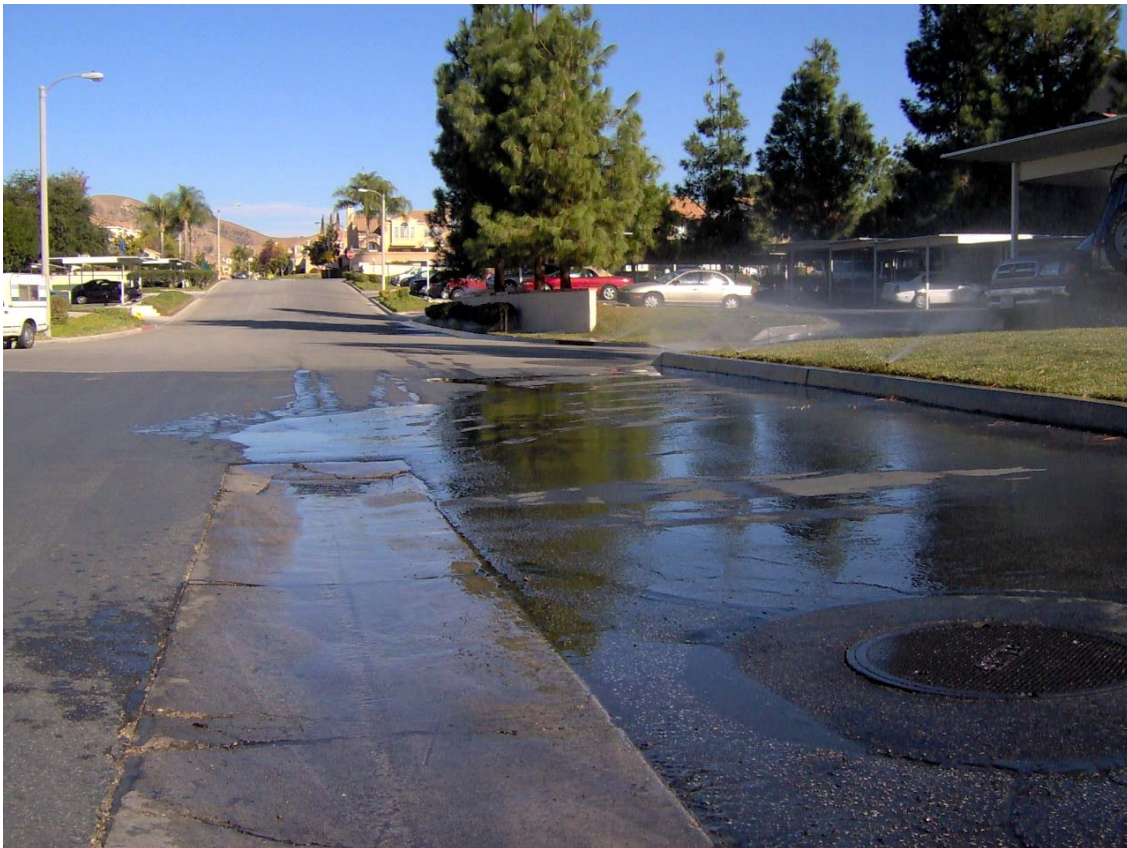
An extreme example of over-watering was observed on 8 December at the south end of Poppyseed Lane.

Image 3: Irrigation runoff at south end of Poppyseed lane entering a storm drain

Urban runoff could most likely be reduced significantly if people that construct and use watering systems are educated in the problems caused by over-watering and misdirected sprinklers. Once they are aware of the problem, they can easily avoid sending irrigation water down the storm drain system.

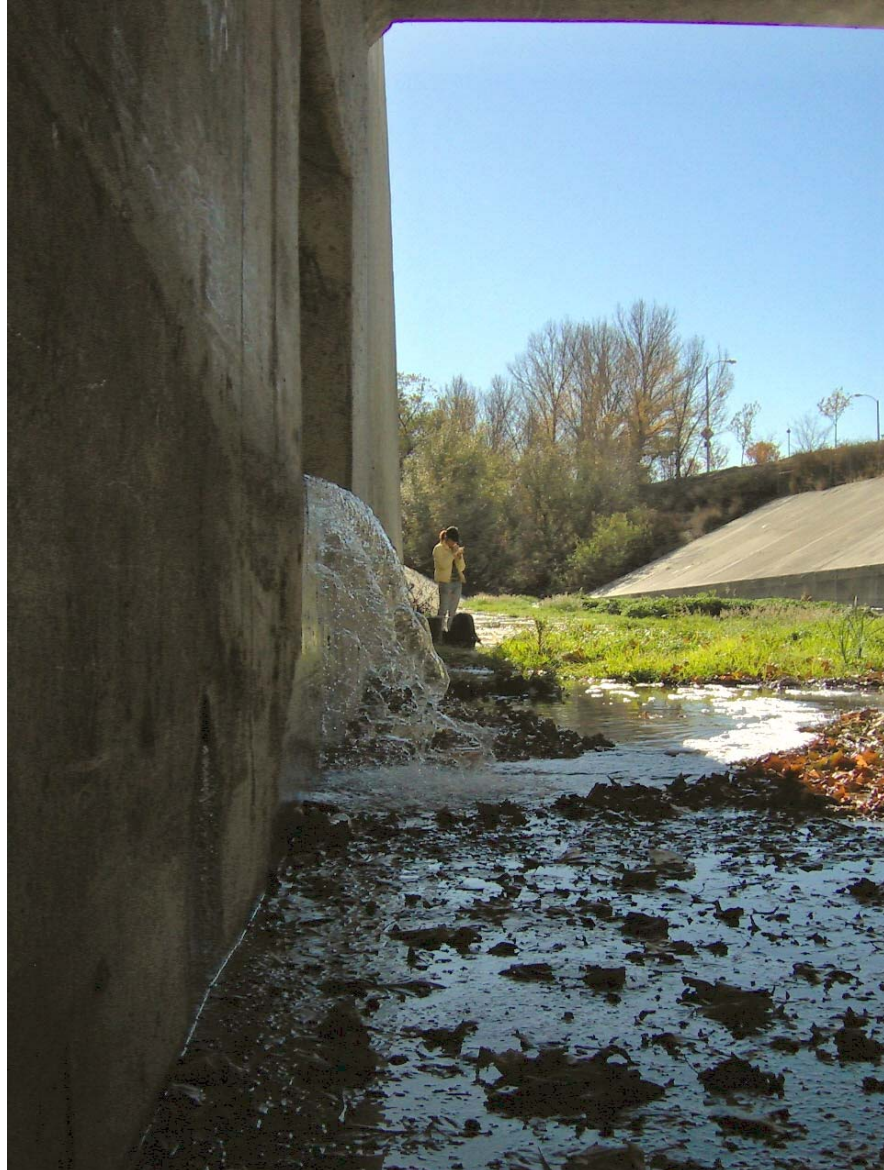
Image 4: Runoff from Poppyseed Lane entering Las Virgenes Creek

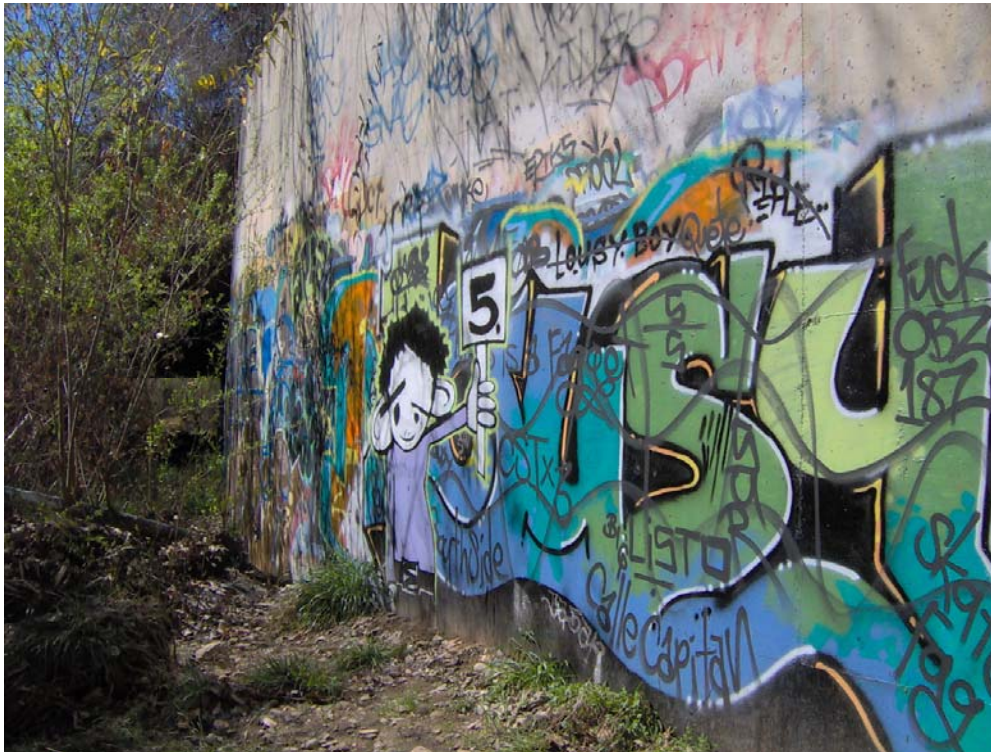
West bank immediately upstream from Las Virgenes Road

Of particular concern is the bridge where Las Virgenes Road crosses Las Virgenes Creek just north of the 101 freeway.

Concrete walls along the stream bank at this location are popular among graffiti vandals. They routinely leave spray paint cans, used paint brushes, and even cans partially full of highly toxic oil-bases paint in the stream channel, where it is subject to entrainment by high storm flows.

This problem is not easily solved. Here are a few recommendation, but it can be reduced by:
