September 24, 2019

**RE: POST WOOLSEY FIRE OAK TREE ASSESSMENT REPORT
'WEST VILLAGE' DEVELOPMENT PROJECT
4790 LAS VIRGENES ROAD, CALABASAS, CALIFORNIA**

**DRAFT POST-WOOLSEY FIRE
OAK TREE IMPACT ASSESSMENT EXHIBIT**

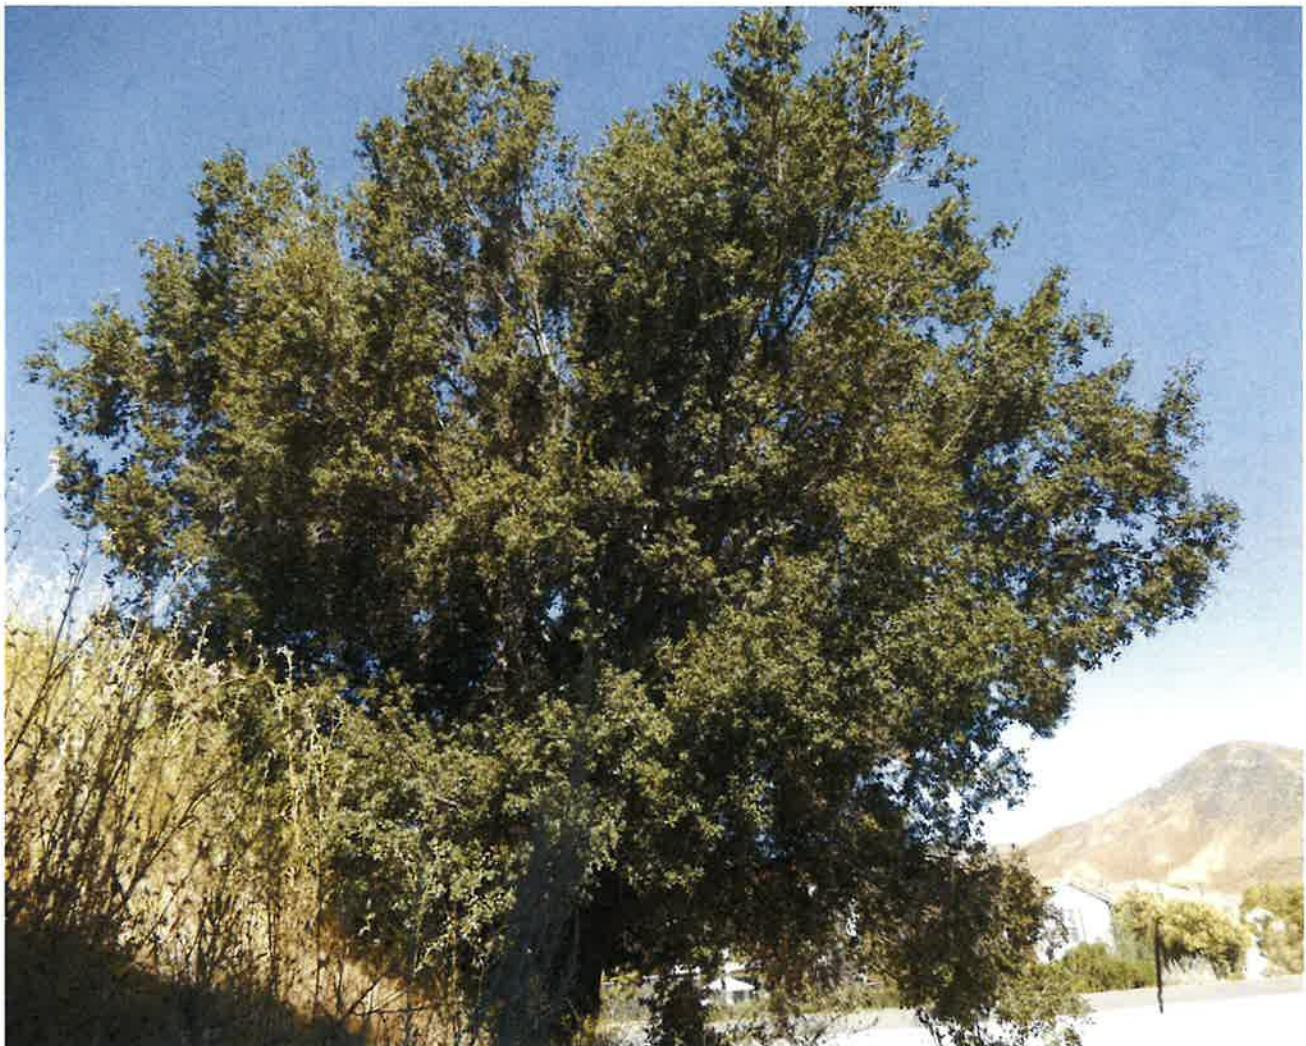
- No fire damage noted in the crown or on the trunk
- Minor fire damage on the trunk or limbs that is confined to only the outer bark
- Minor leaf desiccation throughout the crown or only a small portion of the canopy scorched
- No cavities or minor, pre-fire cavities that have not been worsened
- Minor or no defoliation of the canopy

Example of an oak tree with minor fire damage

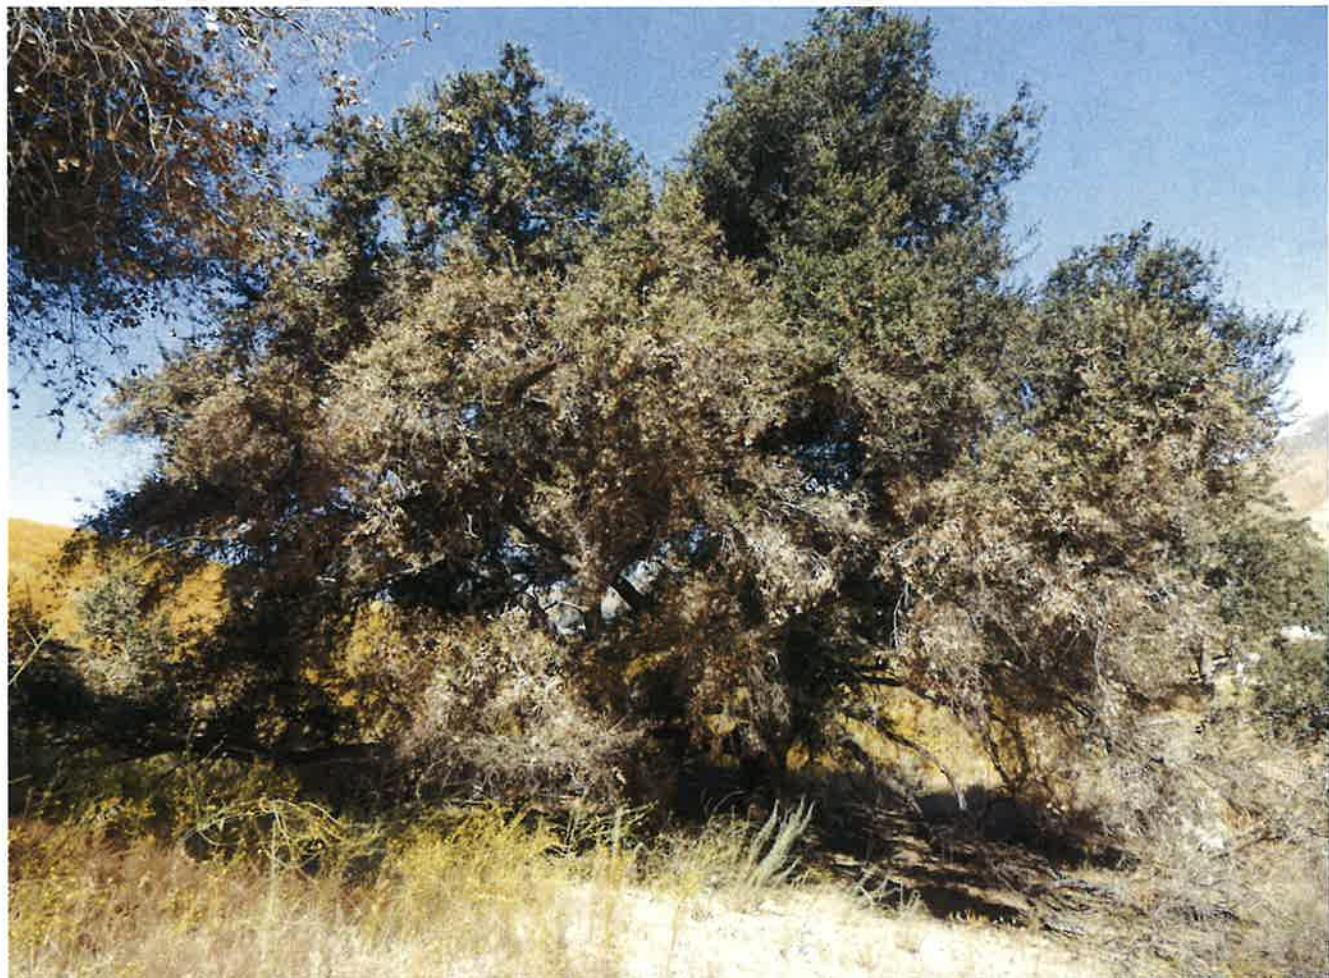
- Moderate fire damage on the trunk, underside of limbs, or entire limbs that has penetrated beyond the outer bark but not to the extent that structural damage is likely in the long term
- Moderate leaf desiccation throughout the crown or up to approximately 50% of the canopy scorched
- New epicormic growth is robust and well distributed
- New cavities in the trunk that are small (generally less than 1/3) relative to the trunk diameter
- Moderate defoliation of the canopy

Example of a tree with moderate fire damage

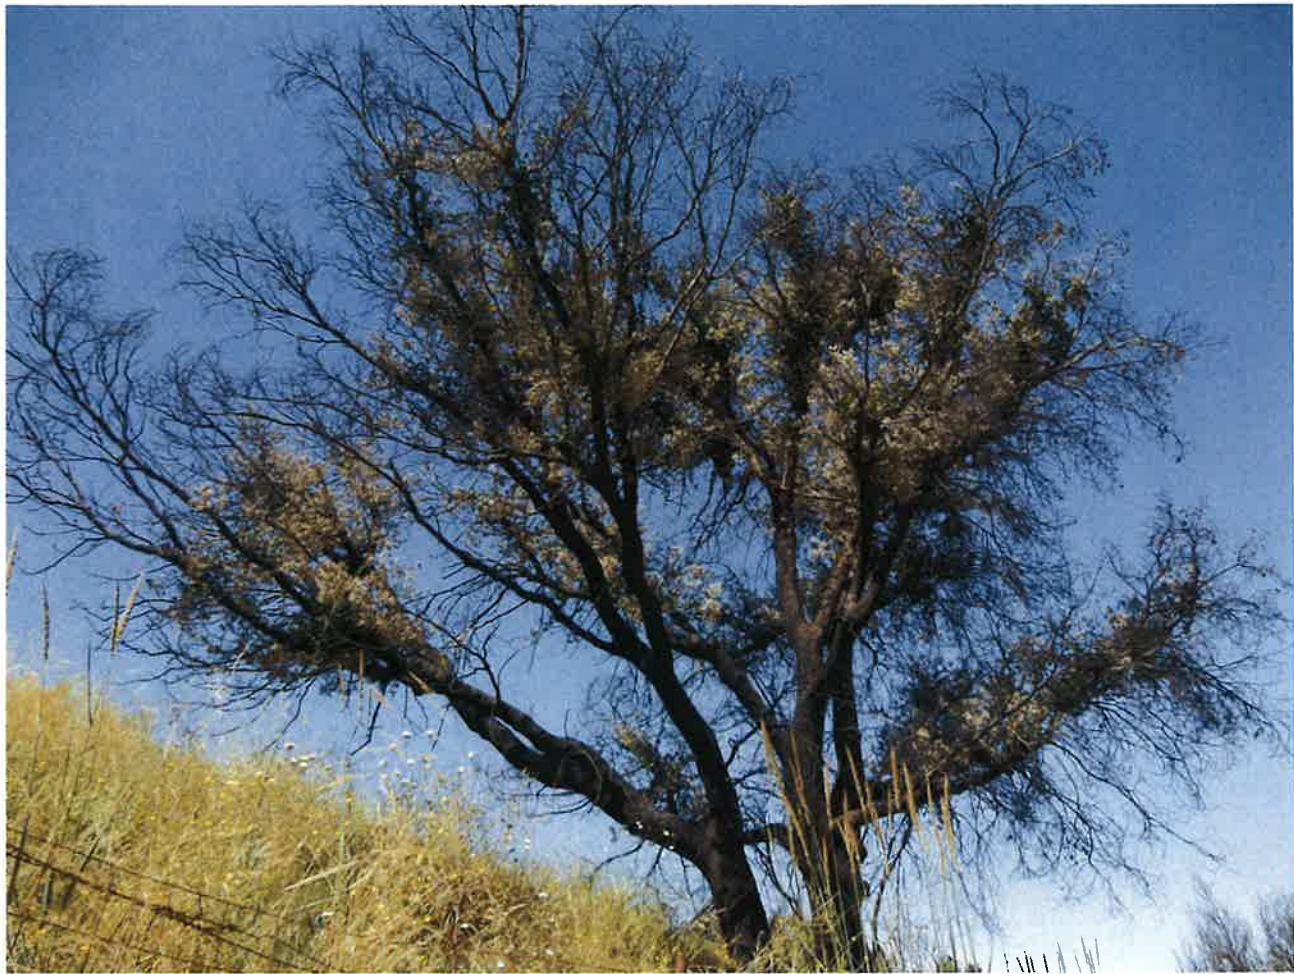
- have been completely or significantly defoliated
- have severe bark damage that may have penetrated to the cambium layer underneath
- have cavities and/or hollows that have been significantly worsened (structural issues)

Example of a tree with severe fire damage - with some recovery

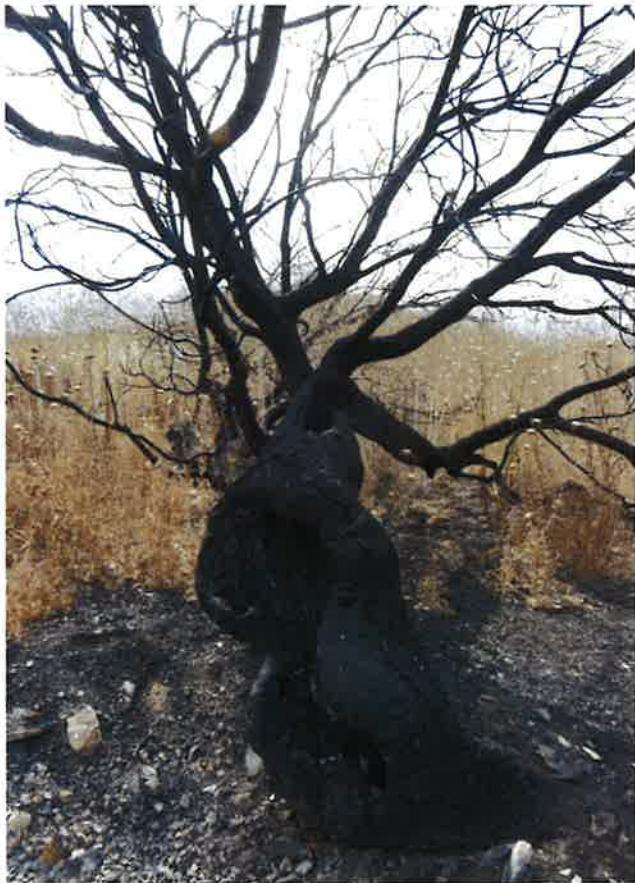
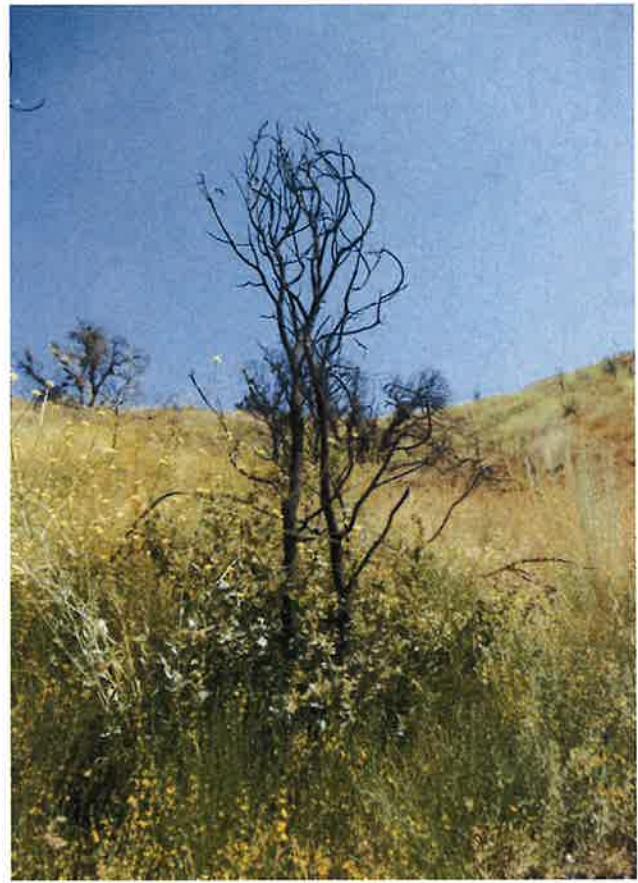
- new epicormic growth may be present from the basal root stock or in the canopy
- most of the severely impacted but recovering trees that put out epicormic growth have suffered from a fungal disease of the new young shoots called powdery mildew. It infects tender new shoots, covering them with fungi that deplete fluids, deform and retard growth, and kill twigs and leaf buds. Normally, oaks can handle light-moderate powdery mildew infections by pushing new growth the following season. Post-fire, it is normal for oaks to respond with new epicormic shoots that arise from previously dormant buds on the branches, twigs, and even the trunk. If a tree uses a significant amount of carbohydrate storage from the unburned root system to generate new foliage, and that foliage is killed by disease, photosynthesis will be minimized and the tree may not be able to produce enough new carbohydrate to flush again the following season. Fire-damaged trees are also using stored carbohydrates to form new bark and callus tissue. Severe infections of powdery mildew will inhibit a tree's ability to produce photosynthates and will slow recovery. Some trees may not have sufficient carbohydrate storage to put out a second round of epicormic growth and those trees are high risk for irreversible decline and death.

Example of a tree with severe fire damage - with no recovery on left and with basal sprouts only on right
