June 14, 2022

SUBJECT: Tree Report for 3821 Eddingham Avenue, Calabasas, CA

Tree Report

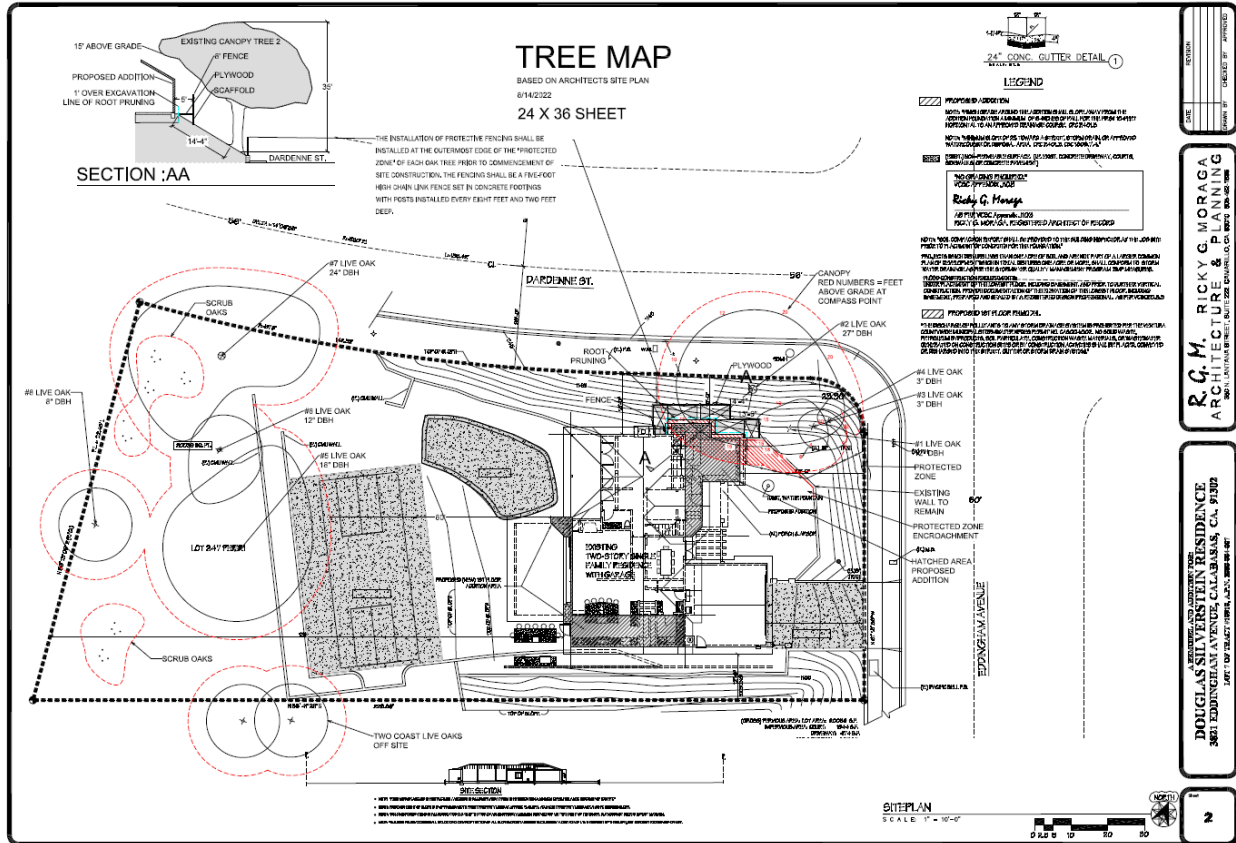
Appendix A Tree Map

Based on my report, you need a permit to encroach into the protected zone of two oak trees including one that is large enough to be called a heritage oak per the city ordinance. Encroachment will affect ten percent of the protected root zone of trees 1 and 2 as shown on the tree map (the red hatched area). The encroachment will be at least fourteen feet from the trunks and lost roots should be replaced in one to two years. This encroachment should not cause any long-term damage to the oak trees if the protection measures are used as recommended.

The tree map shows the location of trees relative to the renovation. Canopies are shown as measured in the field. Proposed protection measures are shown on the tree map including root pruning at the limits of excavation, root zone protection by way of a scaffold and wire mesh construction fence to protect the tree. The city may impose other conditions.

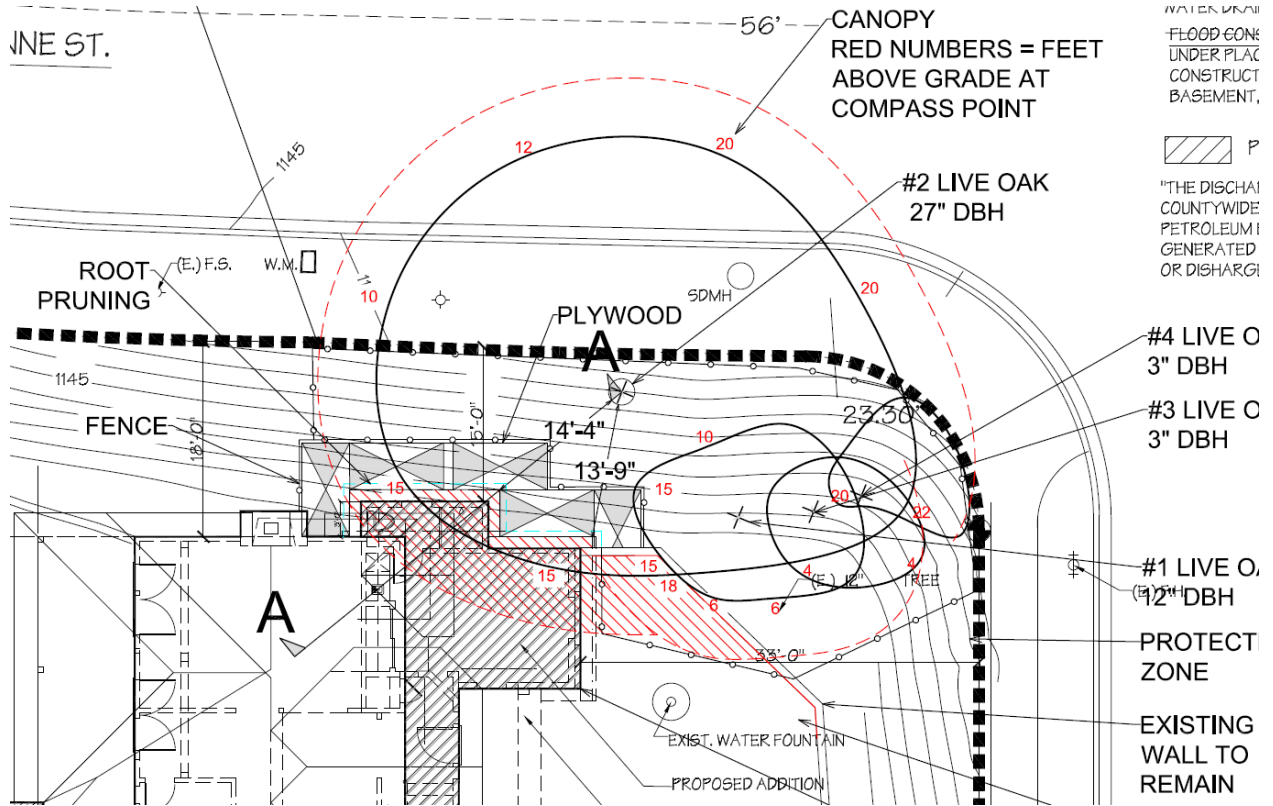
Enlarged Detail of area of concern from Tree Map

There are four coast live oaks (botanical name *Quercus agrifolia*) within the area of proposed improvements to your house in Calabasas. The largest tree (ID number 2) will have about ten percent of its root zone disturbed by the foundation for the proposed house addition. This vigorous young tree will likely replace the lost roots in one or two growing seasons and should suffer no long-term negative impact. Tree #1 will have some minor impact to its protected zone in the form of landscaping. No other protected trees on the lot will be affected.

Tree 2 is a heritage tree by virtue of its trunk circumference but is probably two or more young oak trees growing together. That means this tree is probably younger and more vigorous than the typical heritage tree. This tree should tolerate the ten percent root loss. It is important to properly prune the roots to limit the damage. Before digging make sure the root zone is moist. Hand dig a root pruning trench at the edge of excavation under oak tree #2. Expose all woody roots for 18 to 24 inches deep. Cut the exposed roots with a saw or pruning shears, cover the trench side with burlap and wet it down.

The slope under tree #2 is too steep for standing so scaffold will be needed for any exterior work. The scaffold deck will protect the root zone. The tree protection fence should be placed right behind the scaffold and tree protection signs posted every 20 feet.

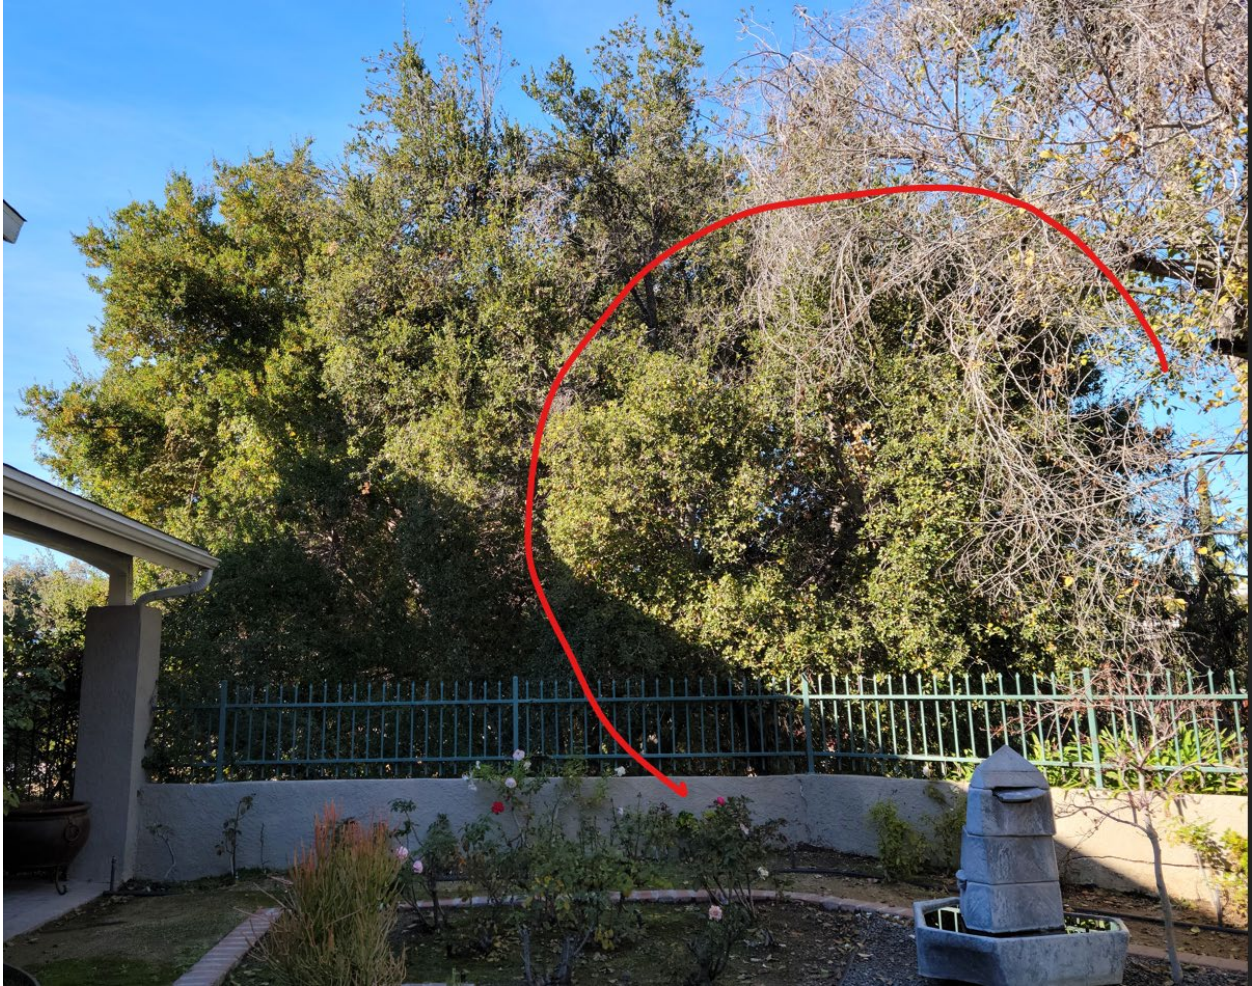
1 Coast Live Oak

Tree 1 is separated from the proposed construction by a three foot block wall. The canopy will not be affected. Some roots may be disturbed by the installation of new landscaping.

The roots and trunk of tree 1 appear normal. No pest or insects visible from the ground, no signs of borers on the trunk. No treatment needed. I would check this tree again in eighteen months.

Looking north, canopy merges with tree #2

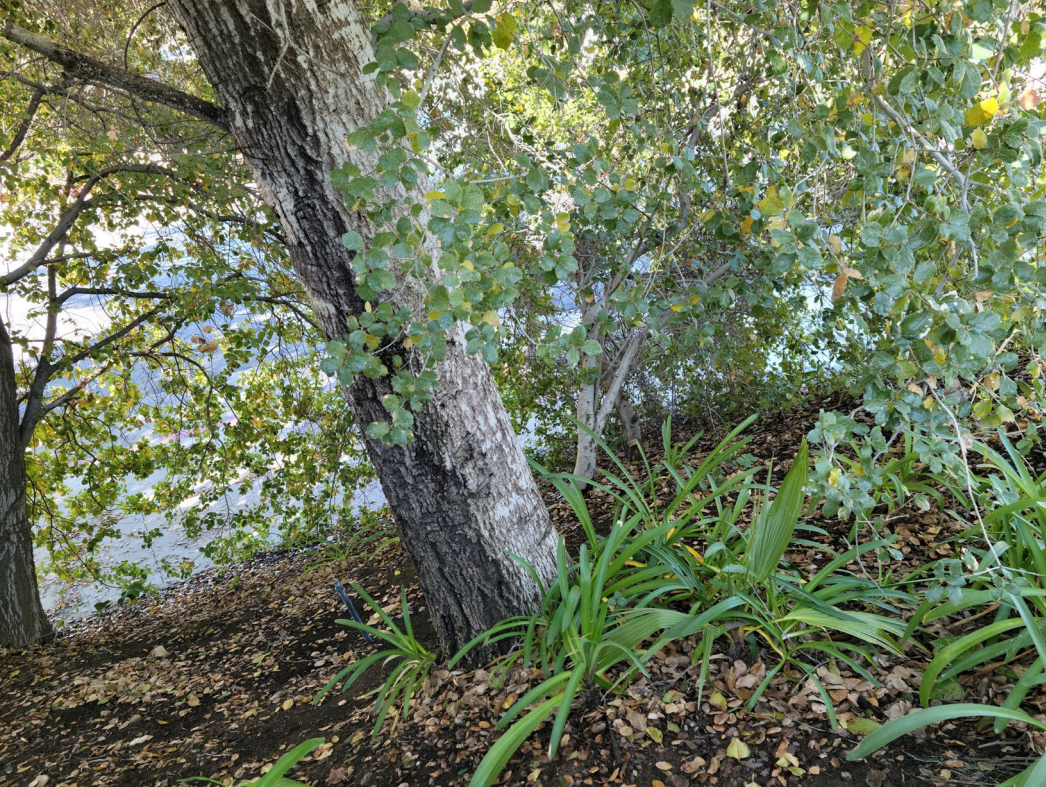
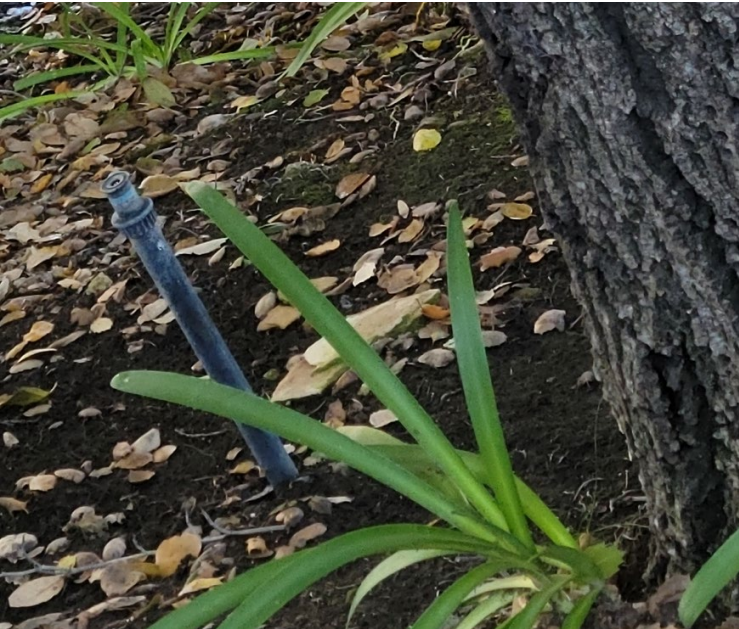
1 Coast Live Oak

Distance/Direction: 10 feet looking north. Root zone okay above average.

relocate head

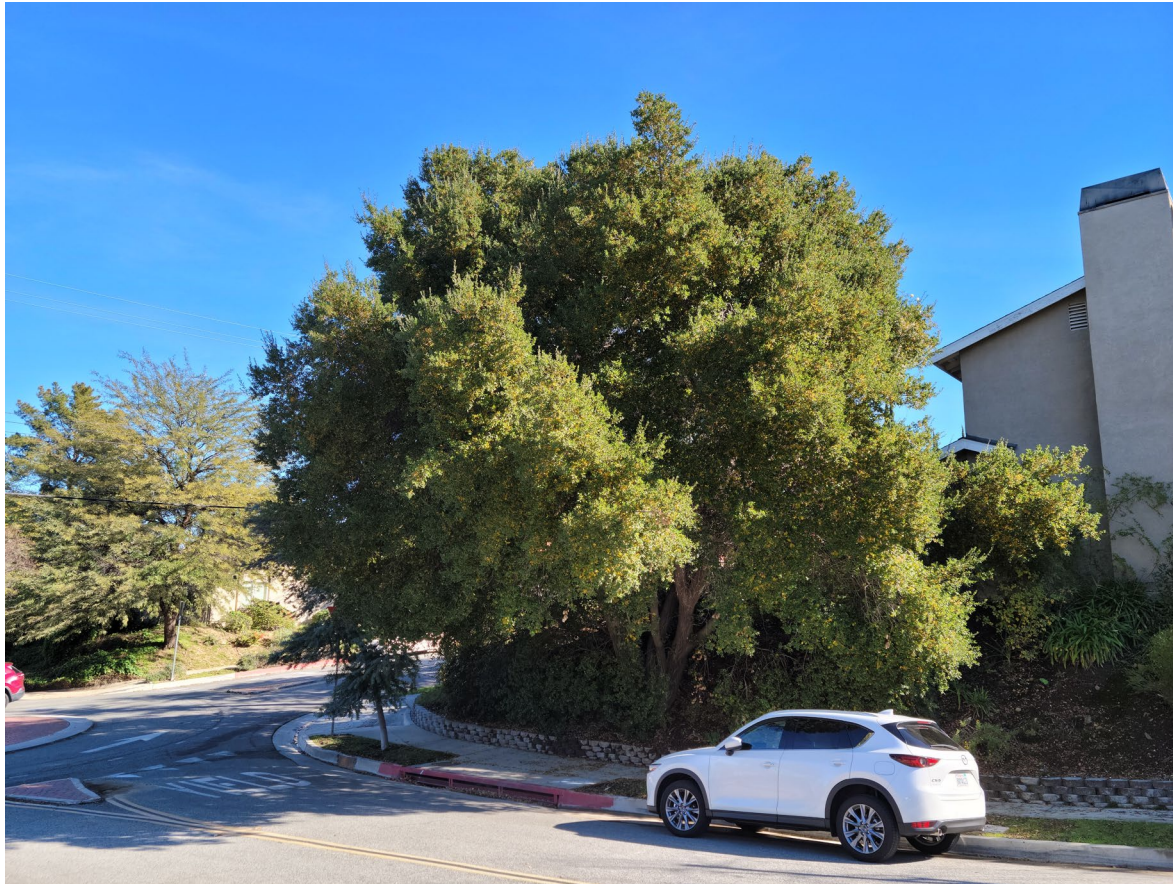
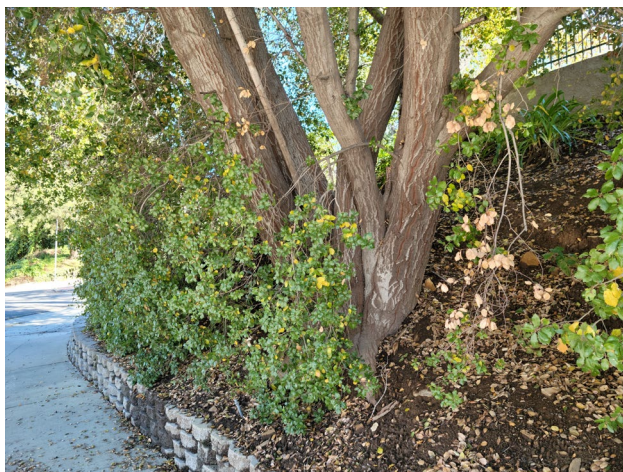
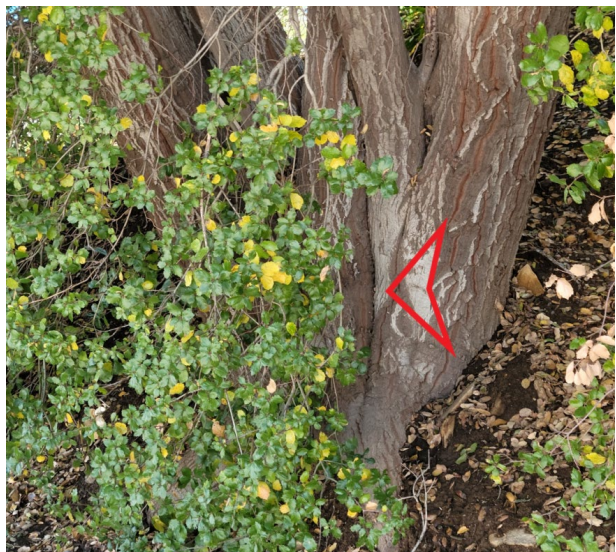
2 Coast Live Oak

Distance/Direction: 60 feet looking south, house photo right, below 6 feet looking south

No canopy pruning should be needed at this time for tree #2. If branches protrude into the working space, they can be temporarily tied back for working clearance. In one or two years tree #2 will need to be pruned for clearance of the house, sidewalk, and street. I recommend hiring as qualified arborist to prepare pruning instructions to shape the canopy for clearance rather than shearing the edges which damages the tree and requires repeated pruning. I would assess this tree for pruning in six to eighteen months.

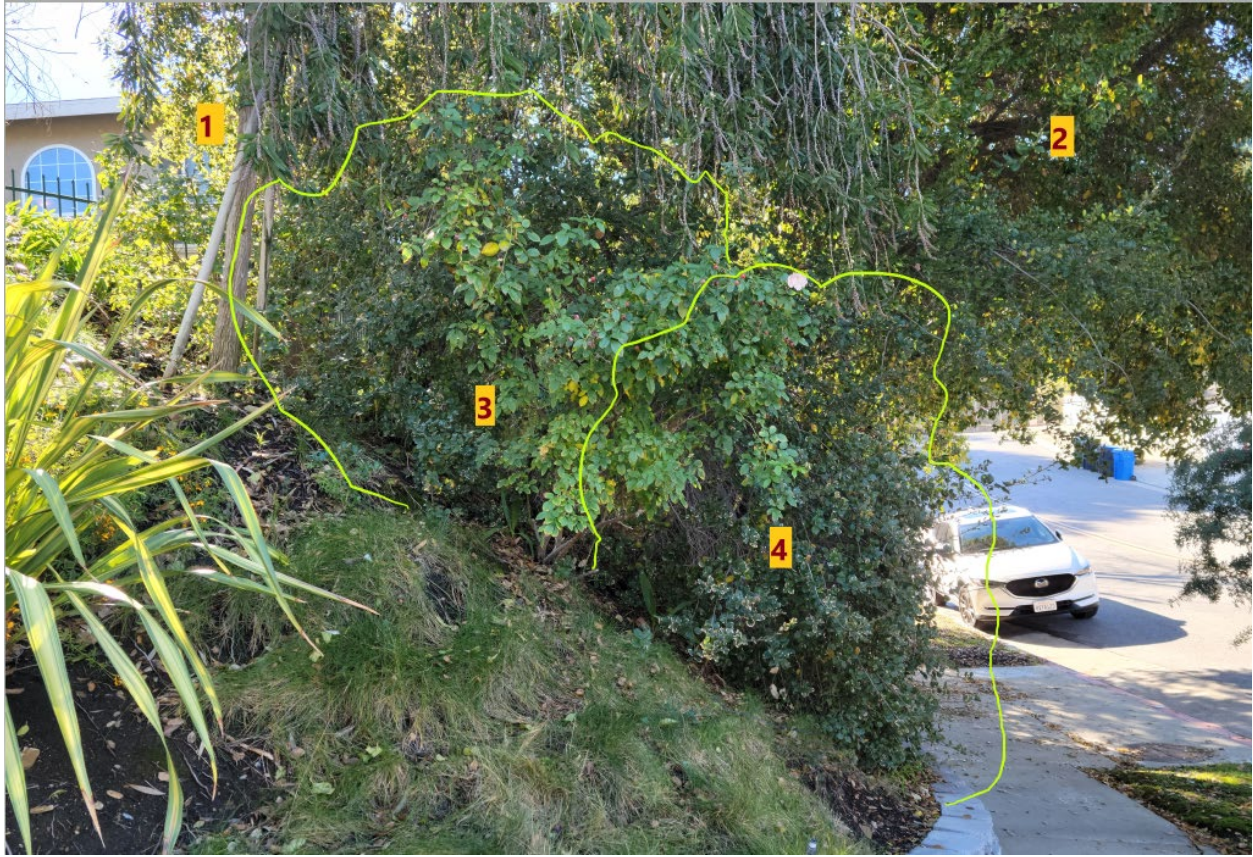
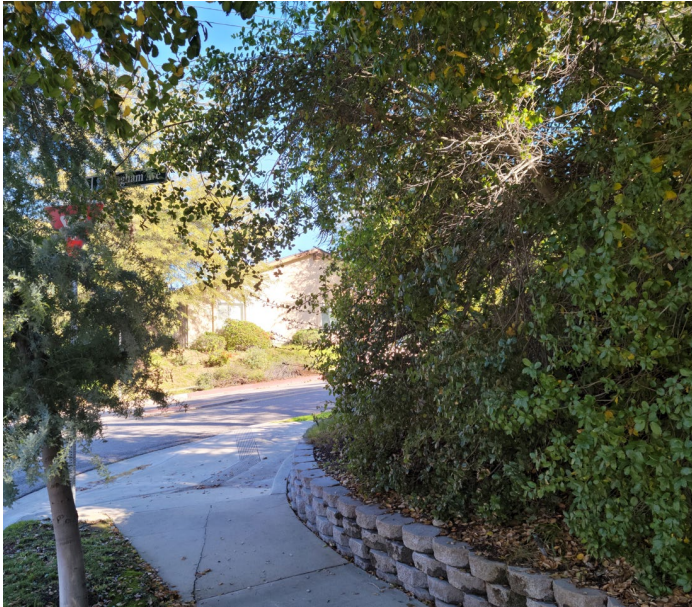
3 and 4 Coast Live Oak

Trees 3 and 4 are suppressed oak trees growing in the shade of oak tree #2. These tree should not be impacted by the proposed improvements. Prune as needed when tree #2 is pruned.

Distance/Direction: 20 feet looking west, below 10 feet looking east

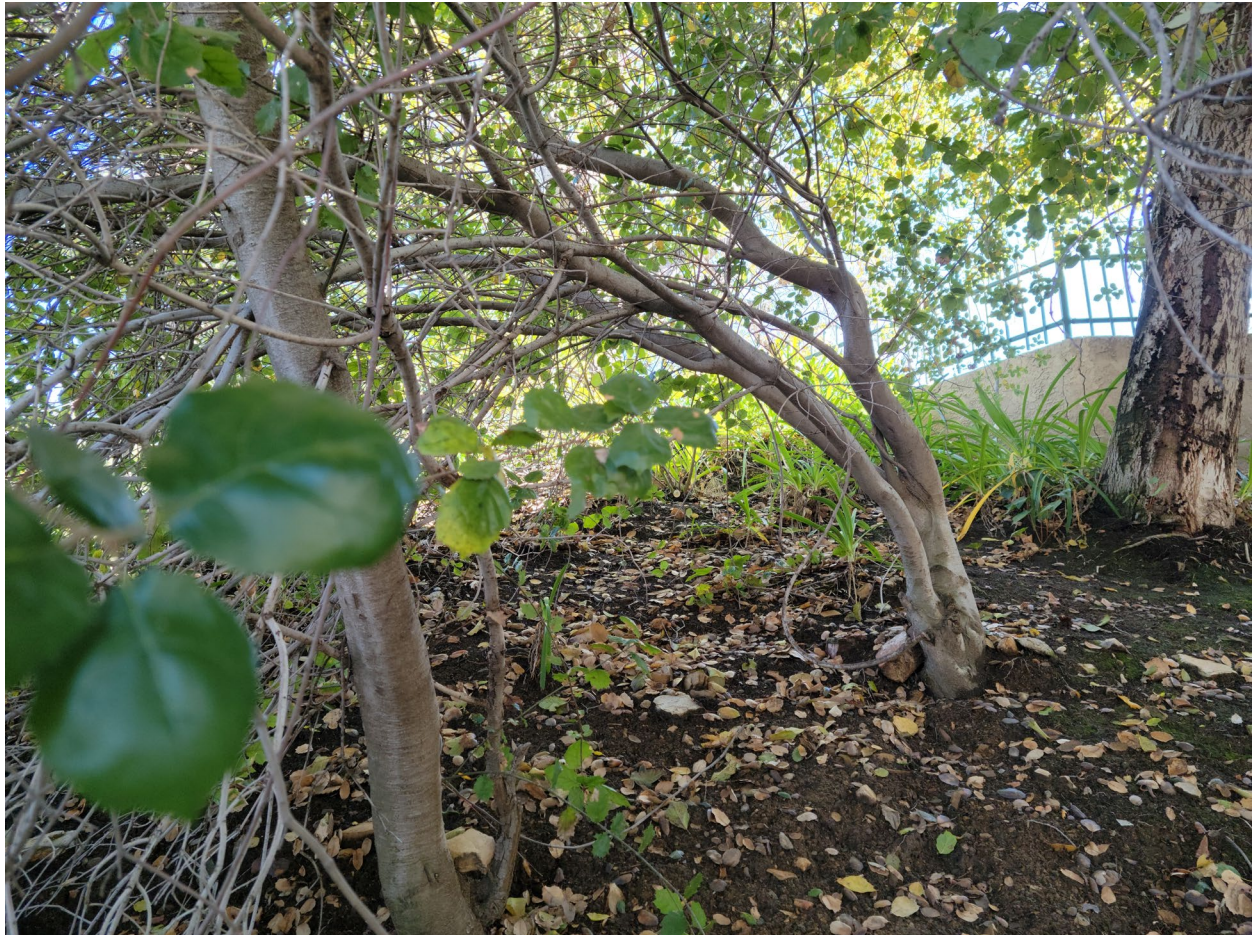
3 Coast Live Oak

Distance/Direction: 10 feet looking south, tree 1 upslope right, tree 4 on left.

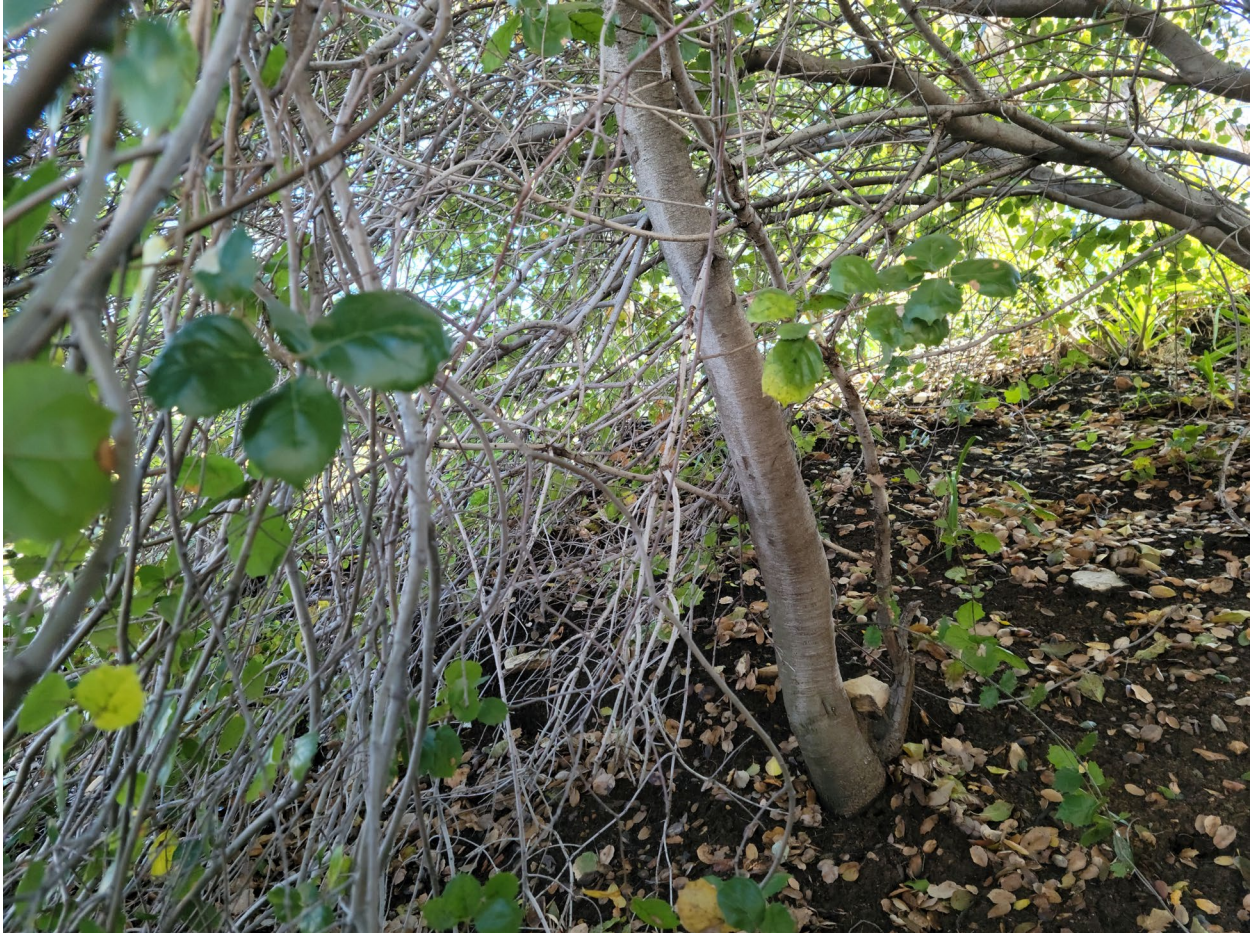
4 Coast Live Oak

Distance/Direction: 5 feet looking south, tree 3 upslope right.
