## MEMORANDUM

**To:** Michael Klein – City of Calabasas  
**From:** Noah Stamm, Calabasas Contract Arborist  
**Subject:** *Minor Healthy Oak Tree Permit Peer-Review Report for 23548 Calabasas Road, Calabasas, California*  
**Date:** September 2, 2021

## Attachment 1 – Site Plan Review Oak Tree Report for 23548 Calabasas Road Representative Site Photographs

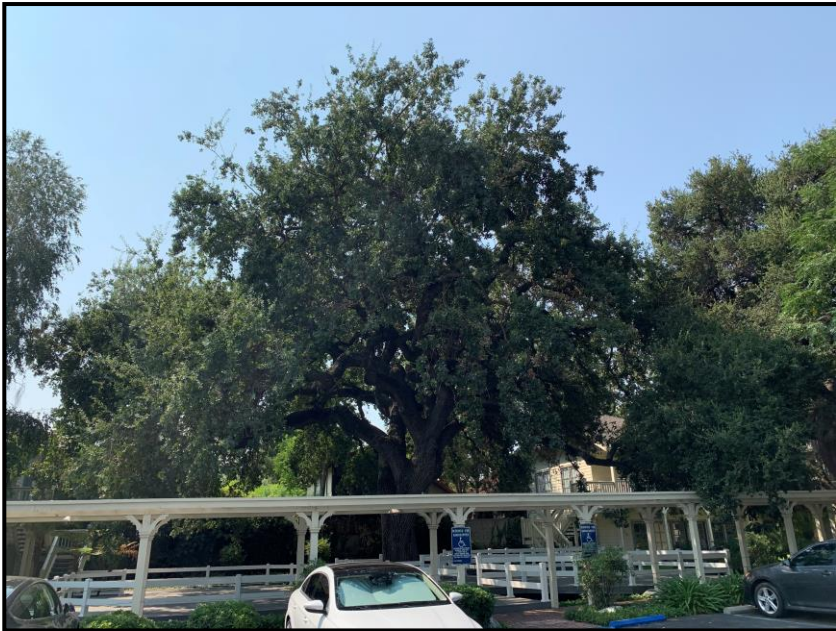
1. Overview of large, 'heritage' Valley Oak Tree located in the courtyard of Leonis Plaza at 23548 Calabasas Road. Photograph taken facing north side of the tree.

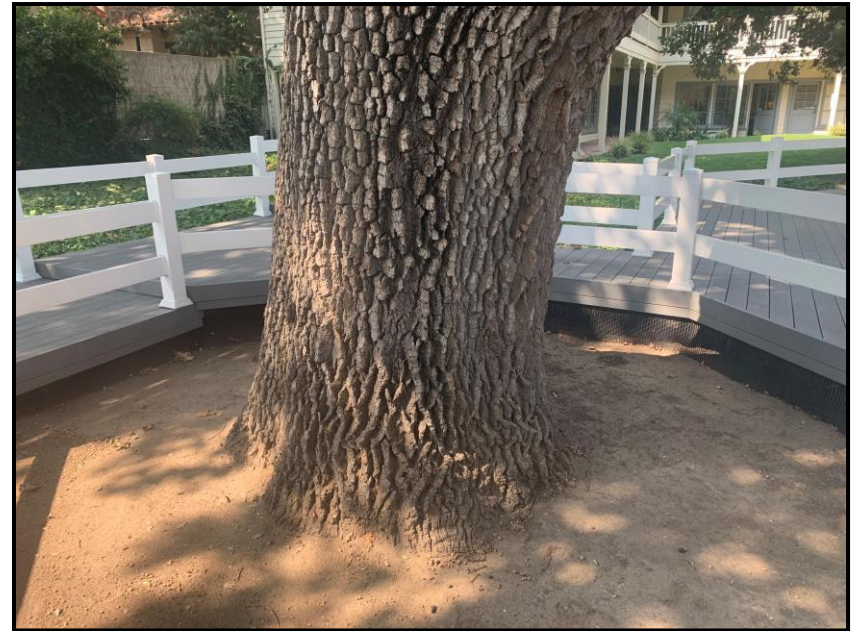
2. Base of large, 'heritage' Valley Oak Tree. Photograph taken facing southeastern side of the tree's trunk.

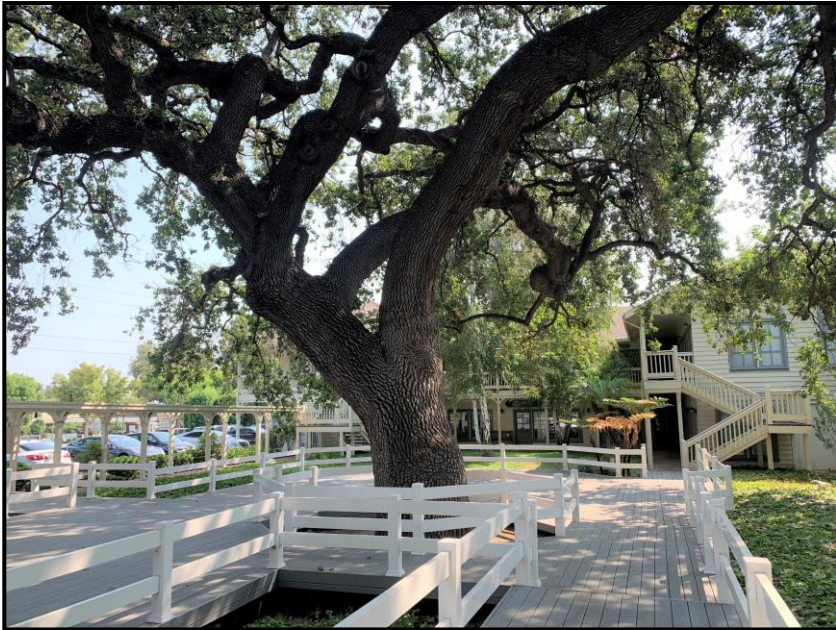
3. Photograph of the lower portion of the western side of the tree's trunk.

branches located on the southeast and southwest sides of the tree's crown that are hanging low over the courtyard area. The branches are identified in photograph nos. 3 through 10 of *Attachment 1*. Cuts should be made cleanly at branch collars thus avoiding potential small branch sprouting (epicormics) along the cuts and reducing future maintenance and shall be done to the appropriate ISA pruning standard.

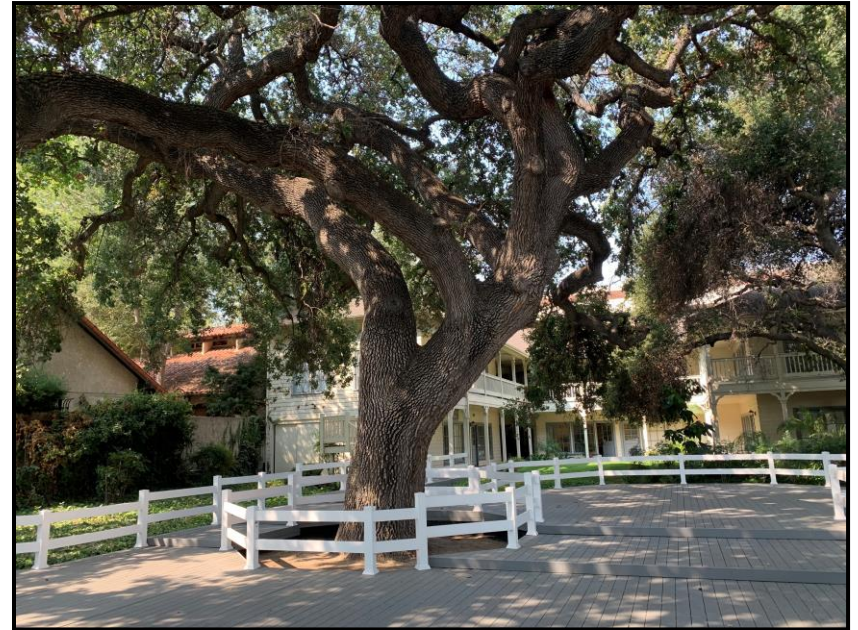
4. Photograph of the lower portion of the eastern side of the tree's trunk.

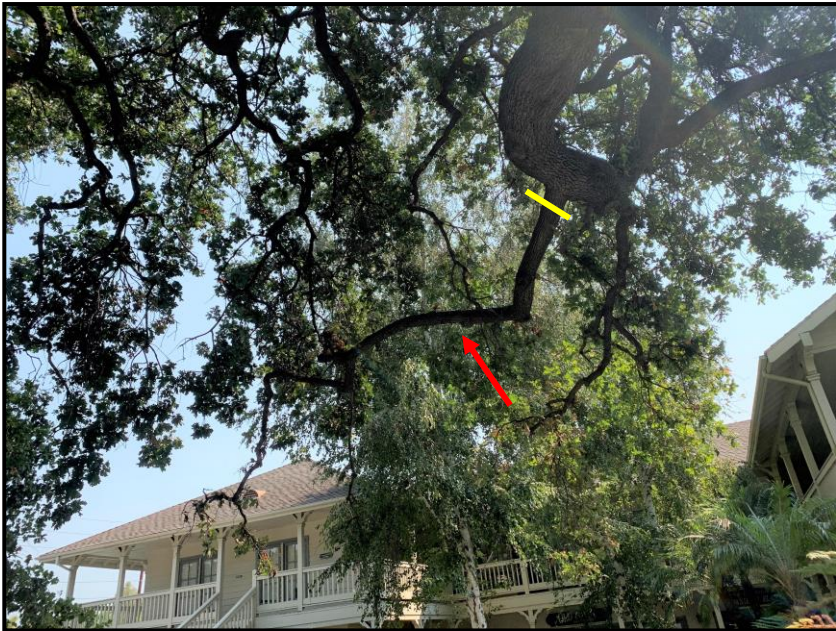
5. Photograph of large branch hanging over property's courtyard (red arrow). Cut should be made back to crotch of main trunk (yellow line). Photograph taken facing up into the eastern portion of the tree's crown.

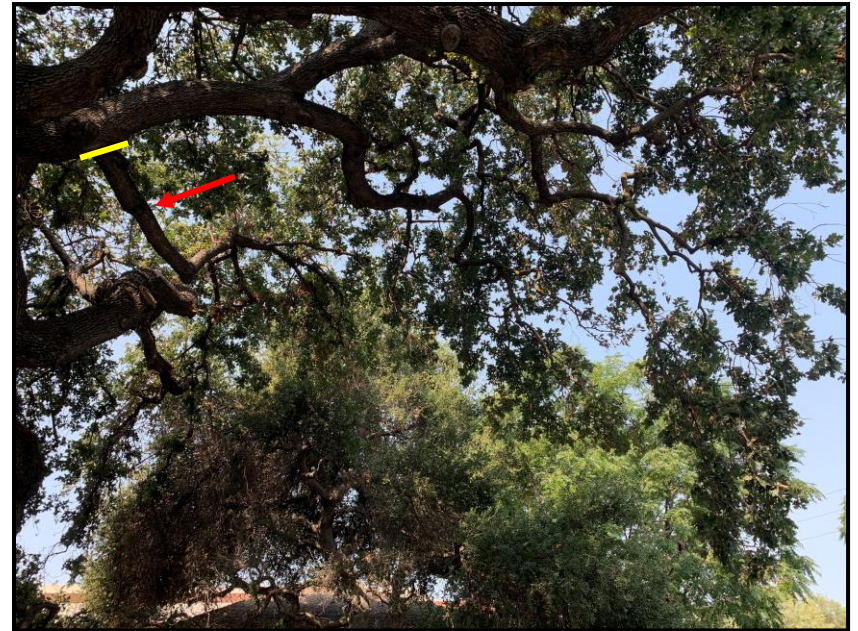
6. Photograph of several branches hanging over property's courtyard (red arrow). Cuts should be made back to crotch of main trunk (yellow line). Photograph taken facing up into the northern portion of the tree's crown. Deadwood throughout the tree's crown can be removed as well.

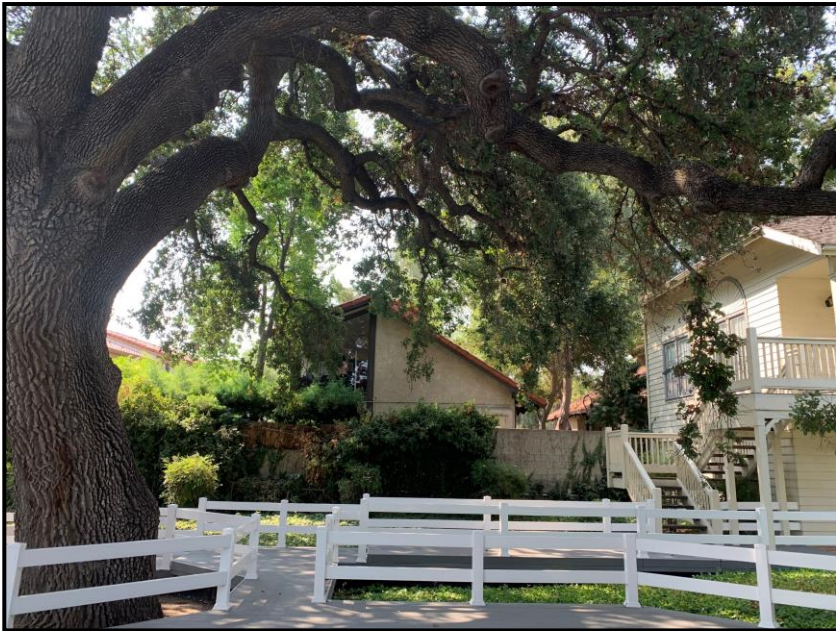
7. Photograph of several branches hanging over the western portion of the property's courtyard. Photograph taken facing up into the western portion of the tree's crown. Deadwood throughout the tree's crown can be removed.

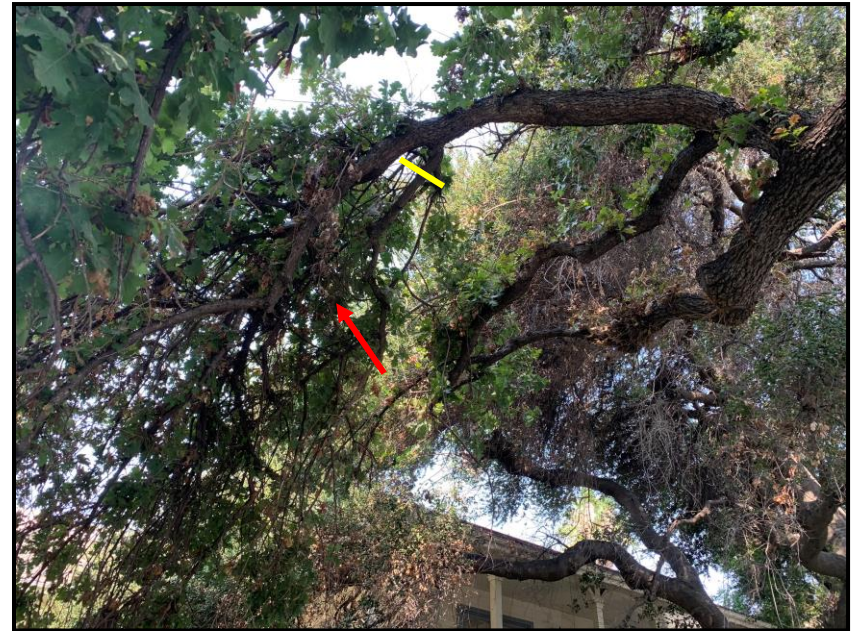
8. Photograph of several branches hanging over the western portion of the property's courtyard (red arrows). Cuts should be made back to crotch of main trunk (yellow line). Photograph taken facing up into the western portion of the tree's crown. Deadwood throughout the tree's crown can be removed.

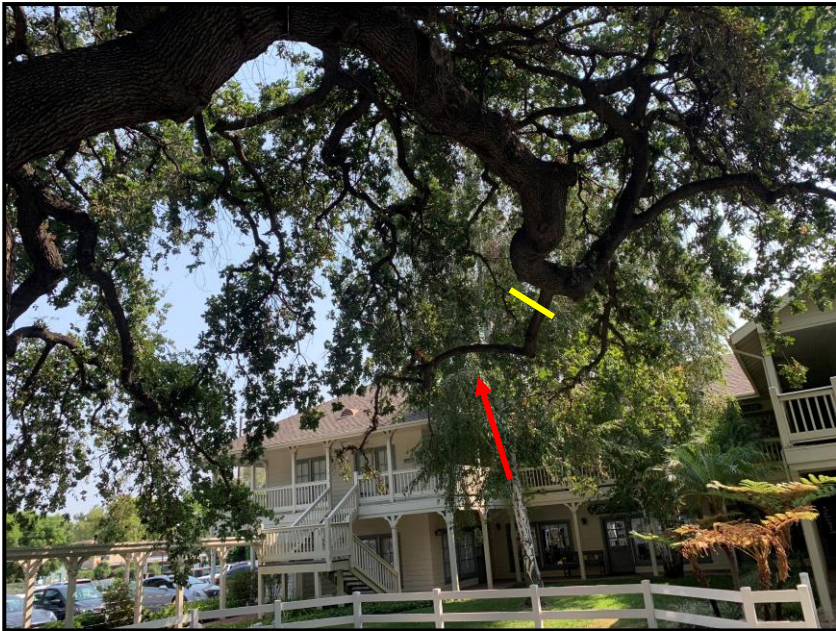
9. Photograph of large branch hanging over property's courtyard (red arrow). Cut should be made back to crotch of main trunk (yellow line). Photograph taken facing up into the eastern portion of the tree's crown.

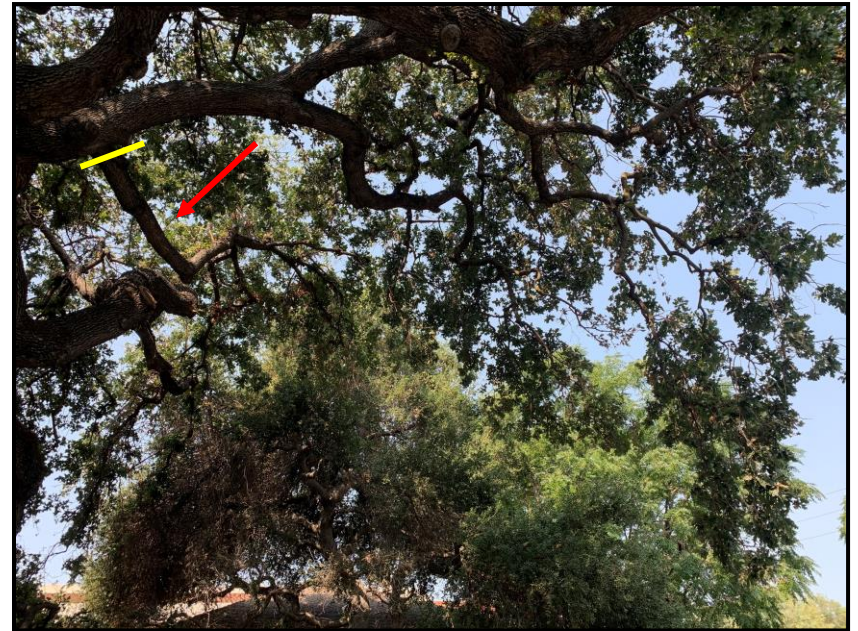
10. Photograph of several branches hanging over property's courtyard (red arrow). Cuts should be made back to crotch of main trunk (yellow line). Photograph taken facing up into the northern portion of the tree's crown. Deadwood throughout the tree's crown can be removed as well.

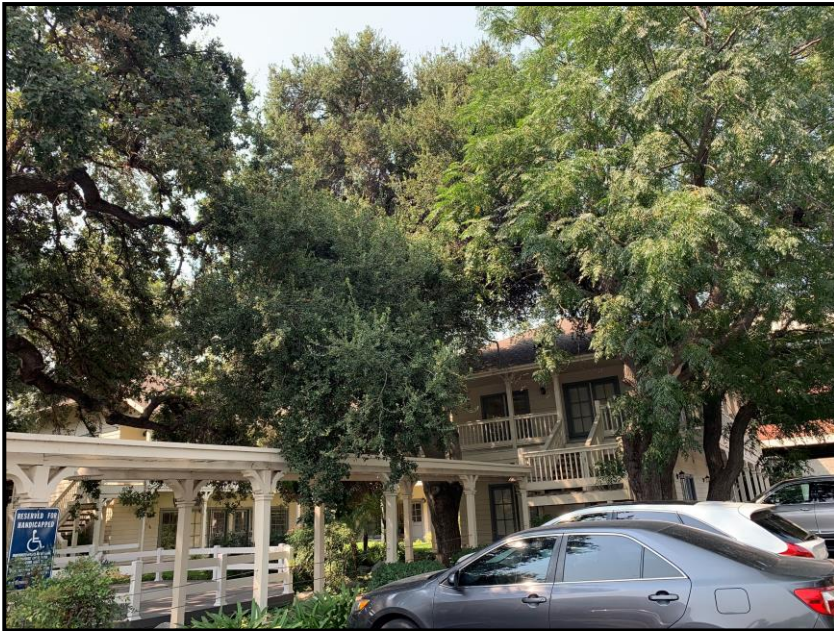
11. Overview of coast live oak tree located in northwestern portion of the Leonis Plaza courtyard. Photograph taken facing southwest.

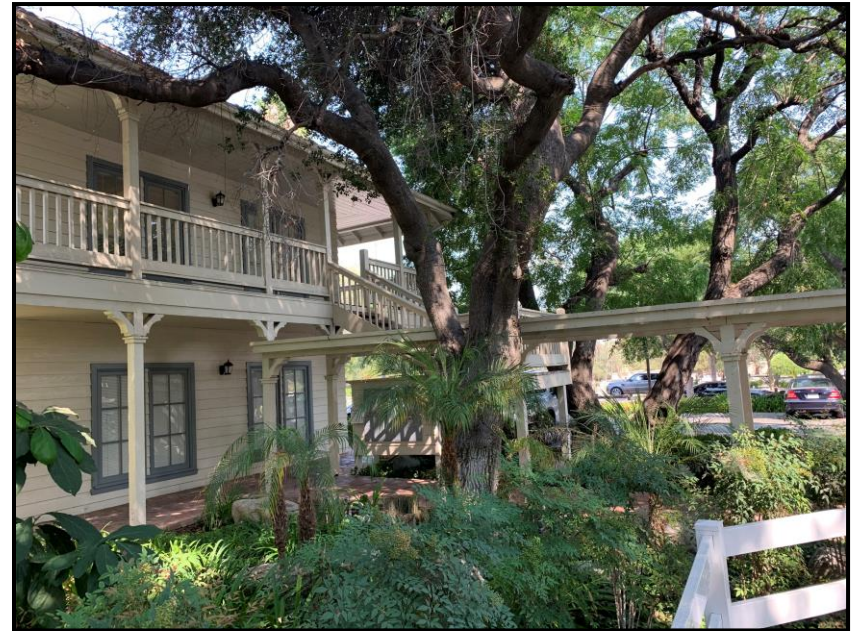
12. Photograph shows deadwood foliage located throughout the crown of the coast live oak tree. Photograph taken facing northwest.

4. It is also recommended that a crown cleaning occur throughout both trees, which is the removal of any additional deadwood foliage smaller than one to two inches diameter, located throughout a trees crown. Pruning shall be done to the appropriate ISA pruning standard. Cuts should be made cleanly at branch collars thus avoiding potential small branch sprouting (epicormics) along the cuts and reducing future maintenance.

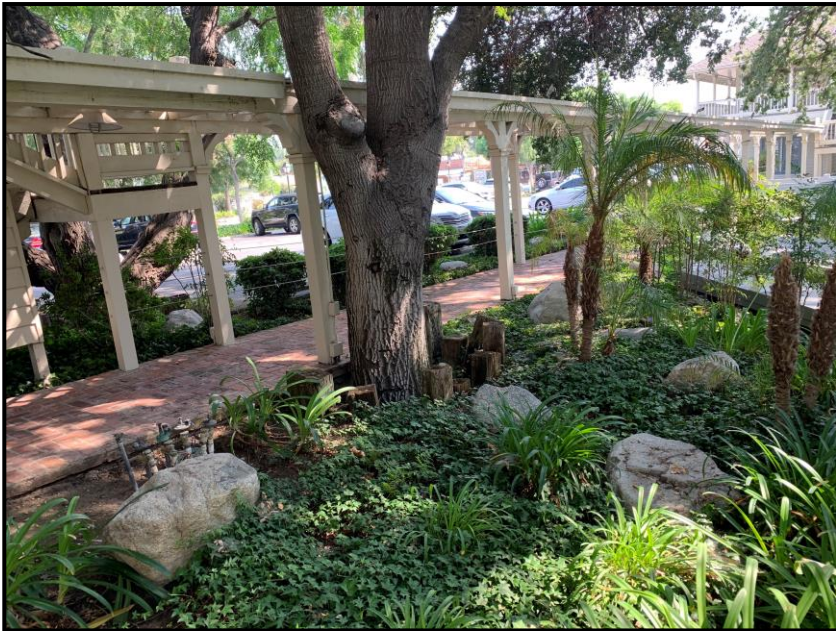
13. Photograph shows the groundcover and plant materials located under the tree's crown and inside the Tree Protection Zone (TPZ). These plants appear to be watered a lot, which is not recommended for coast live oak trees. Photograph taken facing northeast.

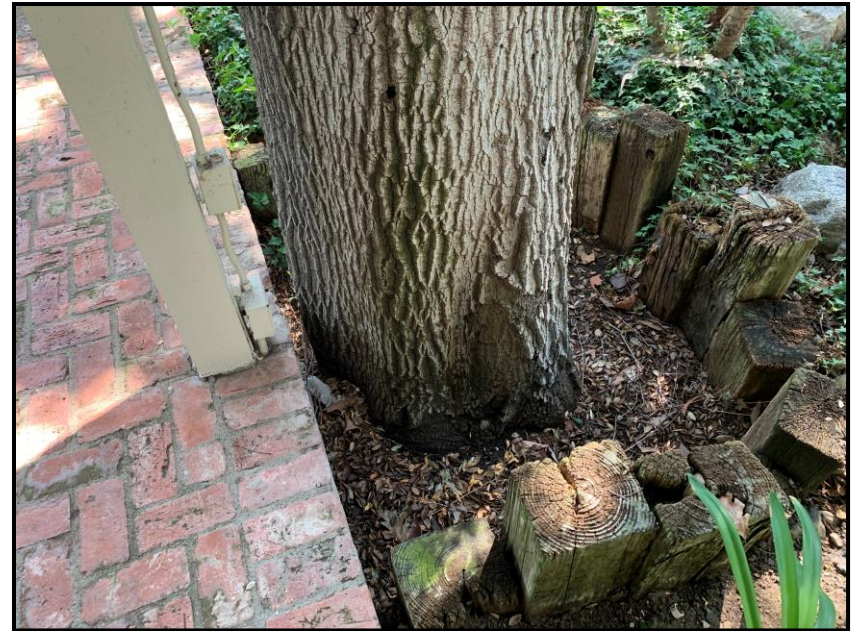
14. Overview of the base of the coast live oak tree. Note the water staining on the southern side of the tree's trunk and the wet ground surrounding the base of the tree. Also note the close proximity of the tree well to the trunk of the tree. Photograph taken facing east.

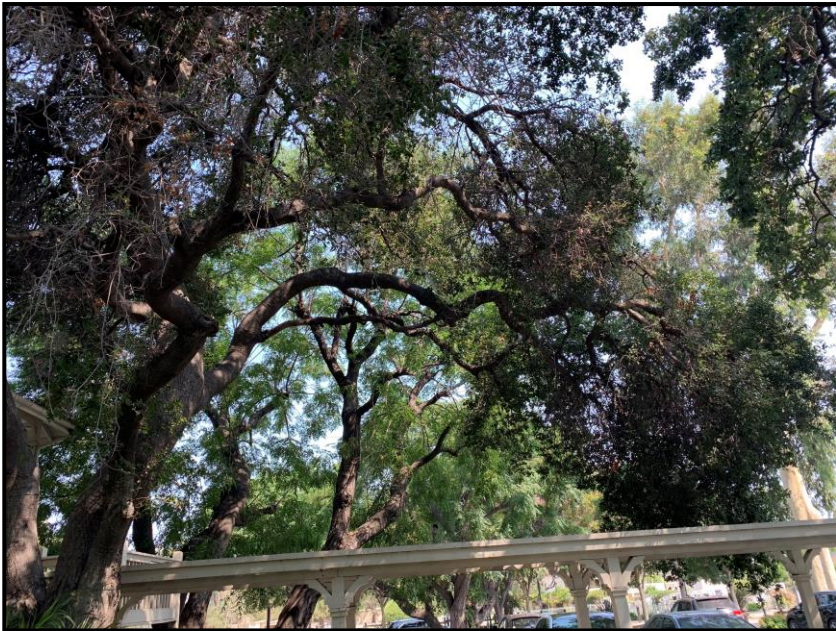
15. Photograph shows deadwood foliage located throughout the crown of the coast live oak tree. Photograph taken facing north.

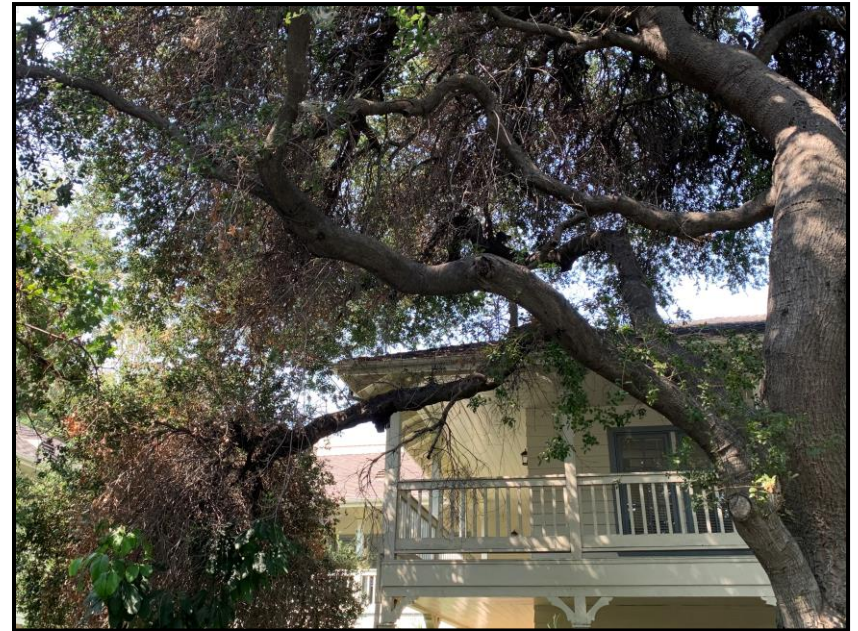
16. Photograph shows deadwood foliage located throughout the southern portion of the crown of the coast live oak tree. Photograph taken facing west.

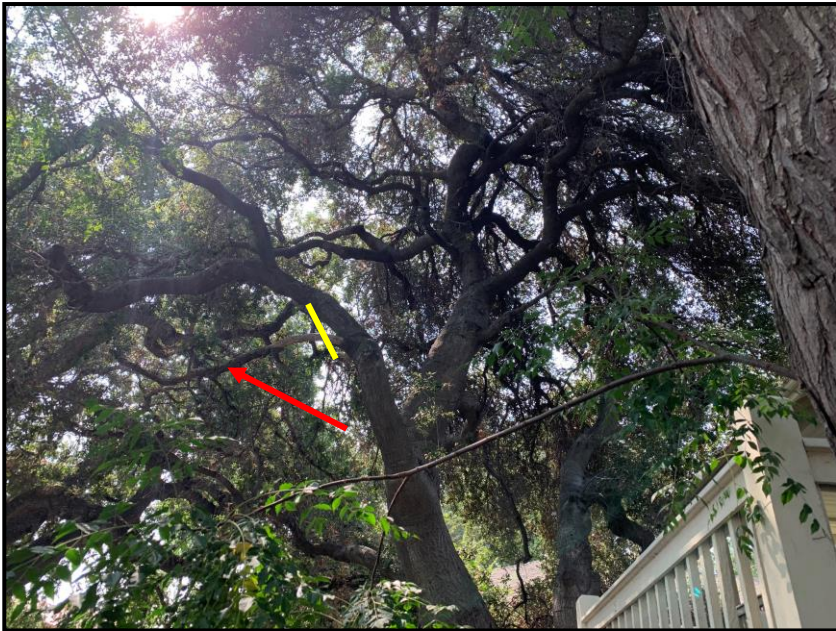
17. Photograph of several branches hanging over property's courtyard (red arrow). Cuts should be made back to crotch of main trunk (yellow line). Photograph taken facing up into the northern portion of the tree's crown. Deadwood throughout the tree's crown can be removed as well.

3. For the adjacent coast live oak tree, it is recommended to remove one (1) approximately 3-inch diameter branches on the north side of the tree's crown, one (1) approximately 7-inch diameter branch to the main stem on the south side of the tree's crown, and two (2) approximately 4-inch diameter branches on the northeast side (parking lot side) of the tree's crown. The branches are identified in photograph nos. 12 through 20 of *Attachment 1*. Cuts should be made cleanly at branch collars thus avoiding potential small branch sprouting (epicormics) along the cuts and reducing future maintenance and shall be done to the appropriate ISA pruning standard.

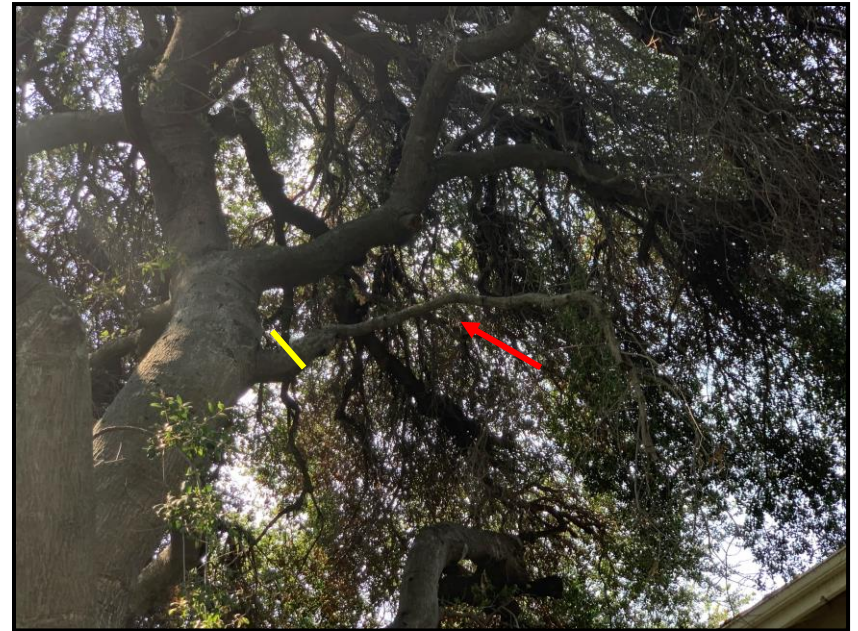
18. Photograph of several branches hanging over property's courtyard (red arrow). Cuts should be made back to crotch of main trunk (yellow line). Photograph taken facing up into the western portion of the tree's crown. Deadwood throughout the tree's crown can be removed as well.

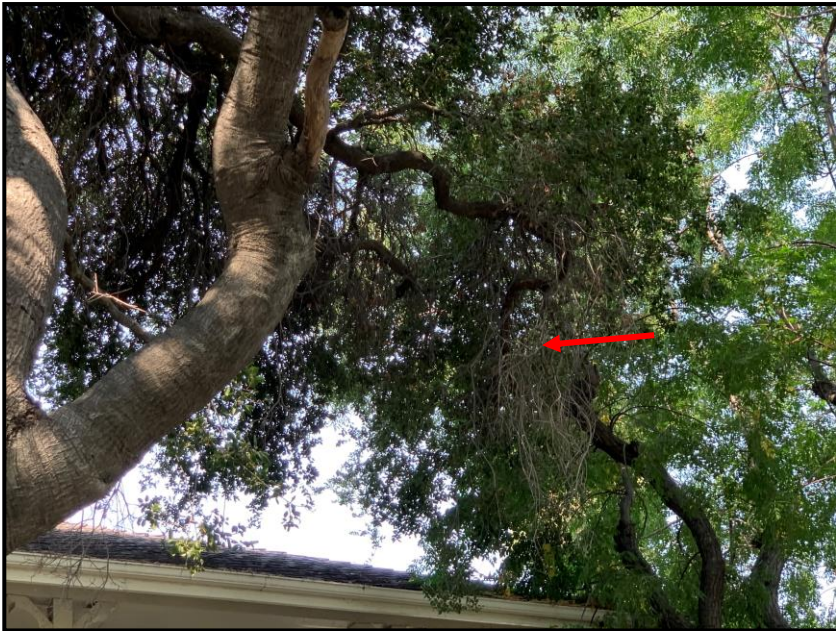
19. Photograph shows deadwood foliage located throughout the crown of the coast live oak tree. Photograph taken facing northwest.

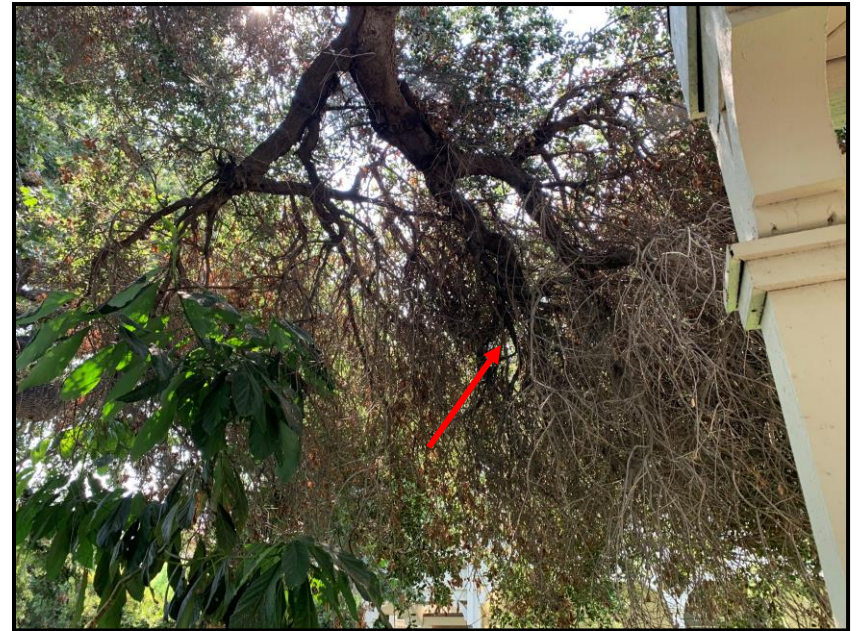
20. Photograph shows deadwood foliage located throughout the crown of the coast live oak tree. Photograph taken facing east.
