SPIEGEL RESIDENCE

**3901 PRADO DEL TRIGO
CALABASAS, CALIFORNIA**

OAK TREE REPORT

SPIEGEL RESIDENCE
3901 PRADO DEL TRIGO
JUNE 9, 2023

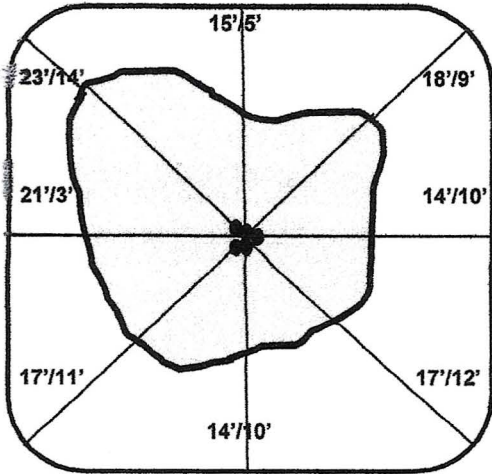
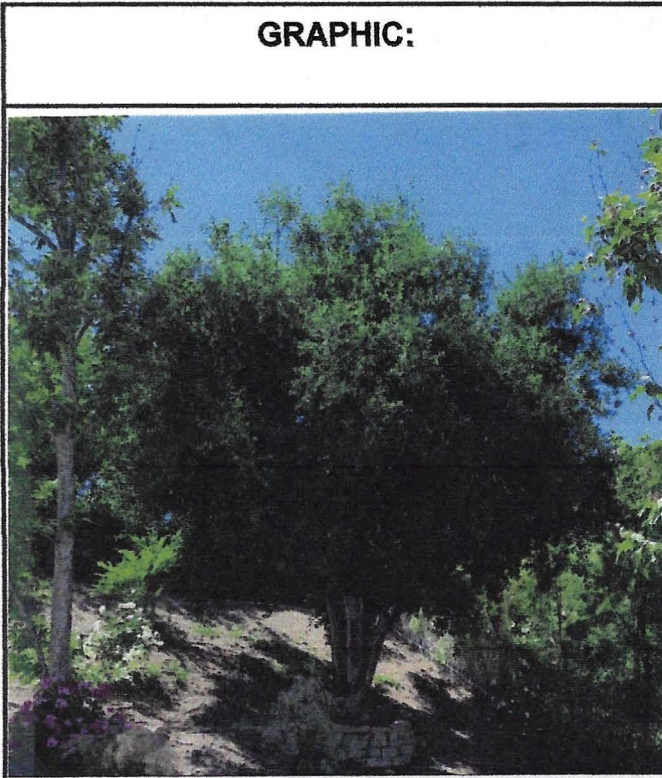
TREE #
SOT-1

SPECIES: *Quercus agrifolia*
Appearance (A-F): B **Date:** 06-09-23
Health: (A-F): C- **Inspector:** RWC
Diameter of Trunk(s) (5) 12 1/4", 11 3/4", 11 3/8", 10 3/8", 9 1/2" @ 54" above grade

VIGOR:
 CHLOROSIS
 GOOD SHOOT GROWTH
 DIEBACK
 MINOR DEADWOOD
 THINNING OF CROWN
 EXTENSIVE EPICORMIC GROWTH

STRUCTURE:
 BROKEN BRANCHES
 PRIOR STUB-CUT PRUNING
 MECHANICAL INJURY
 WIRE / NAILS / SPIKES
 TORN BRANCH SCARS
 LOW BRANCHING
 WATER TRAP
 CAVITY – SCAFFOLD
 CAVITY – BRANCH
 LOPSIDED CANOPY
 EXCESS HORIZONTAL GROWTH
 DECAY / ROT SUSPECTED
 FIRE / LIGHTNING DAMAGE
 EXPOSED ROOTS
 HAZARDOUS CONDITION
 CROSSING BRANCHES
 CODOMINANT SCAFFOLDS
 CODOMINANT TRUNKS
 MULTI-TRUNK FORM
 SEMI-MATURE PLANTED OAK

PESTS:
 BORERS / TERMITES
 MINOR TWIG GIRDLER
 ANTS
 WOODPECKERS
 GALLS
 WITCHES BROOM
 PIT-SCALE
 PLANT PARASITES
 MINOR EHRHORN'S SCALE

DISEASE:
 MARGINAL LEAF SCORCH
 EXFOLIATION
 LESIONS
 MINOR EXUDATION STAINS
 CANKERS

ENVIRONMENT:
 ON IRRIGATED AND PLANTED SLOPE
 FILL ON TRUNK & ROOT ZONE
 LOCATED IN ROCK WALL RETAINER
 CANOPY INTERTWINED IN L/S PLANTS
 CANOPY OVERHANGS NEIGHBOR'S YARD

CLEAN AND SCREEN WATER TRAP, AND DIRECTED CAREFULLY REMOVE FILL FROM TRUNK BASE, AS DIRECTED

MONITOR AND DIRECT PROTECTION OF OAK TREE DURING ALL LANDSCAPE REFURBISHMENT ACTIVITIES.

FINAL DETERMINATION OF MITIGATION AND TREATMENT(S) WILL BE AS DIRECTED IN THE FIELD BY THE OAK TREE PRESERVATION SPECIALIST.
