MEMORANDUM

Subject: *Peer-Review Memo Letter for submitted Oak Tree Report for 3901 Prado del Trigo, Calabasas, California*

Attachment 1 – Healthy Oak Tree Report for 3901 Prado del Trigo

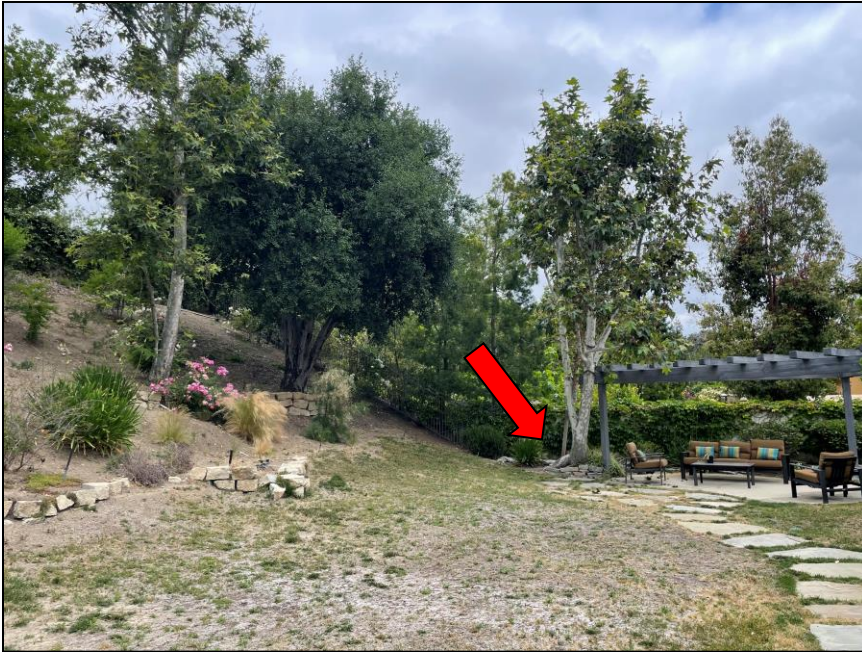
1. Overview photograph of the coast live oak tree (Tag #SOT-1) located in the northwest portion of the rear yard of 3901 Prado del Trigo. Photograph taken facing north. Note the location of the work to be performed (red arrow) in location to the TPZ of the tree.

tree's dripline, will encroach into the TPZ's of the coast live oak tree, all work performed within the TPZ of this oak tree should be performed within the presence of a qualified oak tree consultant and all work should be performed with the use of hand tools only. To protect the tree during construction, 5-foot-tall tree protective fencing will be placed around the TPZ limits of the tree. An ISA Certified Arborist shall be retained to supervise and monitor the condition of the existing protected oak tree throughout the proposed landscape improvement activities.

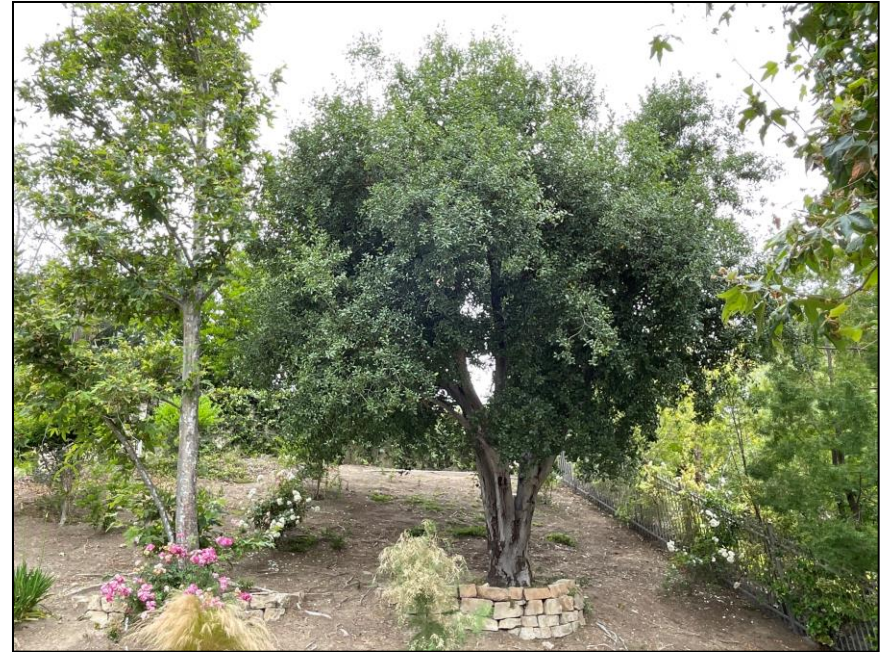
2. Overview photograph of the coast live oak tree (Tag #SOT-1) located in the northwest portion of the rear yard of 3901 Prado del Trigo. Photograph taken facing west.

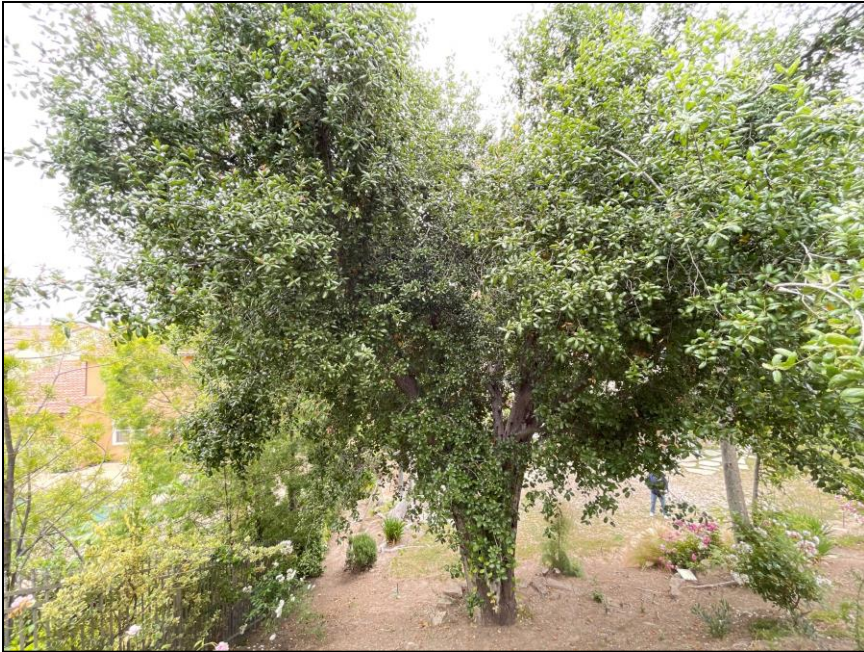
3. Overview photograph of coast live oak tree (Tag #SOT-1) located in the northwest portion of the rear yard of 3901 Prado del Trigo. Photograph taken standing above and looking down at the tree facing east.

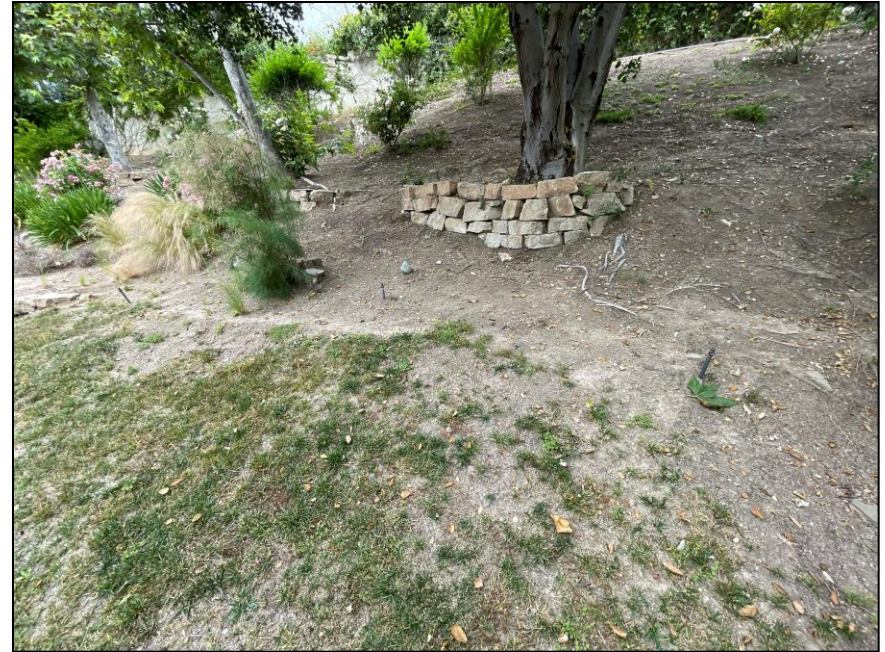
4. Photograph of the base of coast live oak tree #SOT-1 and the existing retaining wall on the downhill (east side of the tree's trunk). Photograph taken facing southwest.

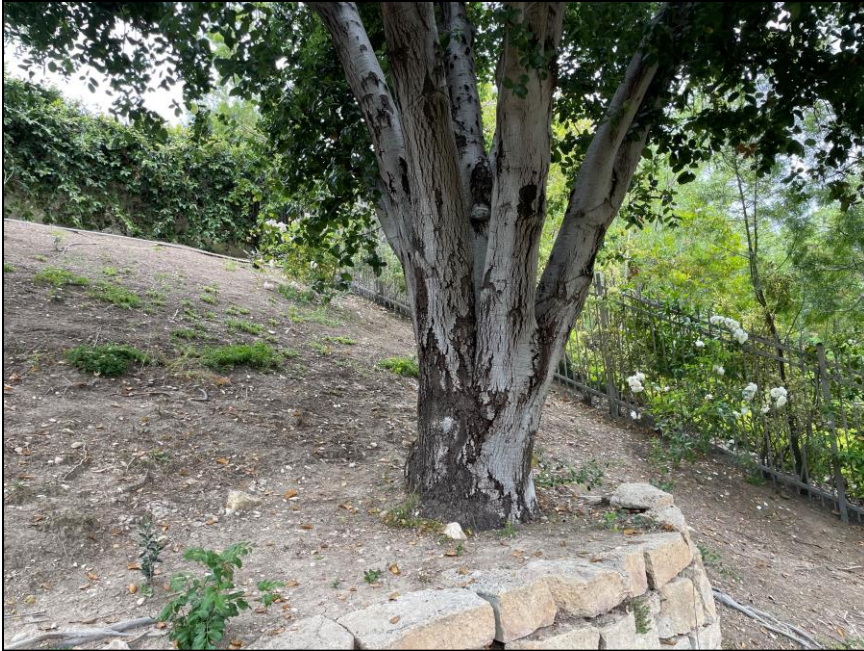
5. Photograph of the base of coast live oak tree #SOT-1 and the existing retaining wall on the downhill (east side of the tree's trunk). Photograph taken facing north.

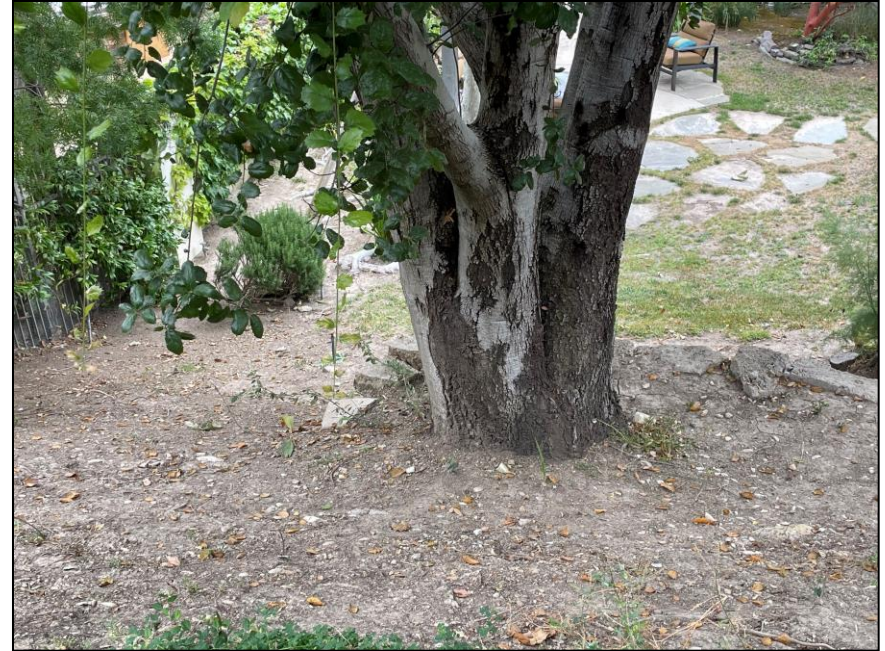
6. Photograph of the base of coast live oak tree #SOT-1 and the existing retaining wall on the downhill (east side of the tree's trunk). Photograph taken facing east.

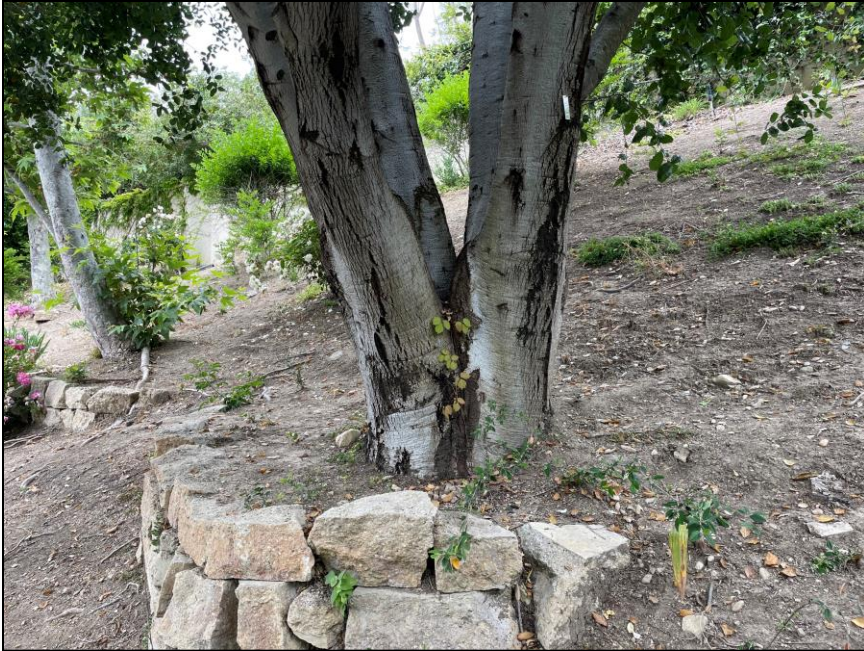
7. Photograph of the base of coast live oak tree #SOT-1 and the existing retaining wall on the downhill (east side of the tree's trunk). Photograph taken facing south.
