## MEMORANDUM

July 28, 2023

**Subject:** *Peer-Review Memo Letter for submitted Oak Tree Report for 24325 Mulholland Hwy, Calabasas, California*

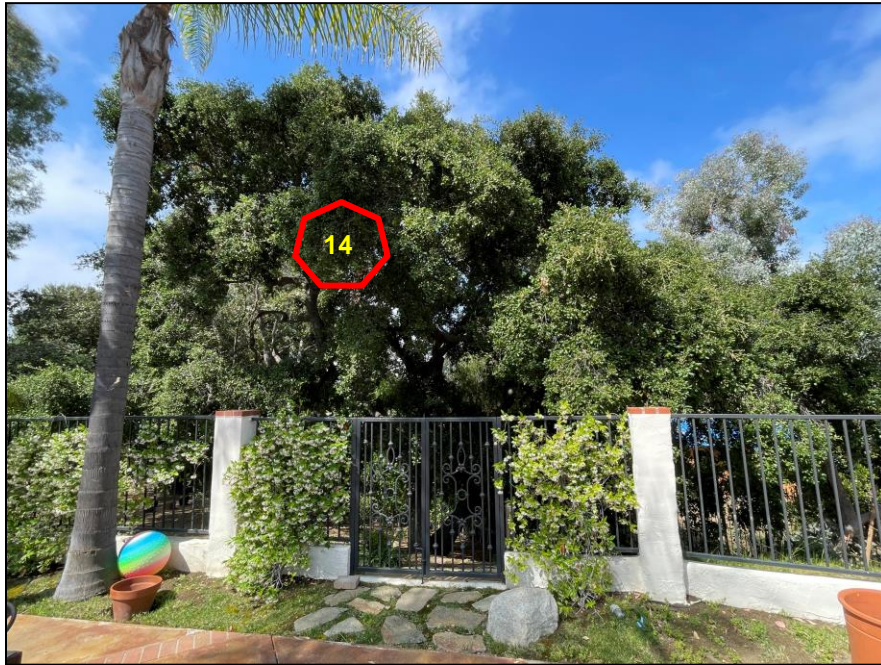
1. Overview photograph of heritage coast live oak (*Quercus agrifolia*) tree located in the rear yard of 24325 Mulholland Hwy, downslope and west of the pool and proposed project area. Photograph taken facing southwest. Note the tree has a tree tag no. 14 on the trunk of the tree.

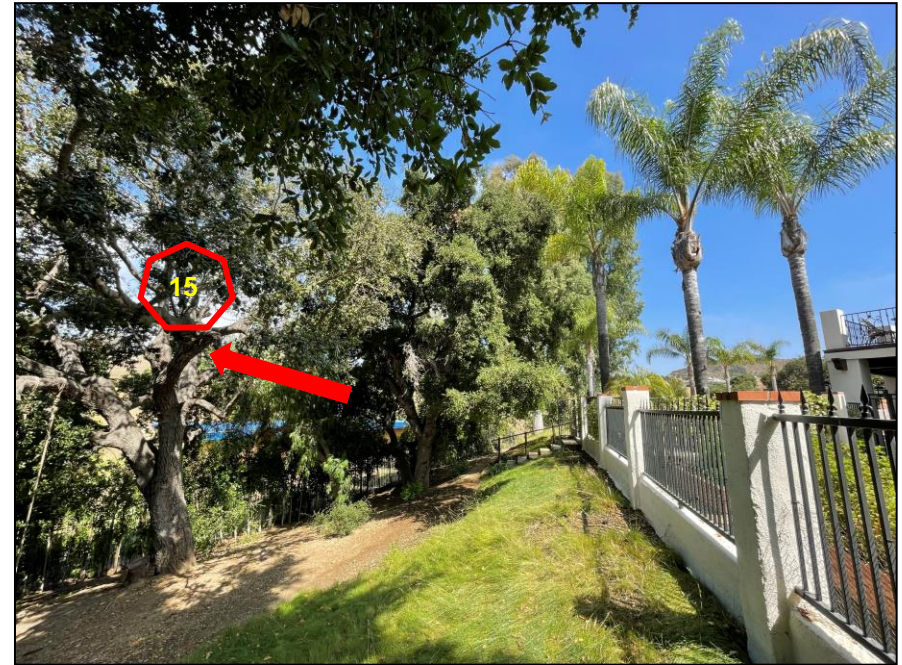
2. Overview photograph of heritage coast live oak tree no. 14 located in the rear yard of 24325 Mulholland Hwy, downslope and west of the pool and proposed project area. Photograph taken facing north. Note the location of tree no. 15 located approximately 20 feet south/southwest of tree no. 14 (red arrow).

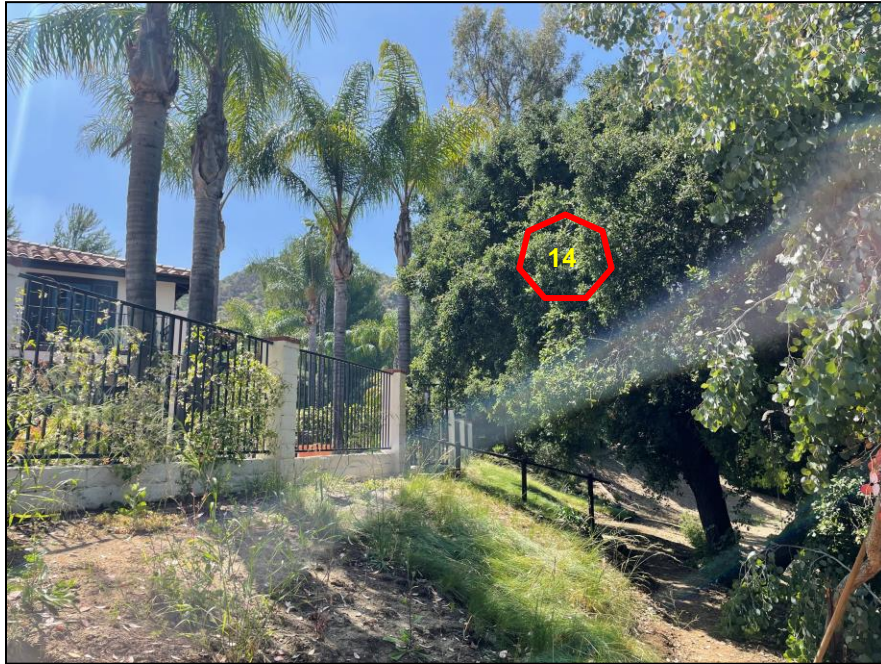
3. Overview photograph of heritage coast live oak tree no. 14 located in the rear yard of 24325 Mulholland Hwy, downslope and west of the pool and proposed project area. Photograph taken facing south.

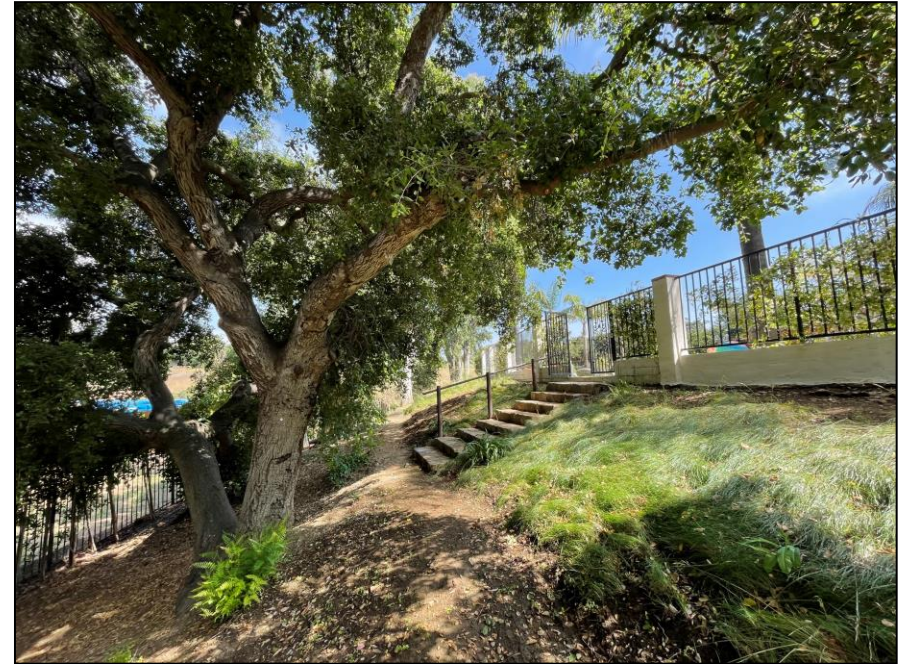
4. Overview photograph of the base of heritage coast live oak tree no. 14 located in the rear yard of 24325 Mulholland Hwy, downslope and west of the pool and proposed project area. Photograph taken facing south.

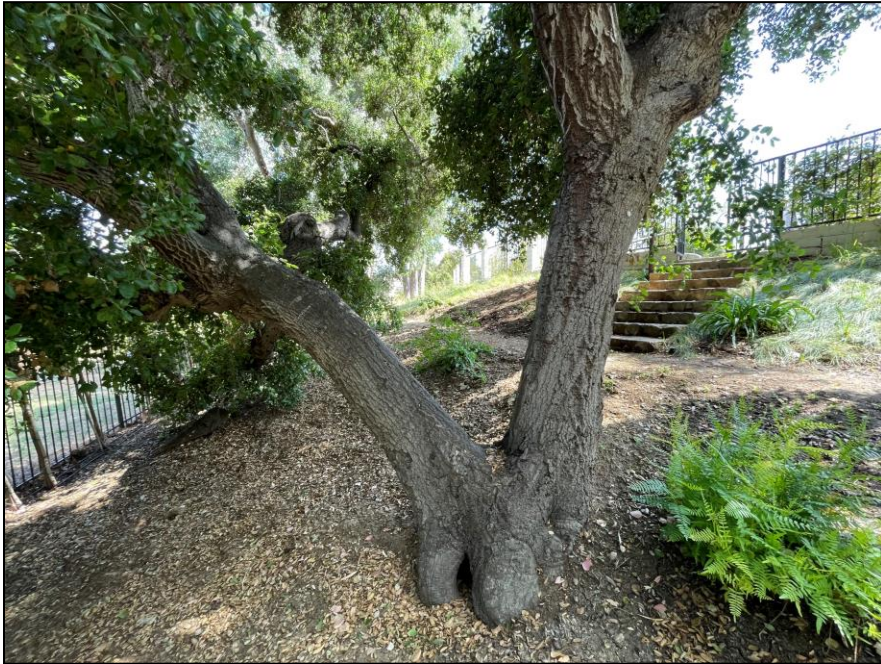
5. Overview photograph of the base of heritage coast live oak tree no. 14. Photograph taken facing north looking at co-dominant stems and an approximately 1-foot-wide cavity on the south side of the tree's trunk.

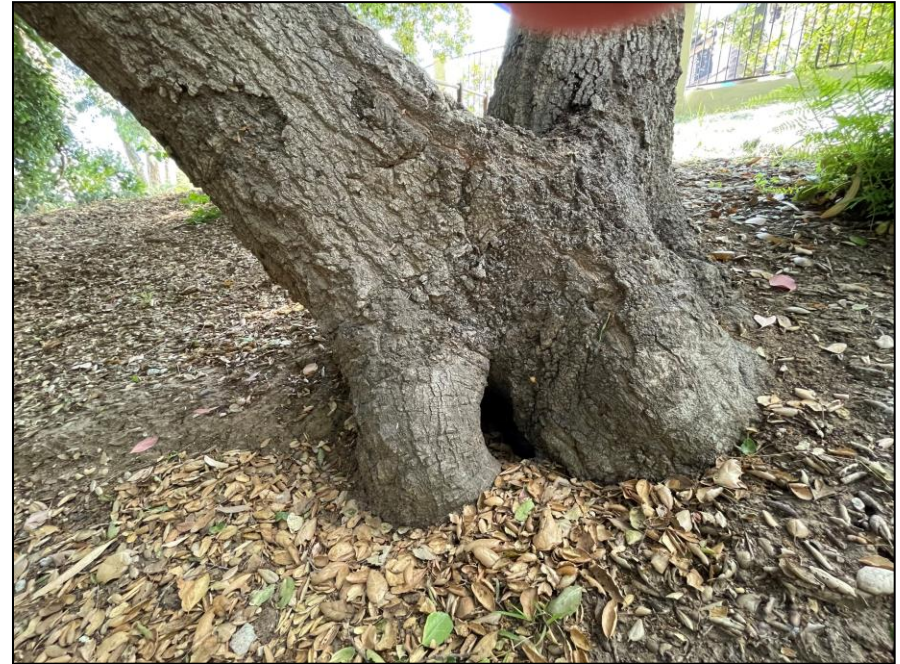
6. Photograph of a cavity at the base of heritage coast live oak tree no. 14. Photograph taken facing northeast.

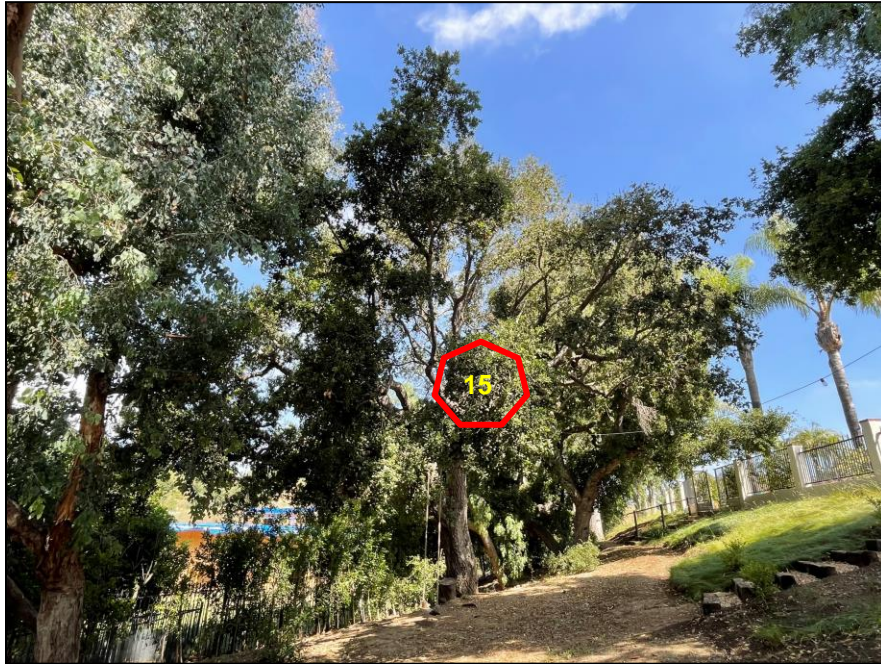
7. Overview photograph of heritage coast live oak tree no. 15 located in the rear yard of 24325 Mulholland Hwy, downslope and southwest of the pool and proposed project area. Photograph taken facing north.

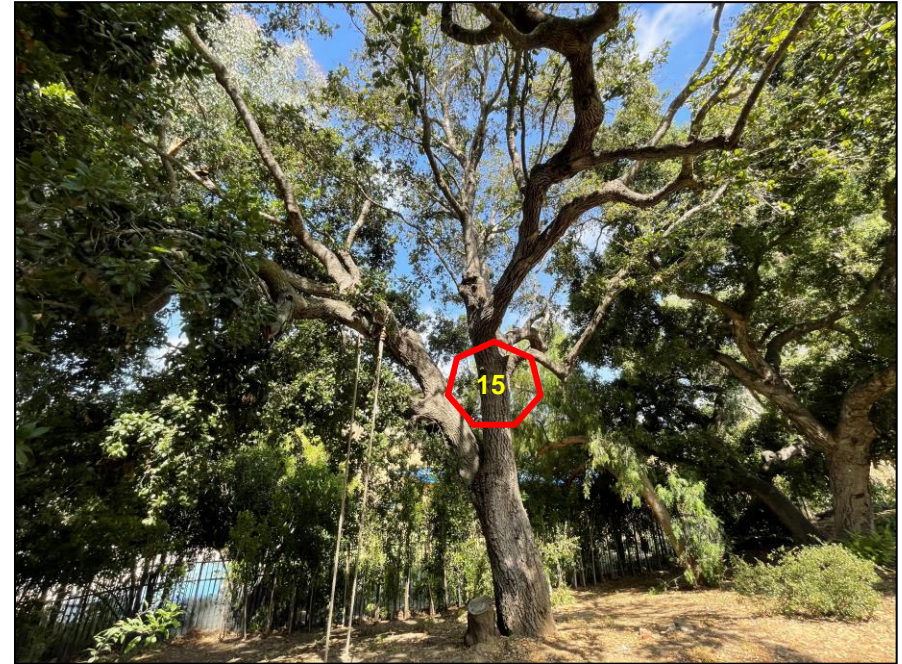
8. Photograph of the base of heritage coast live oak tree no. 15 located in the rear yard of 24325 Mulholland Hwy, downslope and southwest of the pool and proposed project area. Photograph taken facing west. Note the thinning crown.

Dudek is in agreement with the validity of the findings and information included in the Oak Tree Report and associated Oak Tree Map, which identifies the adjacent oak tree within the limits of disturbance, provides a description of the oak tree (including health and locations), as well as recommendations for tree protection and preservation and mitigation measures that should be implemented to prevent construction related damage to the trees that will remain. Because the construction of the pool deck will occur adjacent to the canopies of tree nos. 14 and 15 and will encroach into the TPZ's of the two coast live oak trees, all work performed within the TPZ of this oak trees should be performed within the presence of a qualified oak tree consultant and all work should be performed with the use of hand tools only; it should be noted that the Oak Tree Report notes that before the pier footings are installed, an exploratory pre-excavation assessment will occur around the roots of trees with either an airspade or by hand to determine the size of potential roots that will be impacted and appropriate placement of the pier footings. To protect the trees during construction, all on-site trees will include tree protective fencing around the trunk/TPZs of the trees. An ISA Certified Arborist shall be retained to supervise and monitor the condition of the existing protected oak tree throughout the proposed landscape improvement activities. Furthermore, the Oak Tree Report recommends that a protective layer of bark chip mulch and natural leaf litter be placed around the base of tree nos. 1, 14, 15, 16, and 17 and that the health and structure of tree no. 15 be monitored every several months due to the thinning crown and signs of damage from a wood boring beetle.

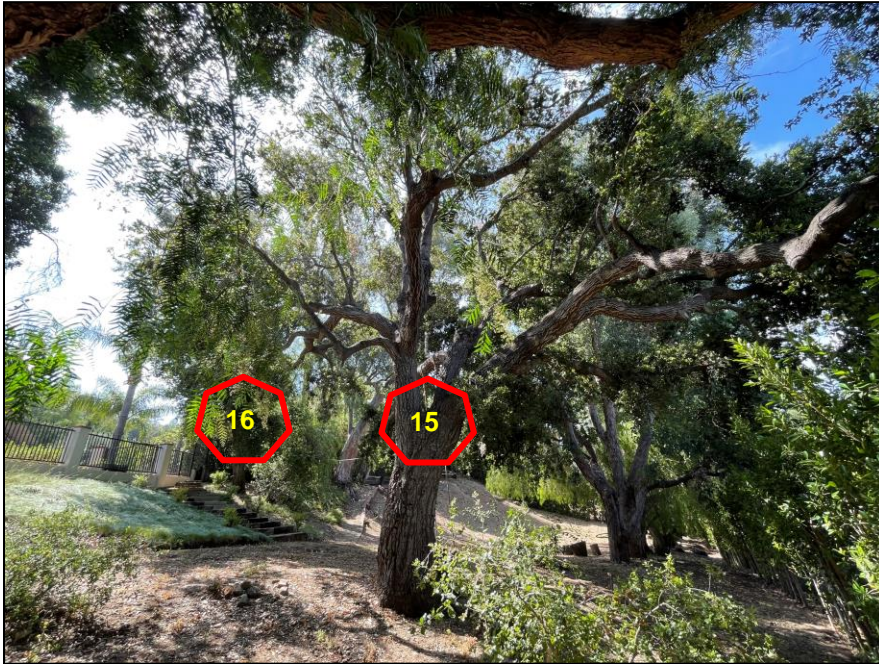
9. Photograph of the base of heritage coast live oak tree no. 15 located in the rear yard of 24325 Mulholland Hwy, downslope and southwest of the pool and proposed project area. Photograph taken facing south/southeast. Note the thinning crown and the location of tree no. 16 southeast of the tree.

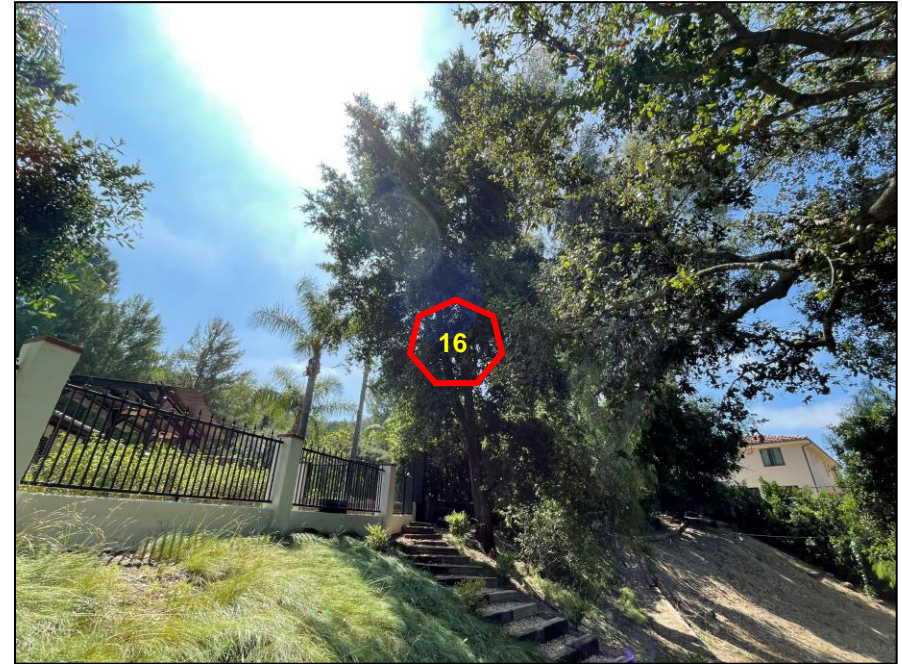
10. Overview photograph of coast live oak tree no. 16 located in the rear yard of 24325 Mulholland Hwy, at the top of the slope and south of the pool and proposed project area. Photograph taken facing southeast.

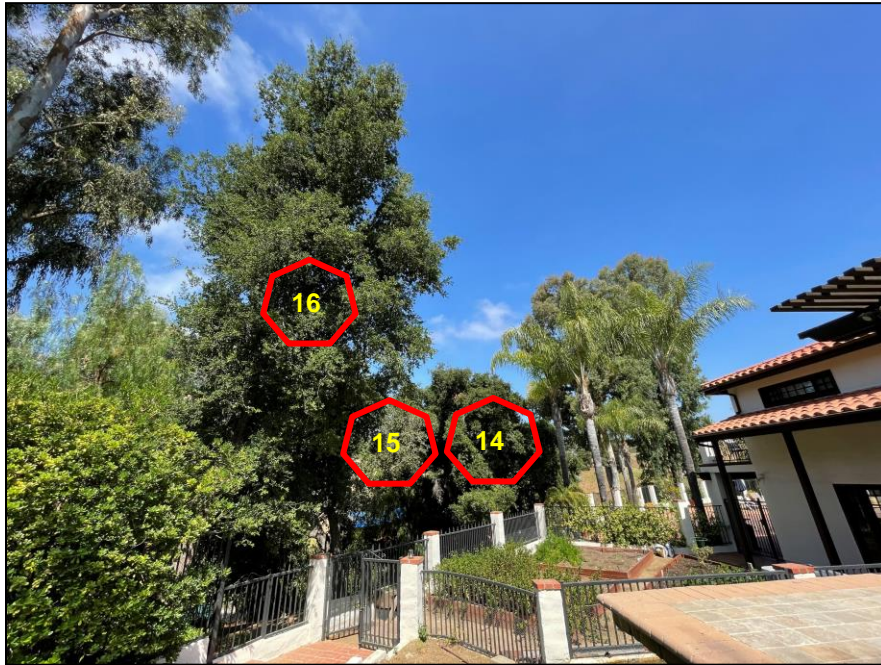
11. Overview photograph of coast live oak tree no. 16 located in the rear yard of 24325 Mulholland Hwy, at the top of the slope and south of the pool and proposed project area. Photograph taken facing northwest. Note the locations of tree nos. 14 and 15 in relation to tree no. 16 and the pool area.

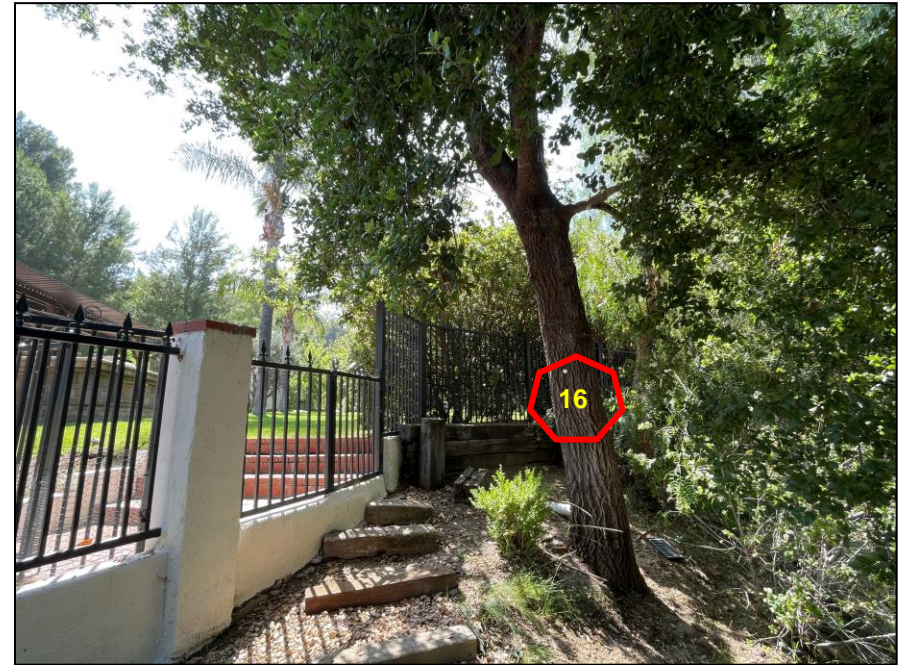
12. Photograph of the base of coast live oak tree no. 16. Photograph taken facing southeast.

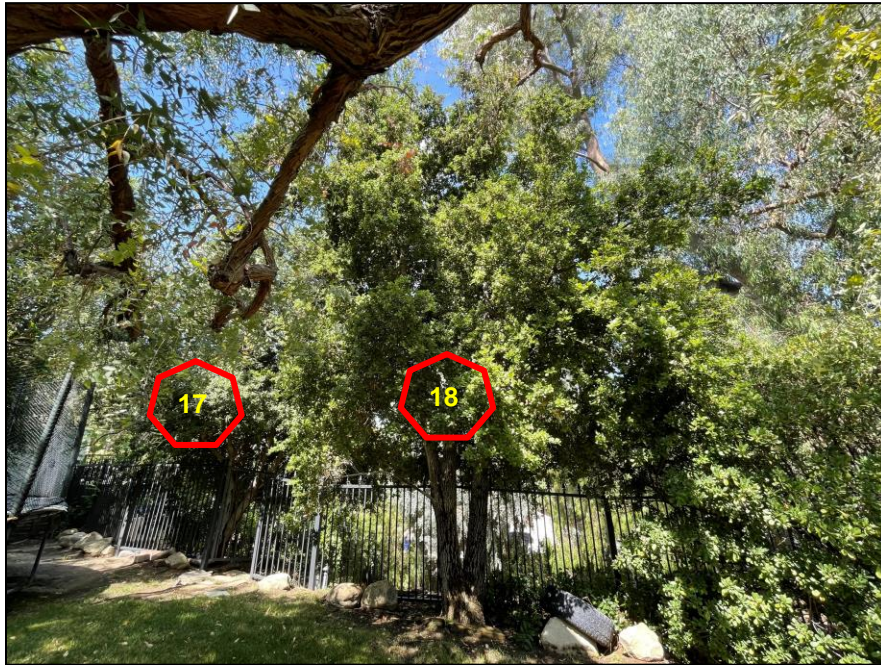
13. Overview photograph of coast live oak tree nos. 17 and 18 located in the southwest corner of the rear yard at 24325 Mulholland Hwy. Photograph taken facing south/southwest. Note these trees are a significant distance away from the proposed work and will not be impacted.

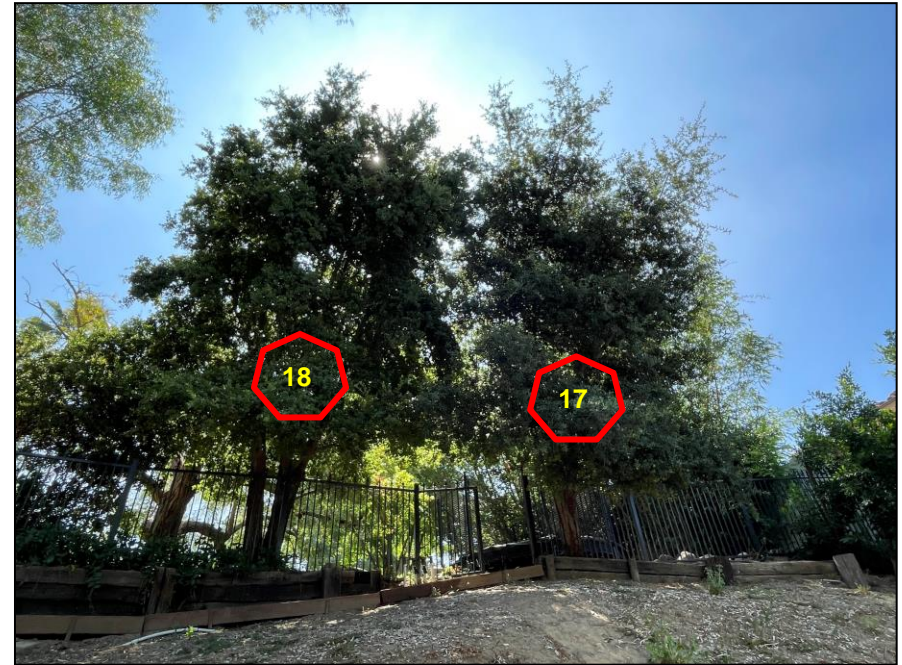
14. Overview photograph of coast live oak tree nos. 17 and 18 located in the southwest corner of the rear yard at 24325 Mulholland Hwy. Photograph taken facing southeast. Note these trees are a significant distance away from the proposed work and will not be impacted.

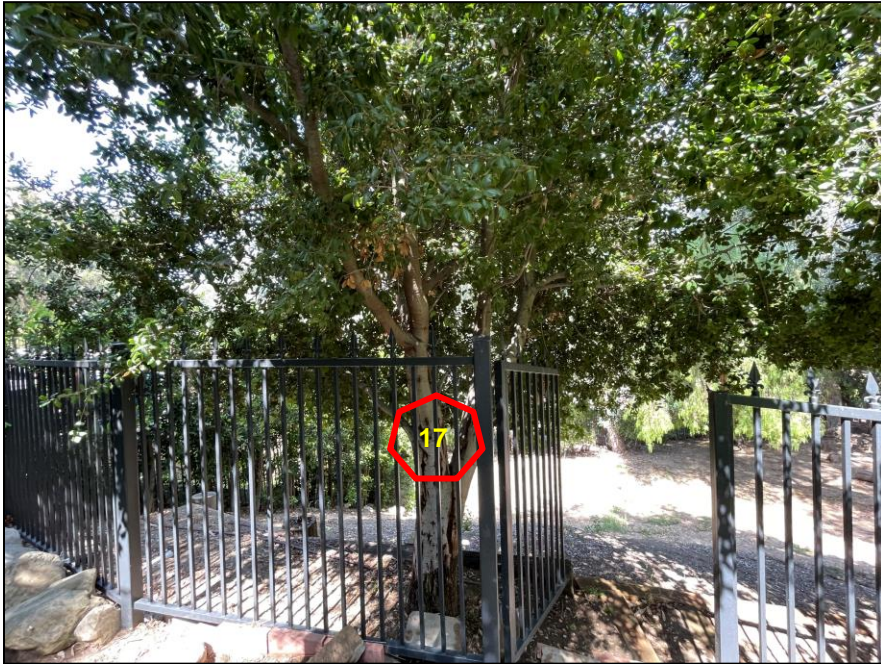
15. Photograph of the base of coast live oak tree no. 17.  
Photograph taken facing west.

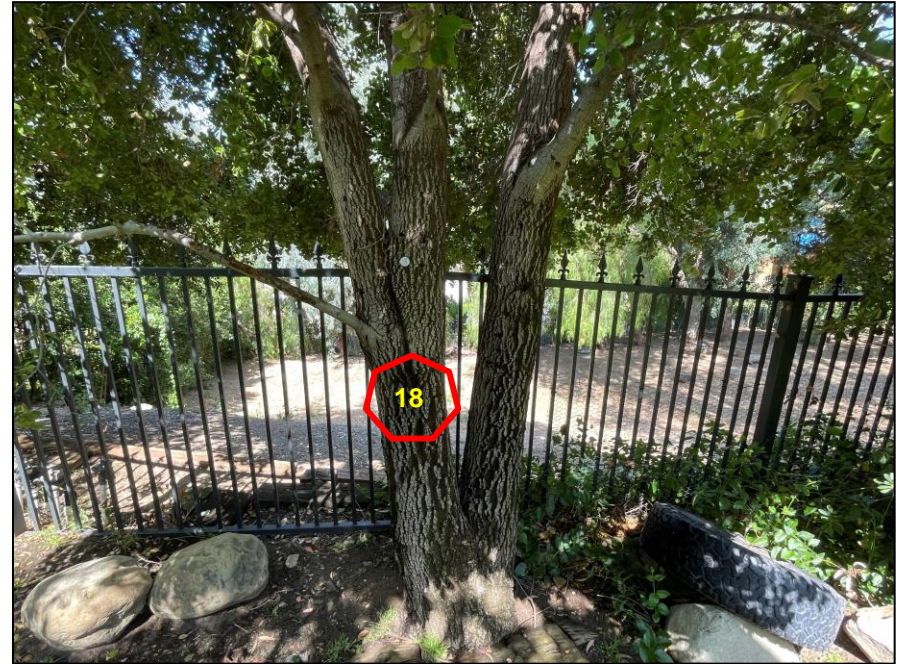
16. Photograph of the base of coast live oak tree no. 18.  
Photograph taken facing west.

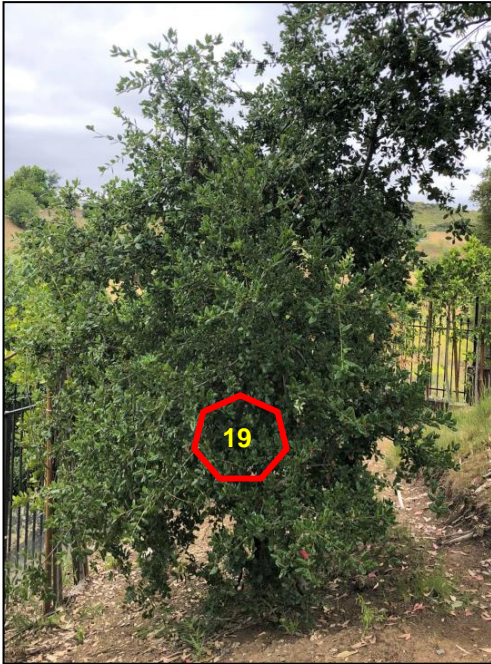
17. Overview photograph of coast live oak tree no. 19 located in the northwest corner of the rear yard at 24325 Mulholland Hwy, west of the pool area. Photograph taken facing north.
