**OAK TREE REPORT
FOR
LAND DEVELOPMENT**

**23616 VALLEY VIEW ROAD
CALABASAS, CA 91302
(APN: 2072-014-005)**

February 26, 2024

Arsen Margossian, MS, Consulting Arborist
Bardez Landscape Services, Inc.
International Society of Arboriculture (ISA) Certified Arborist # WE-7233
Member, American Society of Consulting Arborists (ASCA)
ASCA Academy Graduate (2007)
ISA Tree Risk Assessment Qualified (TRAQ)
California Licensed Pest Control Adviser #071429
California Licensed Forestry Pesticide Applicator #121525
3512 Rosemary Avenue
Glendale, CA 91208
818 669 6469
arsenm@pacbell.net

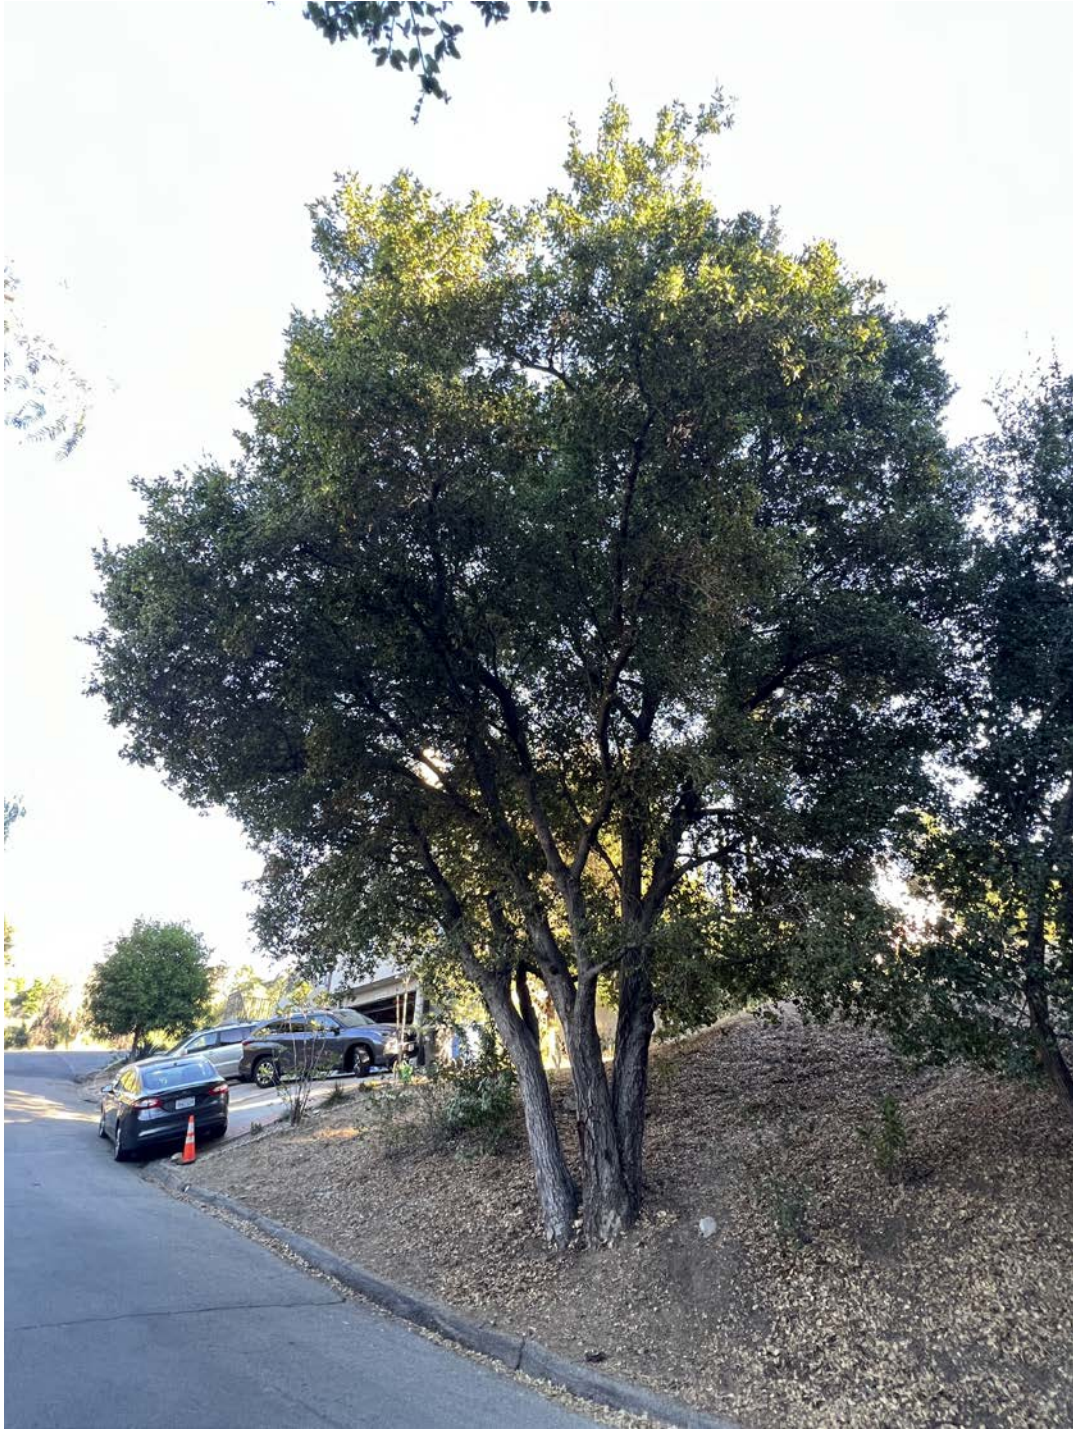
Two trunks emerge at grade; one trunk leans toward the northeast side, has a DBH of 13.5 inches. The other secondary trunk divides to two slightly above grade, and both extend upward. These two stems respectively have 13.5 and 15 inches DBH. The aggregate DBH of this tree is 24.3 inches. And because the DBH of this oak tree is more than 24 inches, it is considered a City of Calabasas "**Heritage Oak**" tree.

Foliage is quite dense and of the characteristic dark-green color. No damage from insects is observed on the leaves. New leaves are seen at the tips of the small branches. There is no **dieback** and **deadwood** in the upper crown. The tree's height reaches almost 30 feet.

Based on the City of Calabasas health and vigor grading on a scale of A to F (A being outstanding and F being dead), the **condition rating** for this tree is C (Average).

Tree #875 seen from the northwest side.

This tree can be retained, but the proposed driveway will encroach into its **drip line**. It should be protected during the entire construction period. A good portion of the designed structure will also encroach into its tree protection zone.

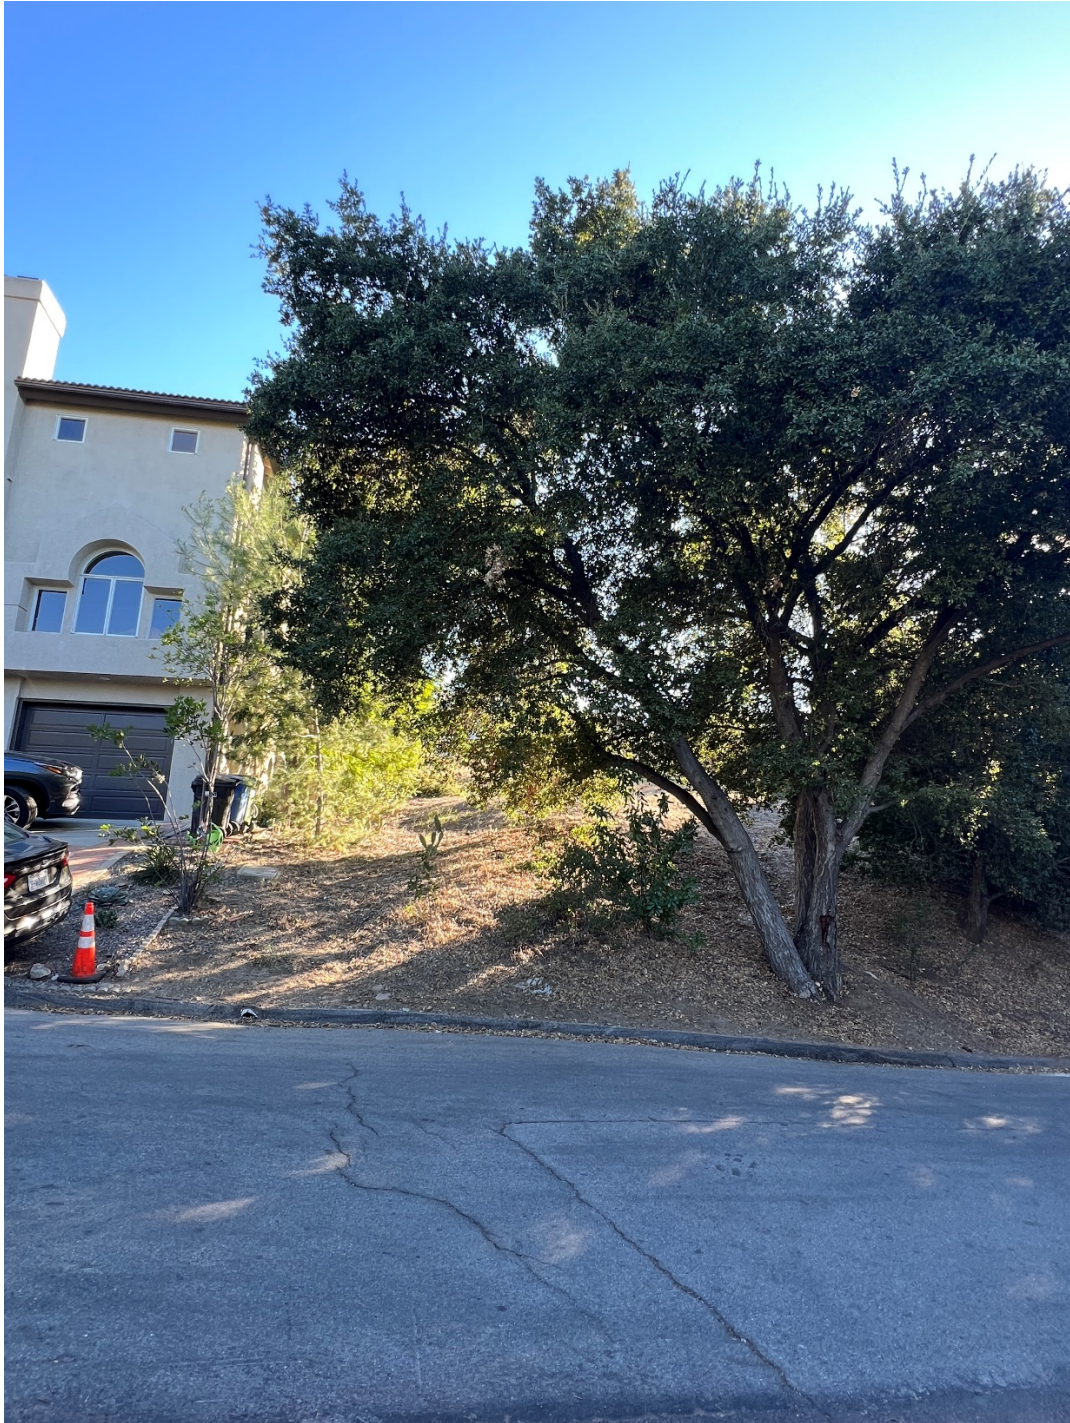
View of Tree #875 from the north side.

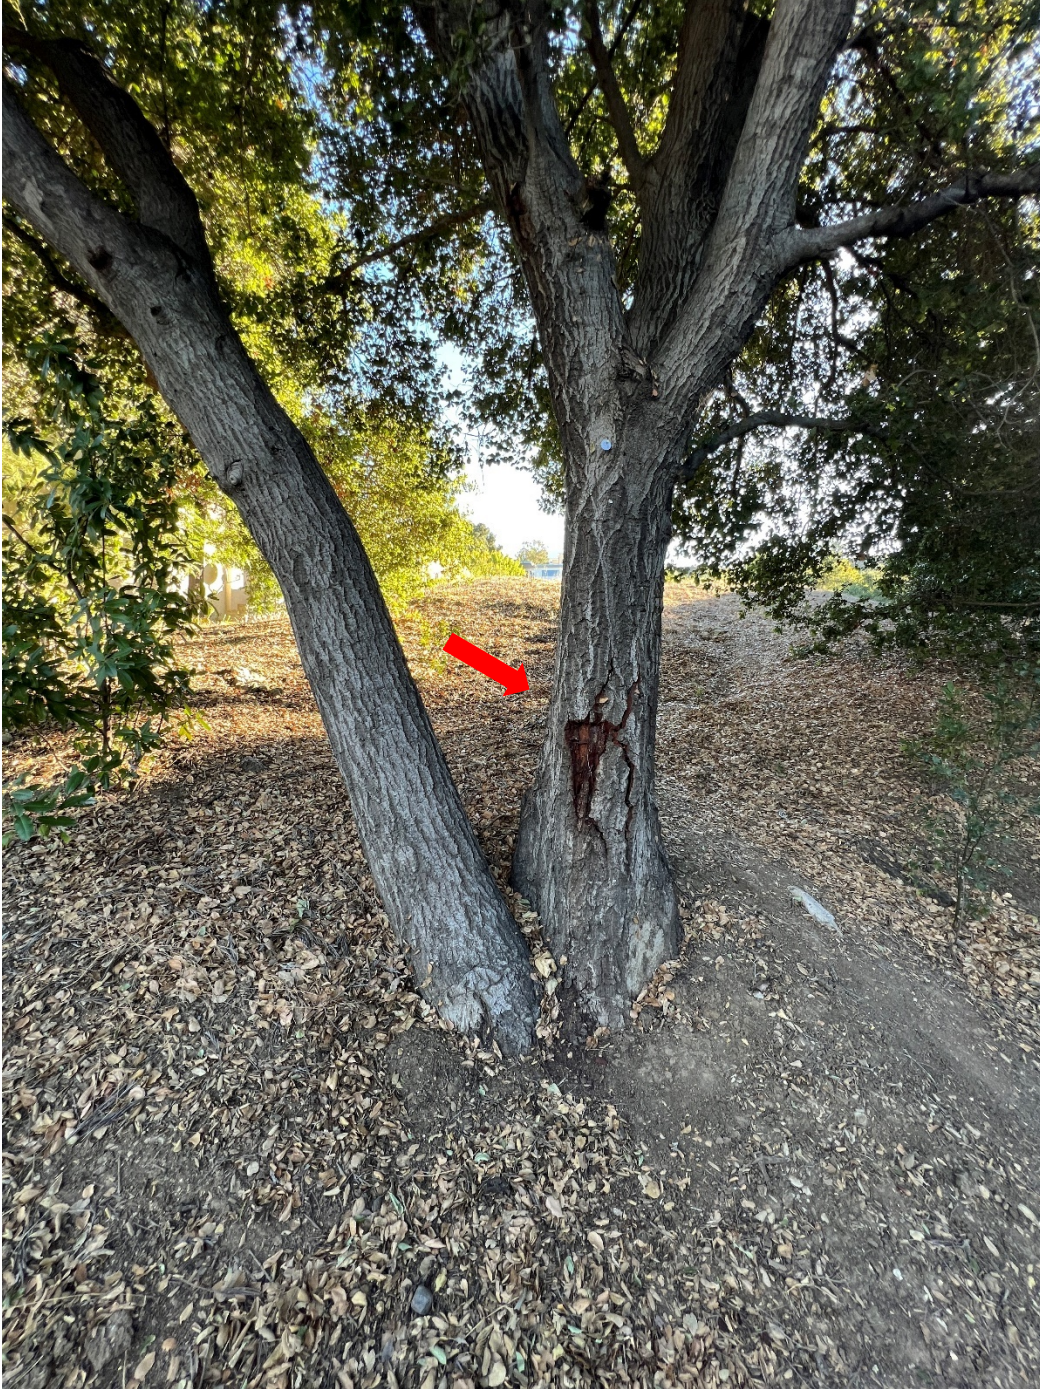
Apparently, the lower section of one of the two main stems has been hit not long ago by a vehicle, and there is apparent damage to the **bark**, which has sloughed off, and the **cambium** underneath the bark is starting to dry.

**View of the lower stems of Tree #875.
Injured bark is shown by the red arrow.**

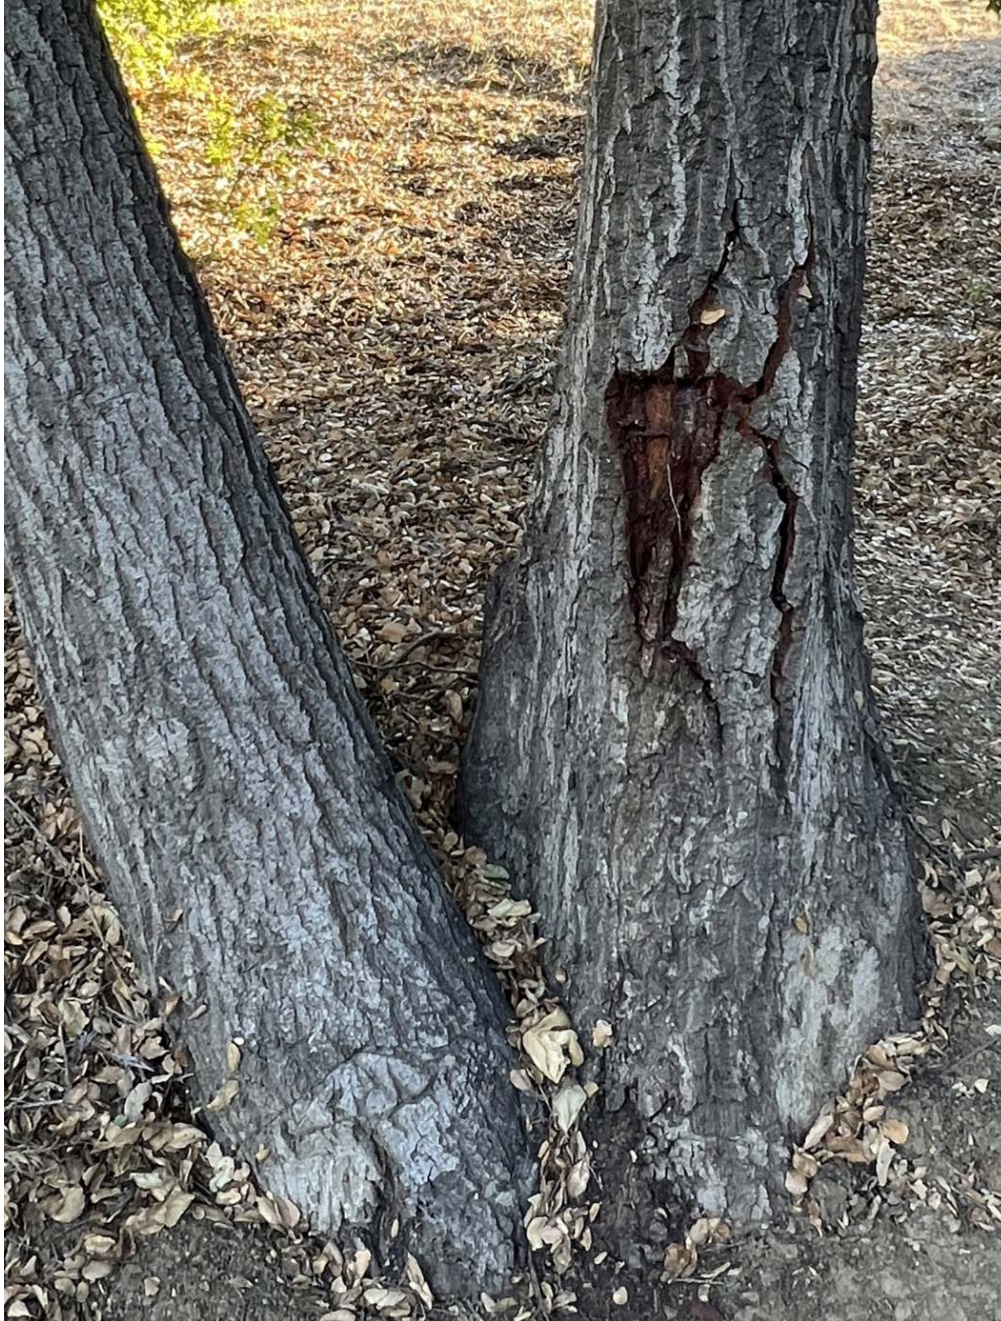
A closer view of the missing and injured bark of Tree #875.

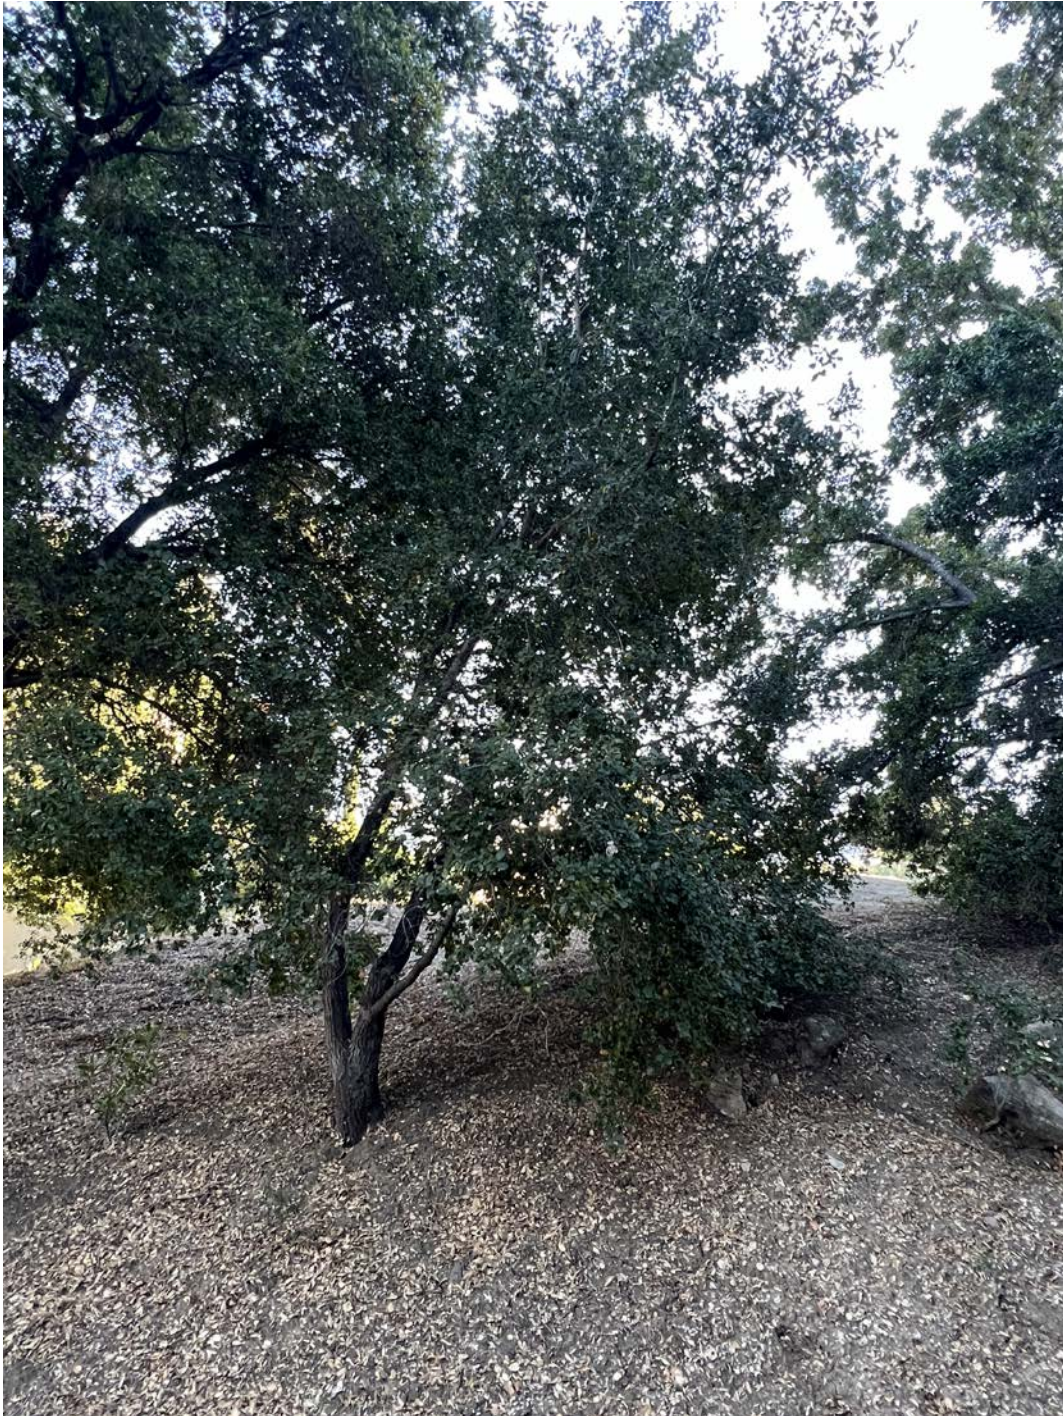
This tree also has the same characteristics of the previous tree, with healthy foliage of dark-green color, no decay, no deadwood and no structural defects. New foliage is visible throughout the edge of the outer crown. And because it is located close to Tree #875, its crown has developed unevenly. Toward the east side, the branches extend only by three feet, while toward the northwest side, or toward the street, the branches extend by almost 15 feet. The longest canopy spread of this tree is in the south to north direction, reaching 21 feet.

rating for this tree also is B (Above Average). This tree is within the footprint of the driveway for the proposed dwelling; therefore, it has to be removed.

Tree #876 seen from the street.

For the removal of Tree #876, the City of Calabasas will decide the replacement tree quantity and their sizes.

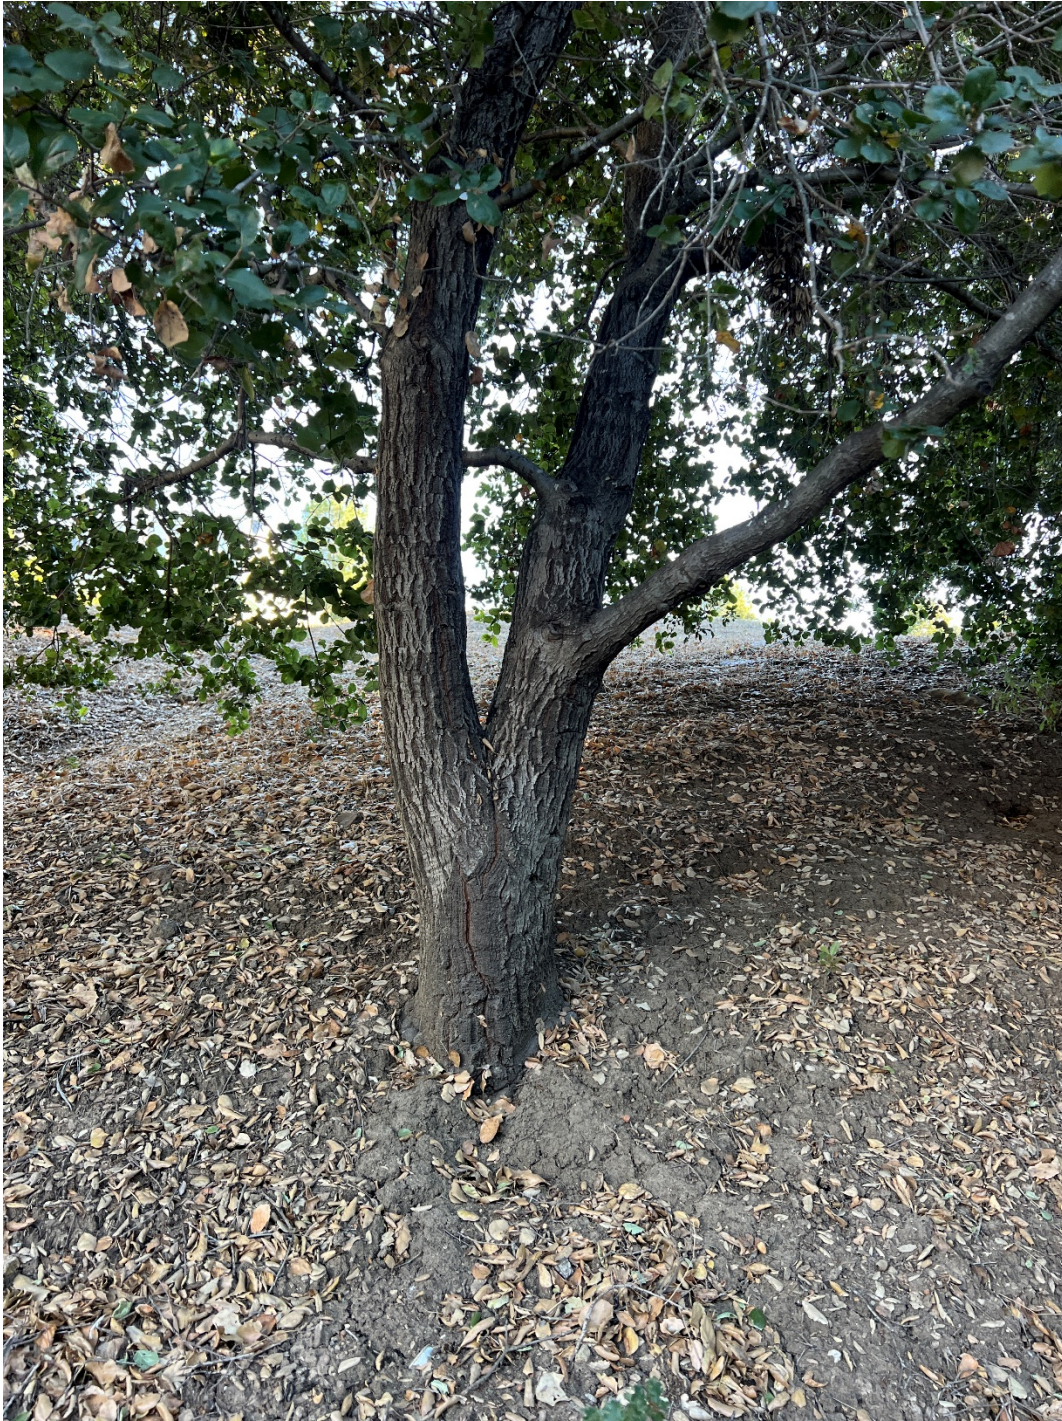
The single trunk divides to two at about 18 inches over grade, and both extend upward, leaning slightly toward the west and south directions. From the latter, a smaller branch emerges, and the respective DBH of all three are 6, 5.75 and 2.5 inches. Therefore, the aggregate DBH is 8.7 inches.

A closer view of the lower section of Tree #876.

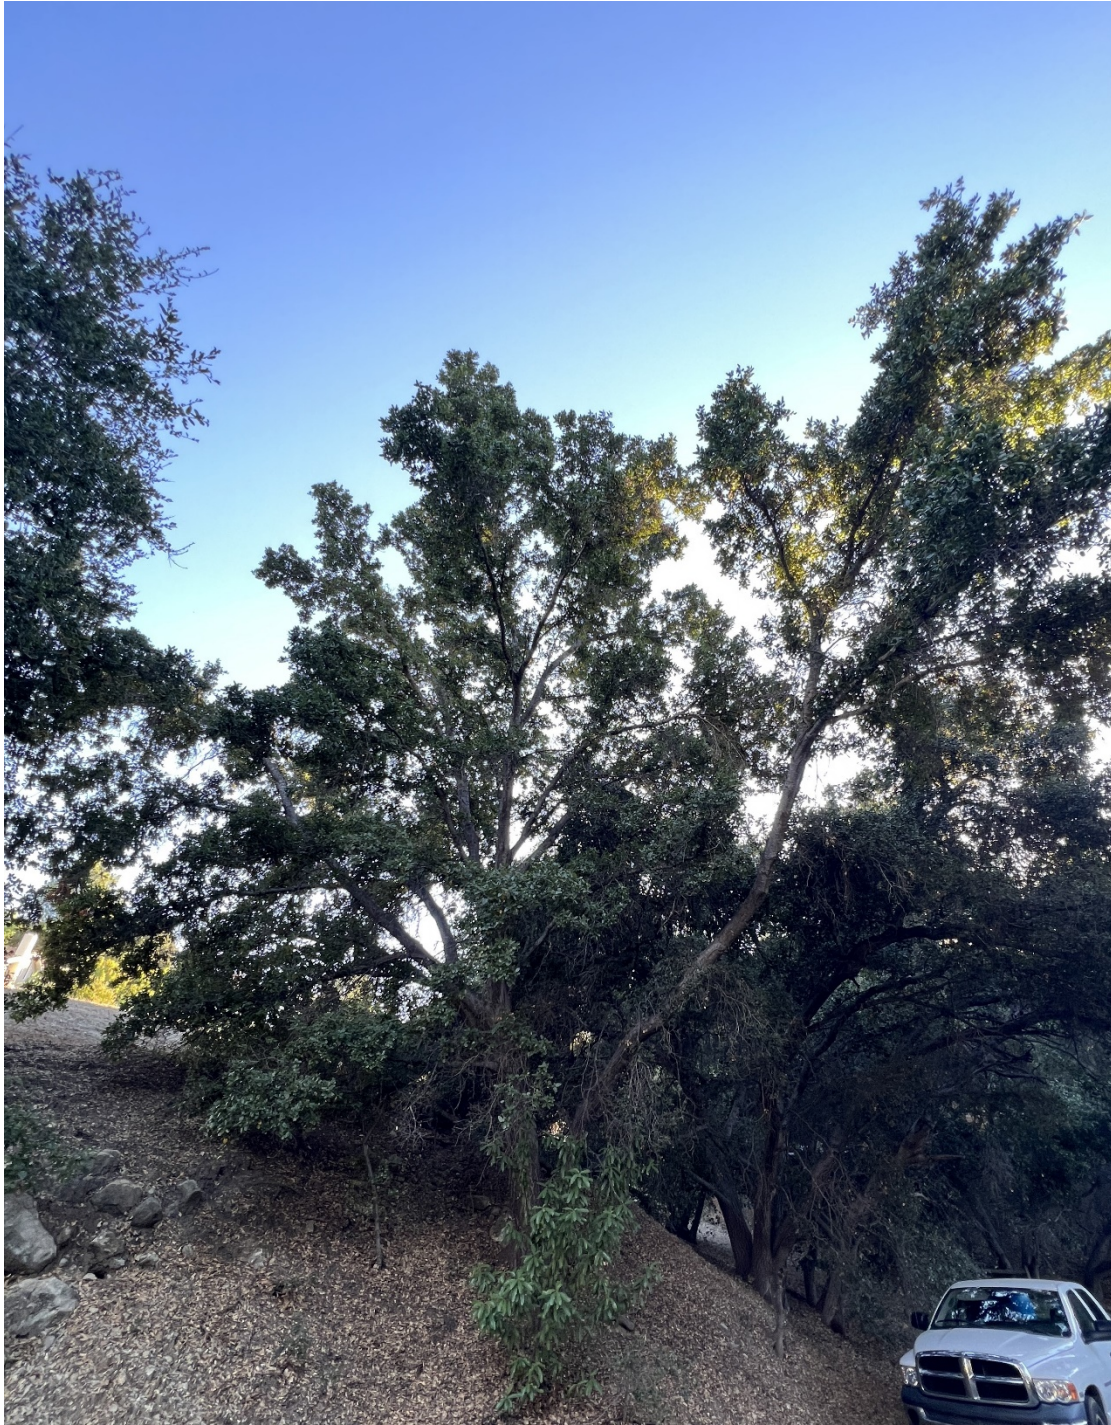
Off-Site Tree #1.

This tree also is a California Live oak (*Quercus agrifolia*) tree. The main trunk divides to two at about two feet over grade, and they respectively have 9.5 and 16.5 inches DBH, or a combined DBH of 18.8 inches.

The height of the tree is about 40 feet, and because of the presence of another much bigger oak tree on its west side, its crown is unevenly spread, extending mostly toward the north, south and east sides. The longest canopy spread of the tree is 54 feet, in the north-south directions. Overall, the tree is in average health, with no apparent structural defects or infestations from insects or fungi.

Based on the City of Calabasas health and vigor grading on a scale of A to F (A being outstanding and F being dead), the condition rating for this tree is C (Average).

A good section of the tree's crown extends over the northwest area of the property, and as designed, the foundations for the house will encroach into its drip line. And as specified, pervious surface cover is being proposed for the west side yard area, and a good portion of its northwest section is also within the drip line of this tree.

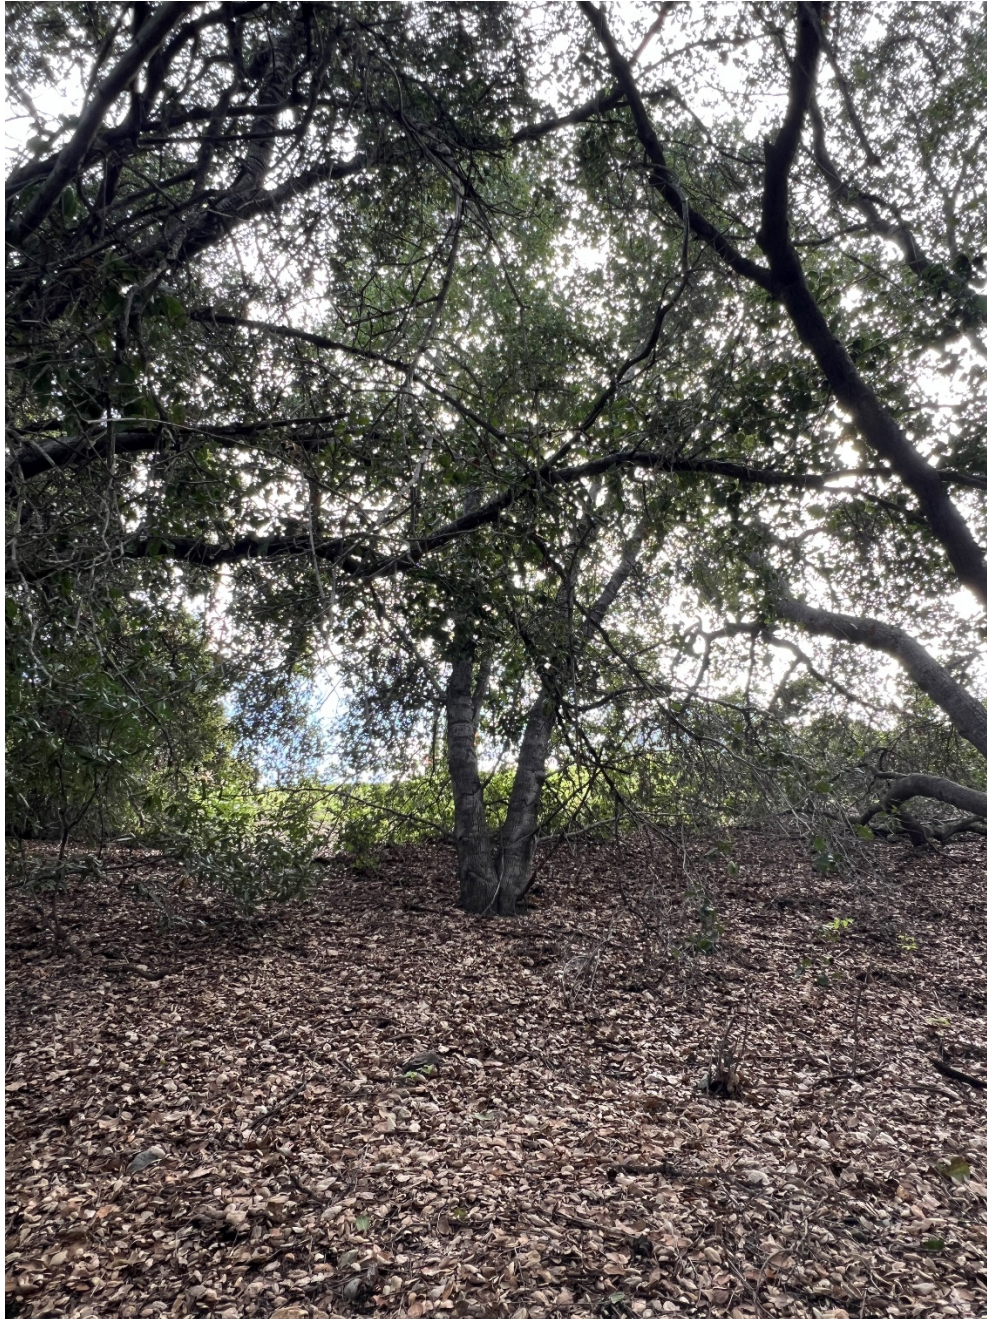
Off-Site Tree #2.

This tree has its main trunk dividing to two stems at about one foot over grade, and both lean slightly toward the south east side. They respectively have 10 and 10.5 inches DBH, or a combined DBH of 14.5 inches.

The height of this tree's crown is 25 feet, and it too is suppressed by the above mentioned further westerly mature oak tree, and the resulting crown of the tree is mostly in the south and west directions. The longest canopy spread is of 24 feet, in the northeast to southwest directions.

This tree has some deadwood in the crown, and it should further be assessed for possible included bark at the crotch of the main two stems.

Based on the City of Calabasas health and vigor grading on a scale of A to F (A being outstanding and F being dead), the condition rating for this tree is C (Average). This tree's crown is completely outside the property lines; however, the proposed west side yard edge encroaches into its tree protection zone, i.e. distance of five feet outside the drip line.

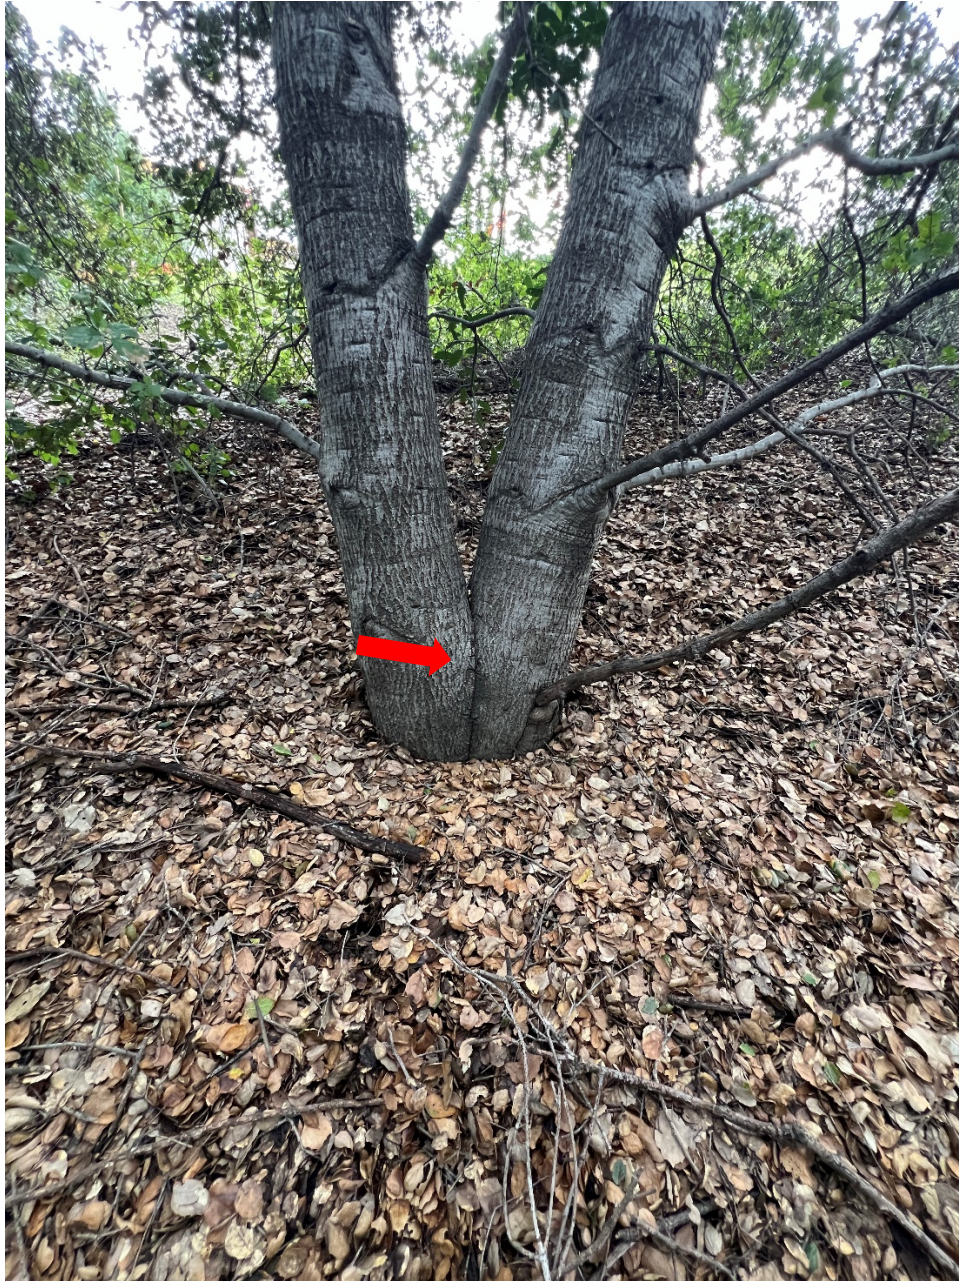
View of the lower section of Off-Site Tree #2.

(The fork of the two stems must further be assessed for possible included bark defect.)
