OAK TREE REPORT

MAHMOUD RESIDENCE
 22534 CALIPATRIA DRIVE
 February 09, 2024
 (revised 3-21-24 and 5-13-24)

OAK TREE REPORT FOR THE MAHMOUD RESIDENCE AT 22534 CALIPATRIA DRIVE IN THE CITY OF CALABASAS, CALIFORNIA 91302

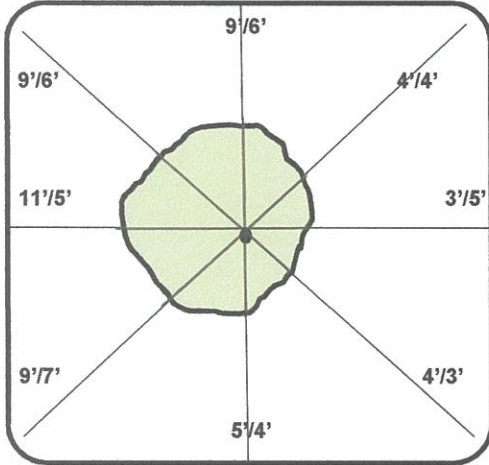
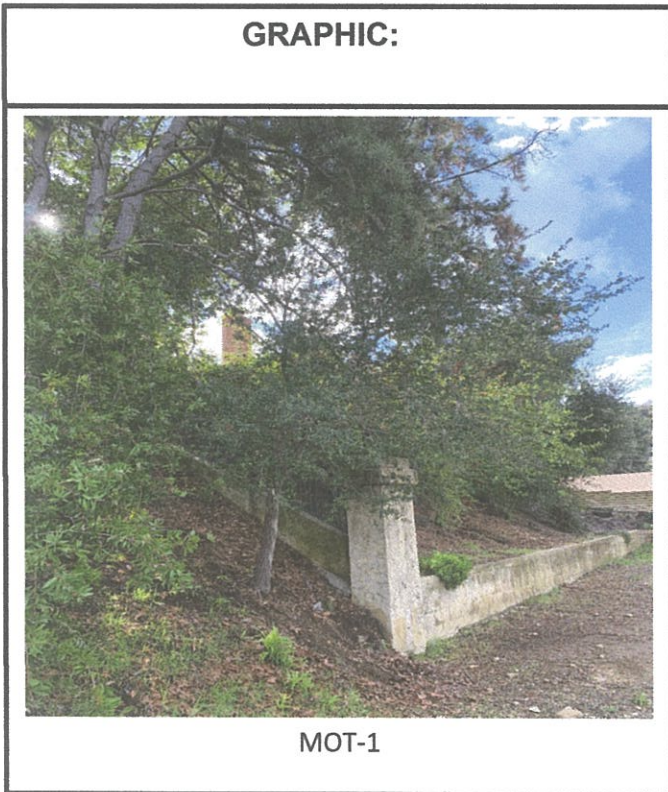
TREE #
MOT-1

Oak Tree MOT-1 is located near the bottom of the front yard slope, next to an existing wall pilaster, in the northeast quadrant of the property. There is a planned new home construction and this existing Oak Tree is located within the building footprint and proposed to be removed.

SPECIES: Quercus agrifolia
Appearance (A-F): C+ **Date:** 02-03-24
Health: (A-F): C- **Inspector:** RWC
Diameter of Trunk(s) 5 1/4" @ 54" above grade

VIGOR:
 CHLOROSIS
 AVERAGE SHOOT GROWTH
 DIEBACK
 MINOR DEADWOOD
 THINNING OF CROWN
 EPICORMIC GROWTH

STRUCTURE:
 BROKEN BRANCHES
 PRIOR STUB-CUT PRUNING
 MECHANICAL INJURY
 WIRE / NAILS / SPIKES
 TORN BRANCH SCARS
 LOW BRANCHING
 WATER TRAP
 CAVITY – SCAFFOLD
 CAVITY – BRANCH
 LOPSIDED CANOPY
 EXCESS HORIZONTAL GROWTH
 DECAY / ROT SUSPECTED
 FIRE / LIGHTNING DAMAGE
 EXPOSED ROOTS
 HAZARDOUS CONDITION
 CROSSING BRANCHES
 CODOMINANT SCAFFOLDS
 CODOMINANT TRUNKS
 MULTI-TRUNK FORM
 SEMI-MATURE OAK

ENVIRONMENT:
 ON IRRIGATED AND PLANTED SLOPE
 FILL ON TRUNK & ROOT ZONE
 ADJACENT TO WALL PILASTER
 CANOPY INTERTWINED IN L/S TREE
 CANOPY OVERHANGS LOT PAD

REMOVE THIS TREE FOR NEW HOME CONSTRUCTION. REPLACE PER REPORT TEXT.

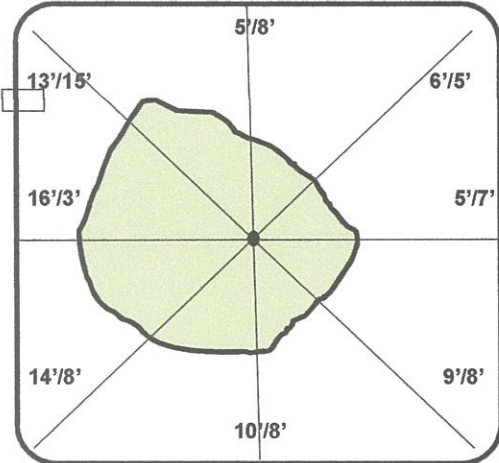
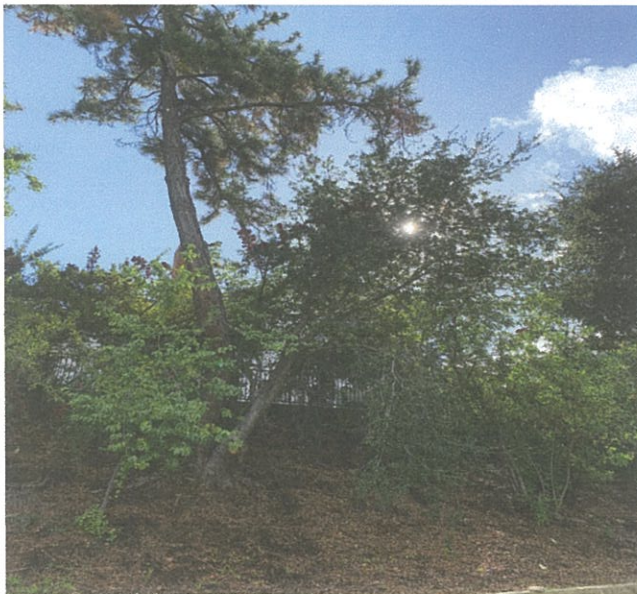
The canopy of Oak Trees MOT-2 and MOT-3 are not expected to be negatively impacted by or pruned for clearance for the proposed new home construction activity area. However, there may be moderate to significant root pruning for the construction of a new concrete block retaining wall about six feet ($\pm 6'$) to the west and downhill from the trunk of Oak Tree MOT-2 and about eight feet ($\pm 8'$) to the west and downhill from the trunk of Oak Tree MOT-3.

Diameter of Trunk(s) 8 1/4", 1 1/8" (TOTAL 9 3/8")

- BROKEN BRANCHES
- PRIOR STUB-CUT PRUNING
- MECHANICAL INJURY
- WIRE / NAILS / SPIKES
- TORN BRANCH SCARS
- LOW BRANCHING
- WATER TRAP
- CAVITY – SCAFFOLD
- CAVITY – BRANCH
- LOPSIDED CANOPY
- EXCESS HORIZONTAL GROWTH
- DECAY / ROT SUSPECTED
- FIRE / LIGHTNING DAMAGE
- EXPOSED ROOTS
- HAZARDOUS CONDITION
- CROSSING BRANCHES
- CODOMINANT SCAFFOLDS
- CODOMINANT TRUNKS
- INCLUDED BARK
- SEMI-MATURE OAK LEANS TO SOUTHWEST

- ON IRRIGATED AND PLANTED SLOPE
- FILL ON TRUNK & ROOT ZONE
- CONJOINED WITH ADJACENT PINE
- CANOPY INTERTWINED IN L/S PLANTS
- CANOPY OVERHANGS LOT PAD

SOME ROOT PRUNING MAY OCCUR DUE TO NEW RETAINING WALL.

PROTECT THIS TREE IN PLACE.

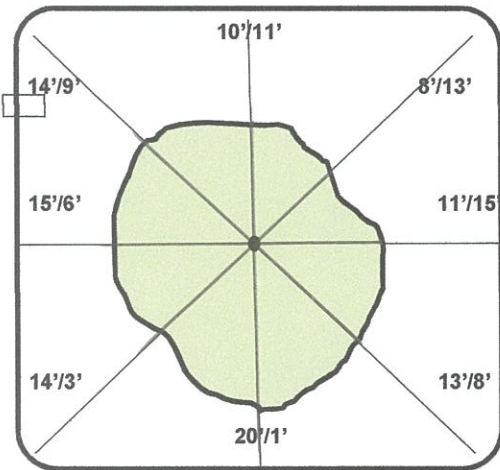
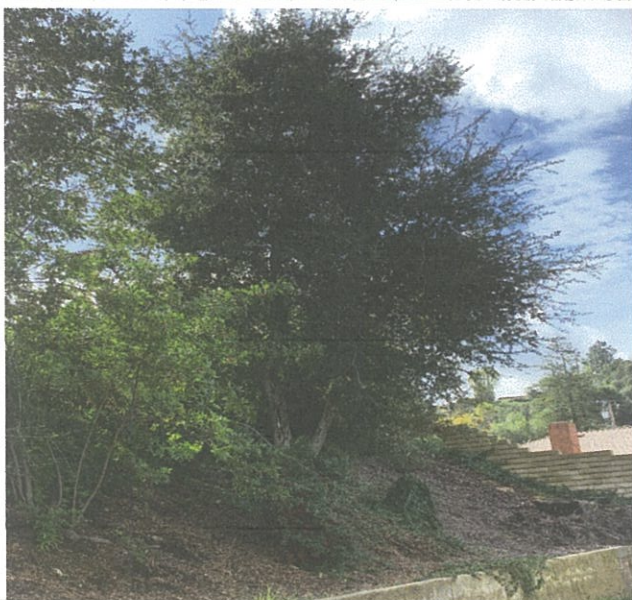
MOT-3

Diameter of Trunk(s) 9 1/4", 6" (TOTAL 15 1/4")

- BROKEN BRANCHES
- PRIOR STUB-CUT PRUNING
- MECHANICAL INJURY
- WIRE / NAILS / SPIKES
- TORN BRANCH SCARS
- LOW BRANCHING
- WATER TRAP
- CAVITY – SCAFFOLD
- CAVITY – BRANCH
- LOPSIDED CANOPY
- EXCESS HORIZONTAL GROWTH
- DECAY / ROT SUSPECTED
- FIRE / LIGHTNING DAMAGE
- EXPOSED ROOTS
- HAZARDOUS CONDITION
- CROSSING BRANCHES
- CODOMINANT SCAFFOLDS
- CODOMINANT TRUNKS
- INCLUDED BARK
- SEMI-MATURE OAK LEANS SLIGHTLY TO SOUTHEAST

- ON IRRIGATED AND PLANTED SLOPE
- FILL ON TRUNK & ROOT ZONE
- CONJOINED WITH ADJACENT PINE
- CANOPY INTERTWINED IN L/S PLANTS
- CANOPY OVERHANGS LOT PAD

SOME ROOT PRUNING MAY OCCUR DUE TO NEW RETAINING WALL.

PROTECT THIS TREE IN PLACE.

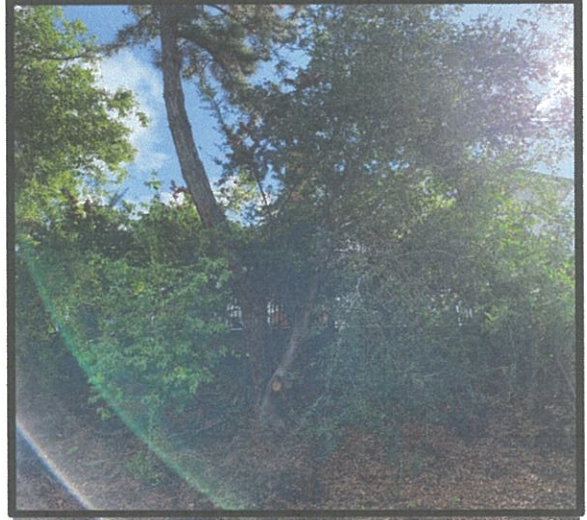
Oak Tree MOT-2 is located in the middle of the easterly rear yard slope and is proposed to be protected-in-place.

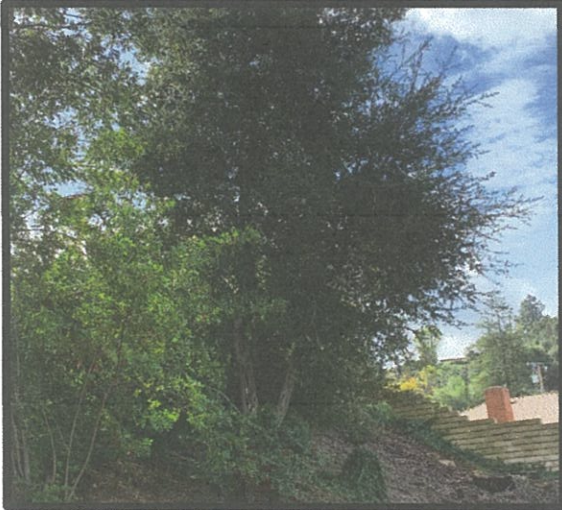
Oak Tree MOT-3 is also located in the middle of the easterly rear yard slope and is proposed to be protected-in-place.
