MAHMOUD RESIDENCE

OAK TREE REPORT

OAK TREE REPORT II

MAHMOUD RESIDENCE
22534 CALIPATRIA DRIVE
 July 23, 2024

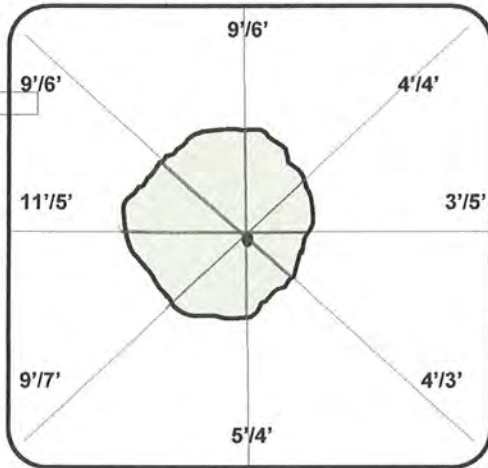
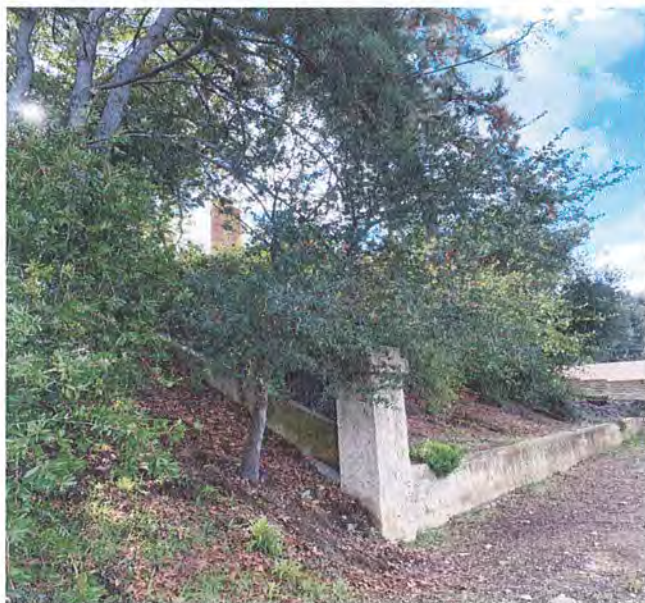
Oak Tree MOT-1 is located near the bottom of the front side-yard slope, next to an existing wall pilaster, in the northeast quadrant of the property. There is a planned new home construction and this existing Oak Tree is located within the building footprint and proposed to be removed.

The condition of this Tree is estimated to be 63%

The impact(s) to this Tree is estimated to be 100.00%

Appearance (A-F): C+

Health: (A-F): C-

Diameter of Trunk(s) 5 1/4" @ 54" above grade

- CHLOROSIS
- AVERAGE SHOOT GROWTH
- DIEBACK
- MINOR DEADWOOD
- THINNING OF CROWN
- EPICORMIC GROWTH

- BROKEN BRANCHES
- PRIOR STUB-CUT PRUNING
- MECHANICAL INJURY
- WIRE / NAILS / SPIKES
- TORN BRANCH SCARS
- LOW BRANCHING
- WATER TRAP
- CAVITY – SCAFFOLD
- CAVITY – BRANCH
- LOPSIDED CANOPY
- EXCESS HORIZONTAL GROWTH
- DECAY / ROT SUSPECTED
- FIRE / LIGHTNING DAMAGE
- EXPOSED ROOTS
- HAZARDOUS CONDITION
- CROSSING BRANCHES
- CODOMINANT SCAFFOLDS
- CODOMINANT TRUNKS
- MULTI-TRUNK FORM
- SEMI-MATURE OAK

- BORERS / TERMITES
- MINOR TWIG GIRDLER
- ANTS
- WOODPECKERS
- GALLS
- WITCHES BROOM
- PIT-SCALE
- PLANT PARASITES
- MINOR EHRHORN'S SCALE

- MARGINAL LEAF SCORCH
- EXFOLIATION
- LESIONS
- MINOR EXUDATION STAINS
- CANKERS

- ON IRRIGATED AND PLANTED SLOPE
- FILL ON TRUNK & ROOT ZONE
- ADJACENT TO WALL PILASTER
- CANOPY INTERTWINED IN L/S TREE
- CANOPY OVERHANGS LOT PAD

Mitigation for the necessary removal of Oak Tree MOT-1, includes the on-site planting of two (2) thirty-six inch (36") box sized nursery-grown specimen Oak Trees. Monitoring of the two (2) mitigation Oak Trees, shall be based upon the Oak Trees' generally accepted semi-annual growth cycles. The property Owner/Applicant shall call upon the Project Consulting Arborist to provide the City-required semi-annual monitoring site-visits for a period of five (5) years, after the initial planting

REMOVE THIS TREE FOR NEW HOME CONSTRUCTION. REPLACE PER REPORT TEXT.

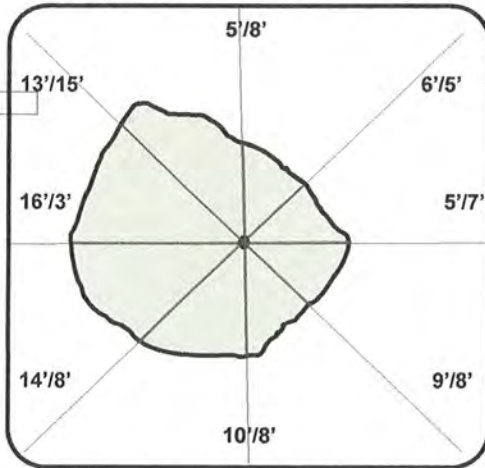
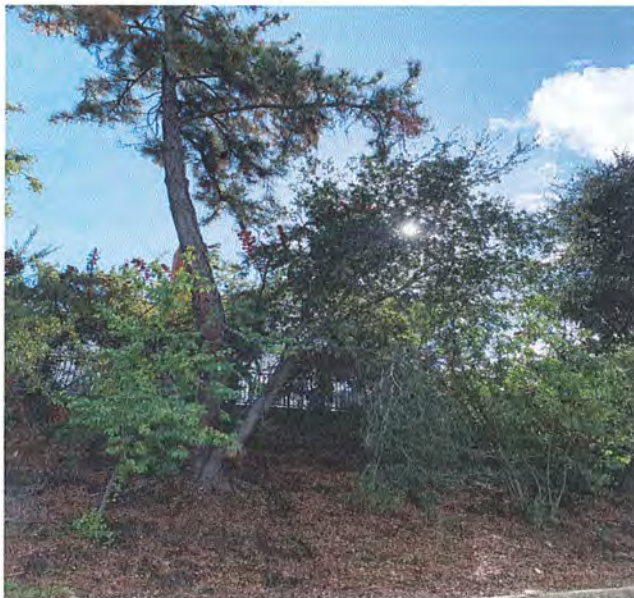
Oak Tree MOT-2 is located in the middle of the easterly rear yard slope and is proposed to be protected-in-place.

The condition of this Tree is estimated to be 77%

Appearance (A-F): C+

Health: (A-F): C+

Diameter of Trunk(s) 8 1/4", 1 1/8" (TOTAL 9 3/8")

- BROKEN BRANCHES
- PRIOR STUB-CUT PRUNING
- MECHANICAL INJURY
- WIRE / NAILS / SPIKES
- TORN BRANCH SCARS
- LOW BRANCHING
- WATER TRAP
- CAVITY – SCAFFOLD
- CAVITY – BRANCH
- LOPSIDED CANOPY
- EXCESS HORIZONTAL GROWTH
- DECAY / ROT SUSPECTED
- FIRE / LIGHTNING DAMAGE
- EXPOSED ROOTS
- HAZARDOUS CONDITION
- CROSSING BRANCHES
- CODOMINANT SCAFFOLDS
- CODOMINANT TRUNKS
- INCLUDED BARK
- SEMI-MATURE OAK LEANS TO SOUTHWEST

- BORERS / TERMITES
- MINOR TWIG GIRDLER
- ANTS
- WOODPECKERS
- GALLS
- WITCHES BROOM
- PIT-SCALE
- PLANT PARASITES
- MINOR EHRHORN'S SCALE

- MARGINAL LEAF SCORCH
- EXFOLIATION
- LESIONS
- MINOR EXUDATION STAINS
- CANKERS

- ON IRRIGATED AND PLANTED SLOPE
- FILL ON TRUNK & ROOT ZONE
- CONJOINED WITH ADJACENT PINE
- CANOPY INTERTWINED IN L/S PLANTS
- CANOPY OVERHANGS LOT PAD

NO NEW IMPACTS, AS EXISTING RETAINING WALL REMAINS IN PLACE.

PROTECT THIS TREE IN PLACE.

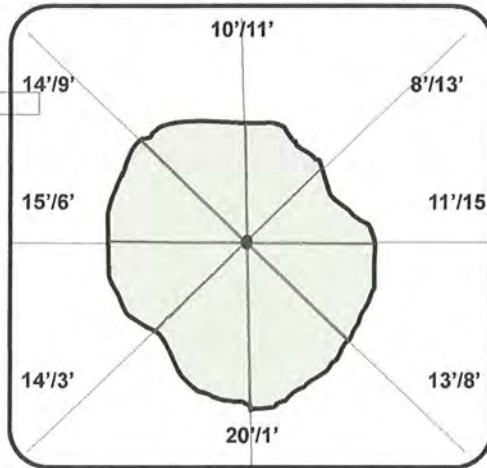
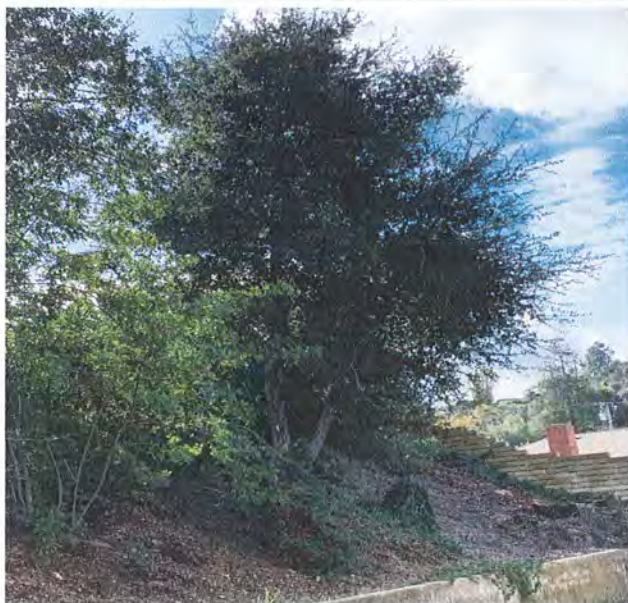
Oak Tree MOT-3 is also located in the middle of the easterly rear yard slope and is proposed to be protected-in-place.

The condition of this Tree is estimated to be 77.0%

Appearance (A-F): C+

Health: (A-F): C+

Diameter of Trunk(s) 9 1/4", 6" (TOTAL 15 1/4")

- BROKEN BRANCHES
- PRIOR STUB-CUT PRUNING
- MECHANICAL INJURY
- WIRE / NAILS / SPIKES
- TORN BRANCH SCARS
- LOW BRANCHING
- WATER TRAP
- CAVITY – SCAFFOLD
- CAVITY – BRANCH
- LOPSIDED CANOPY
- EXCESS HORIZONTAL GROWTH
- DECAY / ROT SUSPECTED
- FIRE / LIGHTNING DAMAGE
- EXPOSED ROOTS
- HAZARDOUS CONDITION
- CROSSING BRANCHES
- CODOMINANT SCAFFOLDS
- CODOMINANT TRUNKS
- INCLUDED BARK
- SEMI-MATURE OAK LEANS SLIGHTLY TO SOUTHEAST

- BORERS / TERMITES
- MINOR TWIG GIRDLER
- ANTS
- WOODPECKERS
- GALLS
- WITCHES BROOM
- PIT-SCALE
- PLANT PARASITES
- MINOR EHRHORN'S SCALE

- MARGINAL LEAF SCORCH
- EXFOLIATION
- LESIONS
- MINOR EXUDATION STAINS
- CANKERS

- ON IRRIGATED AND PLANTED SLOPE
- FILL ON TRUNK & ROOT ZONE
- CONJOINED WITH ADJACENT PINE
- CANOPY INTERTWINED IN L/S PLANTS
- CANOPY OVERHANGS LOT PAD

NO NEW IMPACTS, AS EXISTING RETAINING WALL REMAINS IN PLACE.

PROTECT THIS TREE IN PLACE.
