MEMORANDUM

July 15, 2024

Subject: *Peer-Review Memo Letter of Oak Tree Report for the proposed Single-family Residential and ADU Project at 4440 Park Aurora, Calabasas, California*

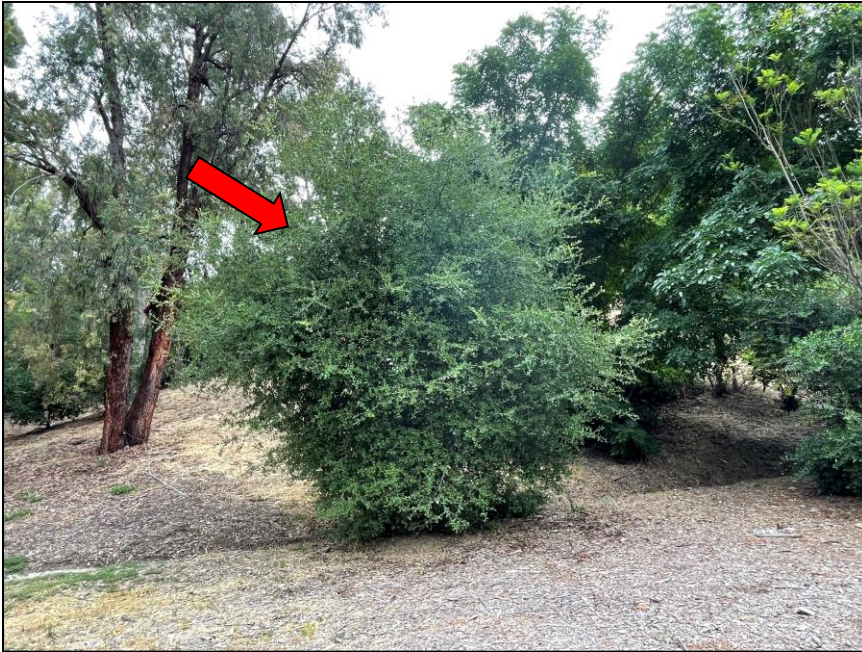
1. Overview photograph of the coast live oak tree (Tag #70) located in the northeast portion of the property of 4440 Park Aurora. Photograph taken facing east.

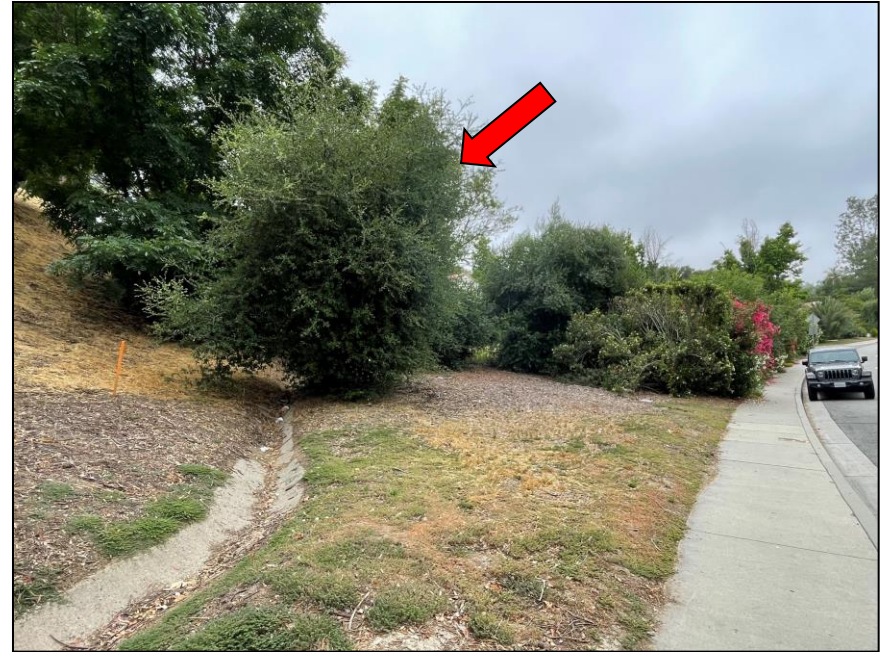
2. Overview photograph of the coast live oak tree (Tag #70) located in the northeast portion of the property of 4440 Park Aurora. Photograph taken facing southwest.

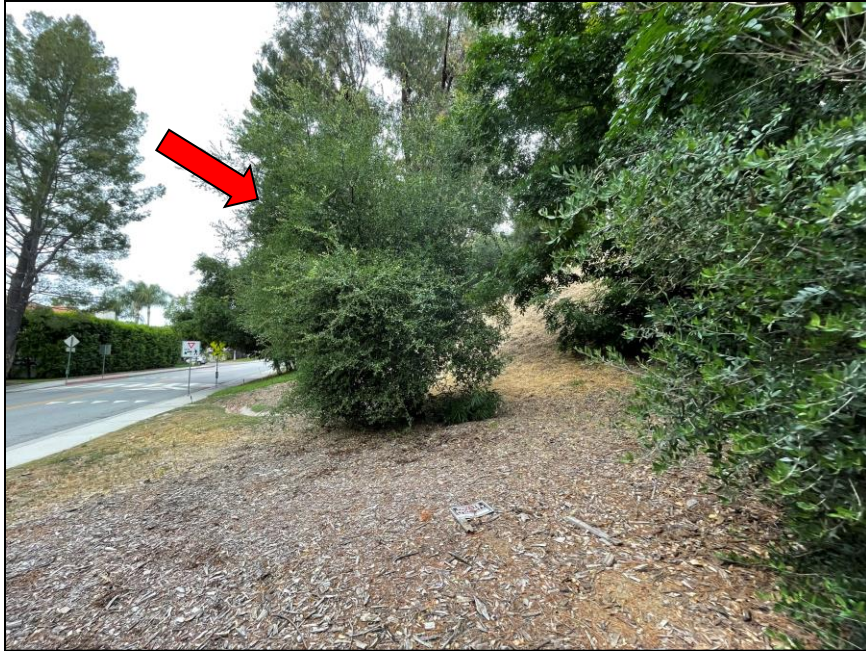
3. Overview photograph of the coast live oak tree (Tag #70) located in the northeast portion of the property of 4440 Park Aurora. Photograph taken facing northeast.

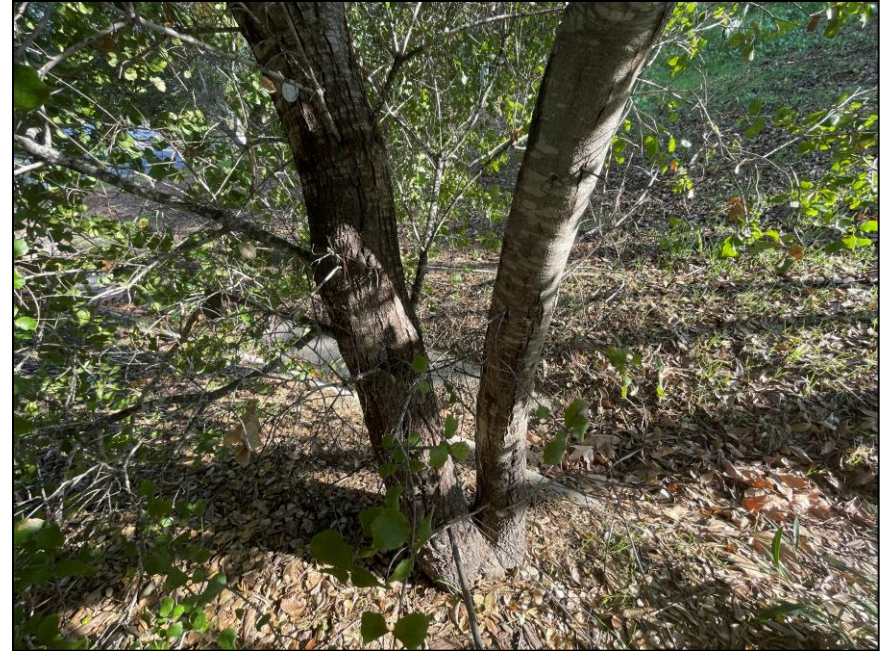
4. Overview photograph of the base of the coast live oak tree (Tag #70) located in the northeast portion of the property of 4440 Park Aurora. Photograph taken looking down facing east.

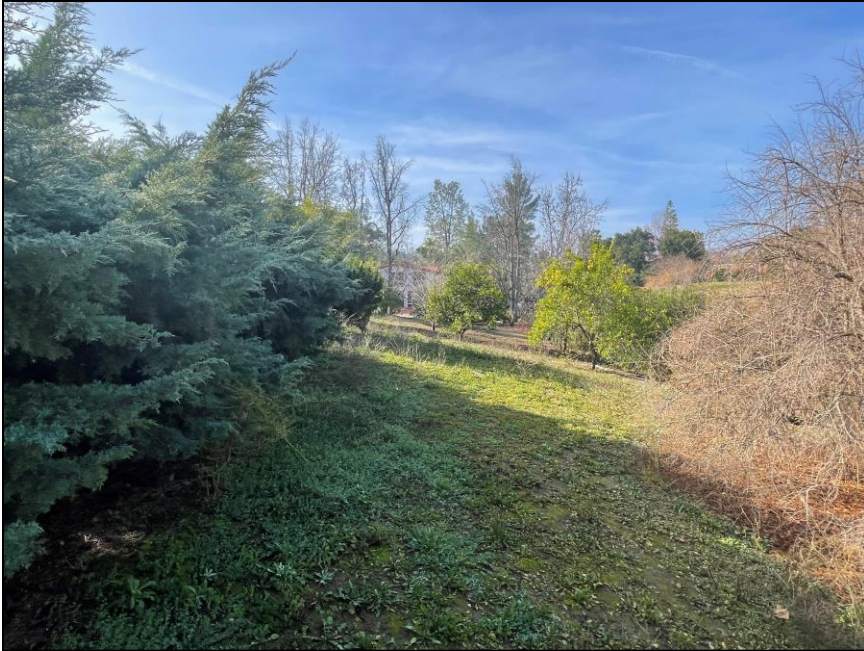
5. Overview photograph looking down the southern property line towards Park Aurora. It should be noted that there are no additional coast live oak trees located in this portion of the project site. Photograph taken facing southwest.

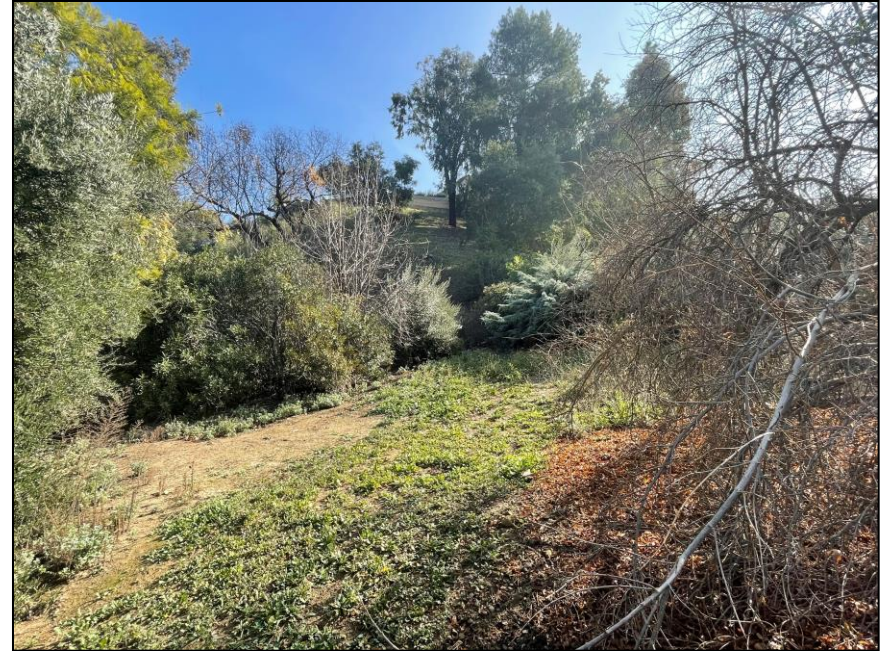
6. Overview photograph looking towards eastern property line towards the location of the single coast live oak tree. It should be noted that there are no additional coast live oak trees located in this portion of the project site. Photograph taken facing east.

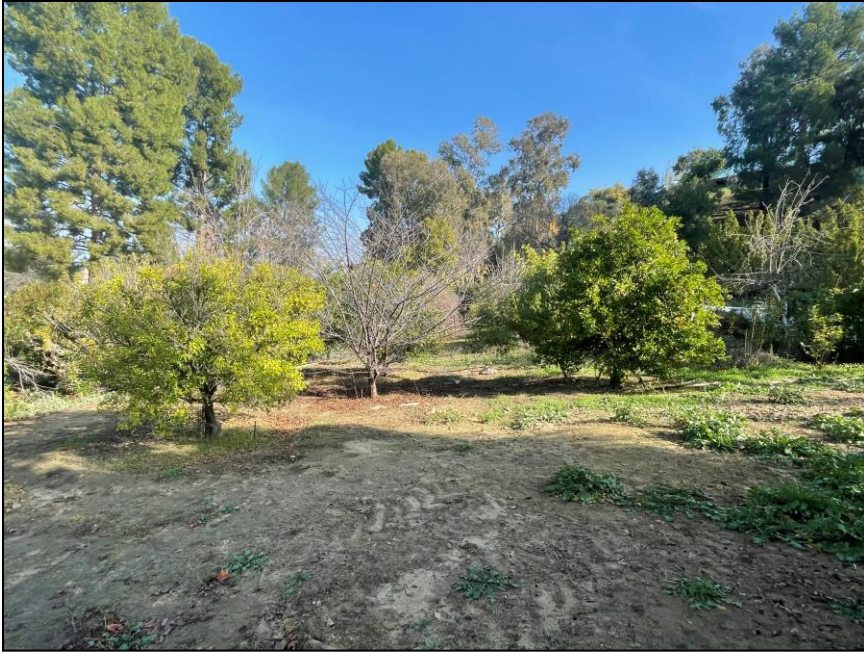
7. Overview photograph looking east/northeast across the project site.

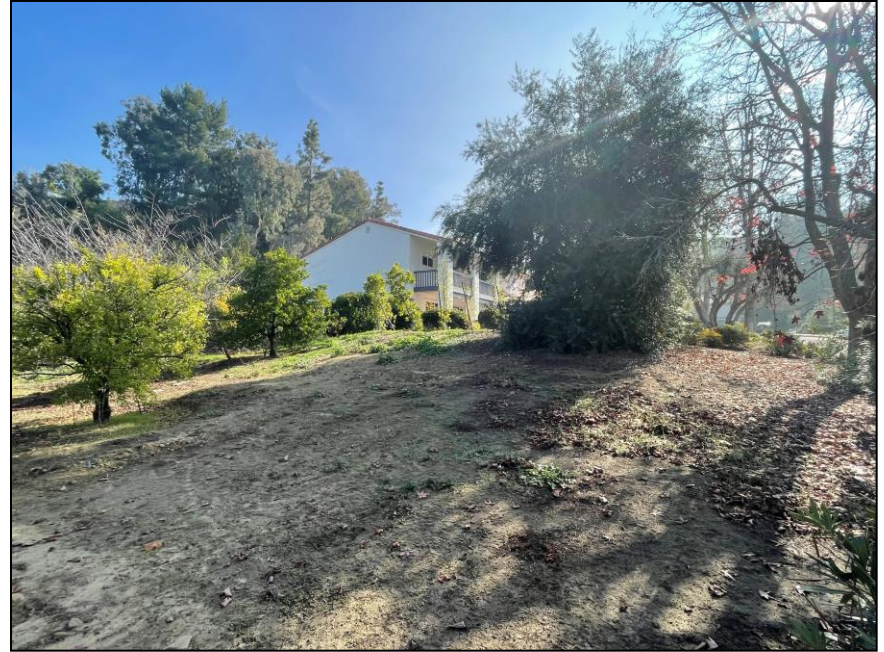
8. Overview photograph looking east across the project site towards the southern property boundary.

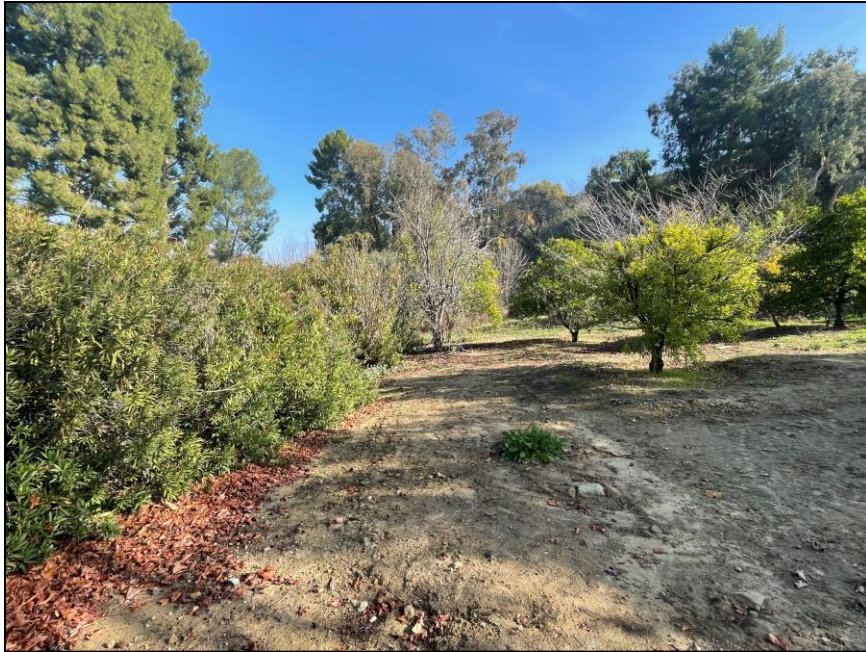
9. Overview photograph looking east/northeast across the project site along the northern property boundary.
