MEMORANDUM

Subject: Permit Peer Review Memo Letter for the submitted REVISED Arborist Report for the proposed Tennis Court Construction at 25201 Prado del Grandioso, Calabasas, California

Attachment 1 – Healthy Oak Tree Report

Representative Site Photographs

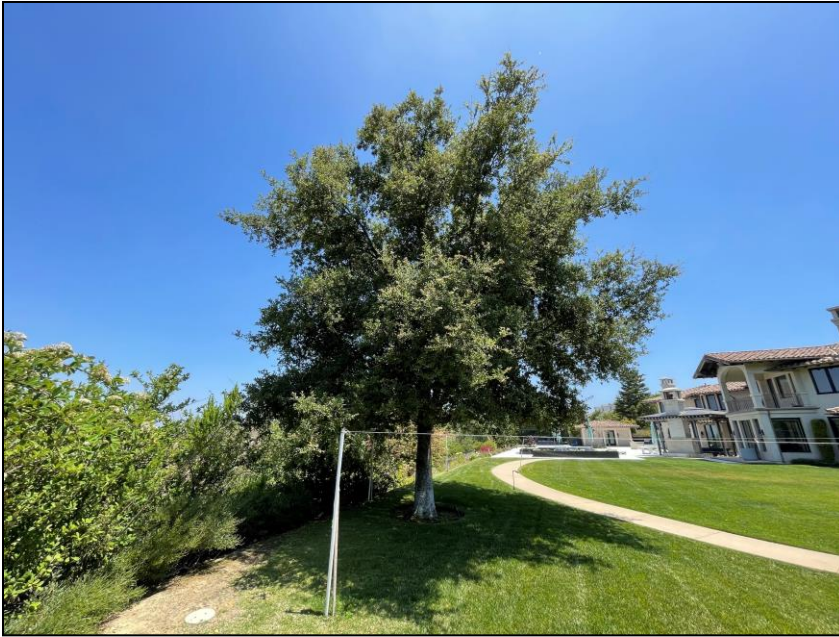
1. Overview photograph of a coast live oak tree located in the NW portion of the rear yard of 25201 Prado del Grandioso. The applicant is proposing to construct a new tennis court, thus having to remove the coast live oak tree. Photograph taken facing east. Note the stakes are the outline of the tennis court.

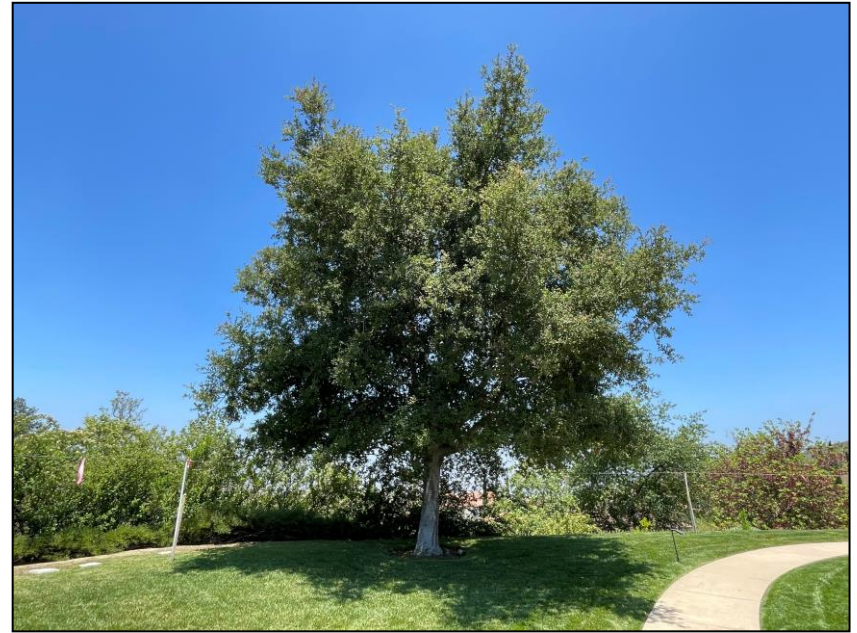
2. Overview photograph of a coast live oak tree located in the NW portion of the rear yard of 25201 Prado del Grandioso. The applicant is proposing to construct a new tennis court, thus having to remove the coast live oak tree. Photograph taken facing north/NW. Note the stakes are the outline of the tennis court.

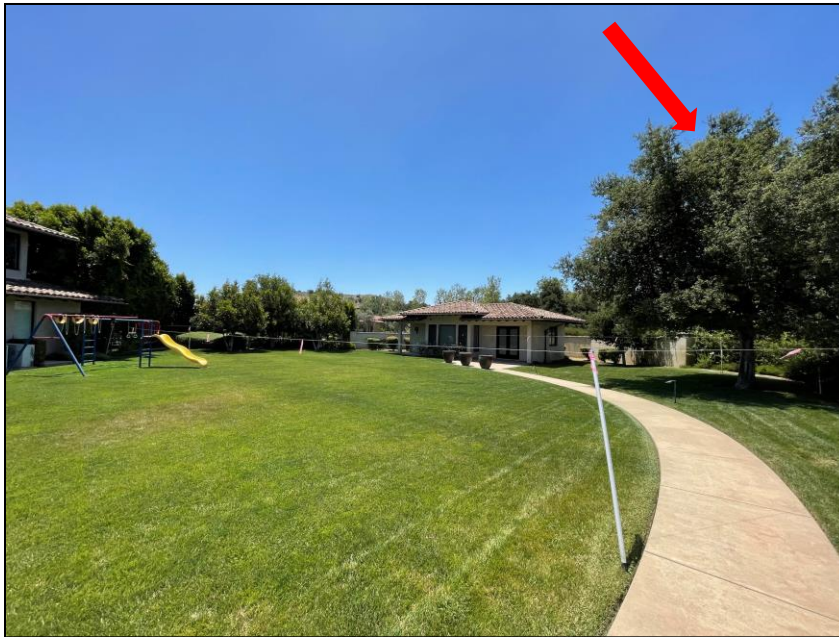
3. Overview photograph of a coast live oak tree located in the NW portion of the rear yard of 25201 Prado del Grandioso (red arrow). The applicant is proposing to construct a new tennis court, thus having to remove the coast live oak tree. Photograph taken facing west. Note the stakes are the outline of the tennis court.

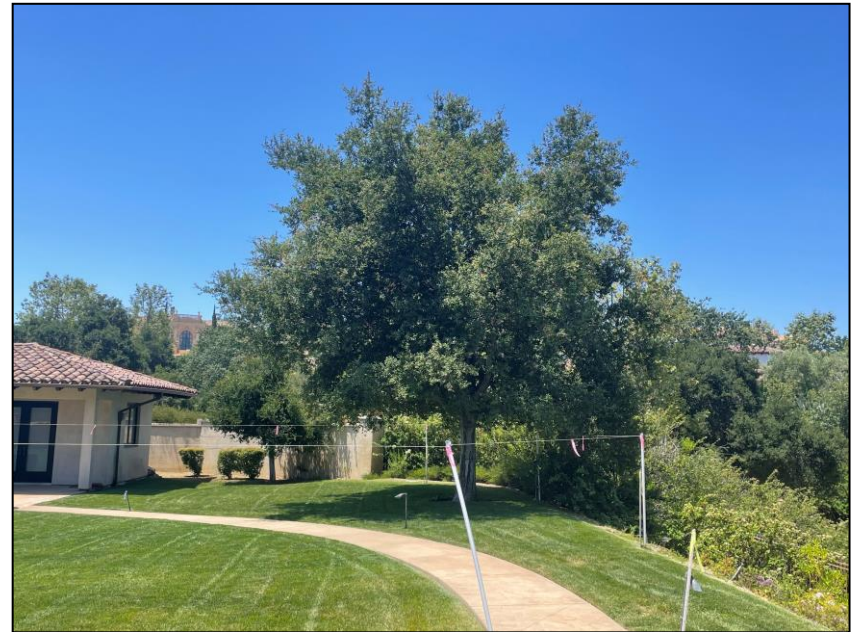
4. Photograph of a coast live oak tree located in the NW portion of the rear yard of 25201 Prado del Grandioso. The applicant is proposing to construct a new tennis court, thus having to remove the coast live oak tree. Photograph taken facing west. Note the stakes are the outline of the tennis court.

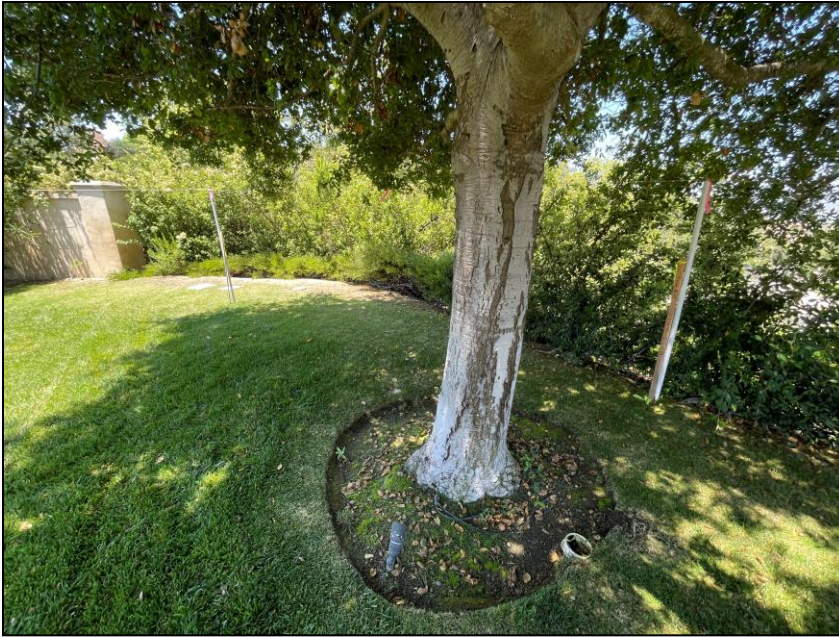
5. Photograph of the base of a coast live oak tree located in the NW portion of the rear yard of 25201 Prado del Grandioso (red arrow). The applicant is proposing to construct a new tennis court, thus having to remove the coast live oak tree. Photograph taken looking down facing west. Note the stakes are the outline of the tennis court.

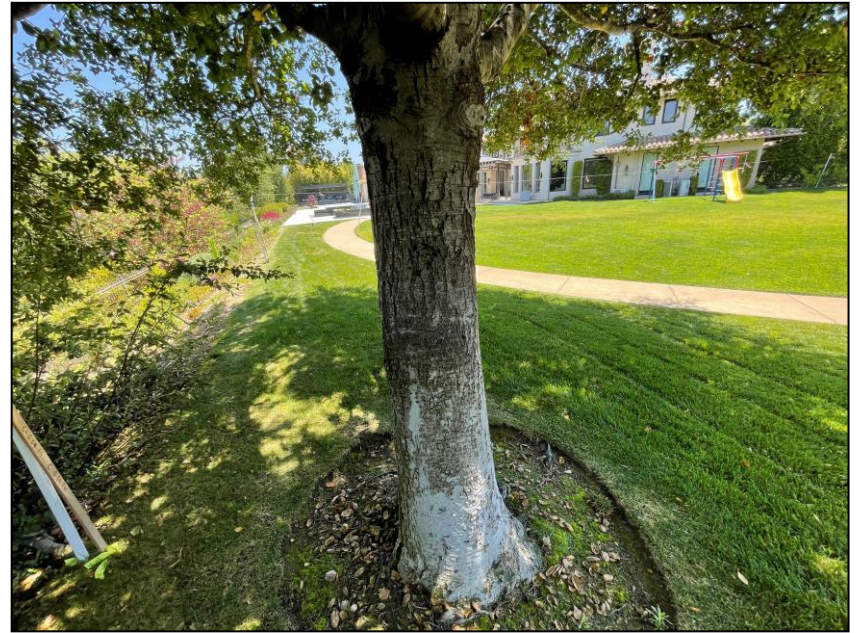
6. Photograph of the base of a coast live oak tree located in the NW portion of the rear yard of 25201 Prado del Grandioso (red arrow). The applicant is proposing to construct a new tennis court, thus having to remove the coast live oak tree. Photograph taken looking down facing east. Note the stakes are the outline of the tennis court.

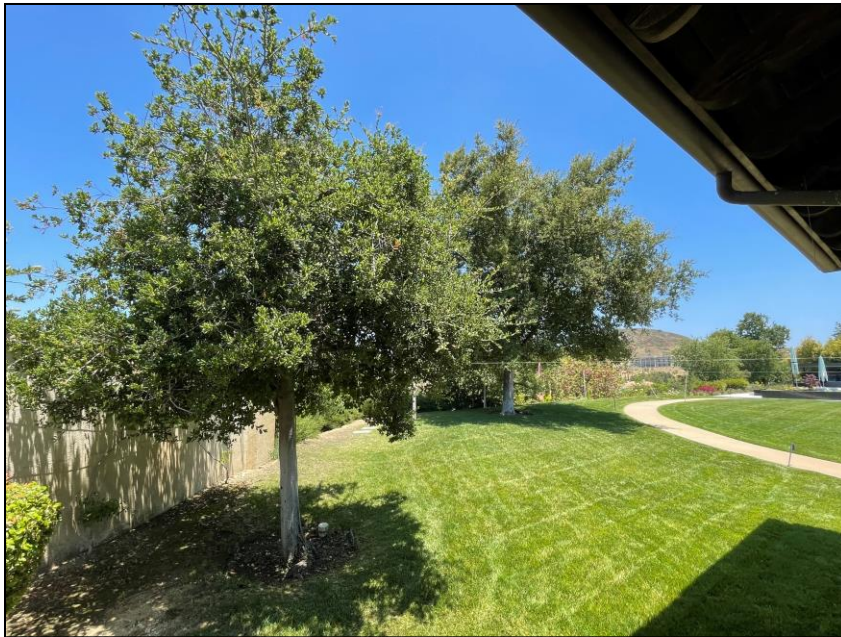
7. Photograph of a second coast live oak tree located approx. 30 feet SW of Oak Tree no.1 and approx. 20 feet west of the outside perimeter of the tennis court construction activities. Photograph taken facing NE. Note: this tree was not included in the original Oak Tree Report and will need to be added to the revised Oak Tree Report.

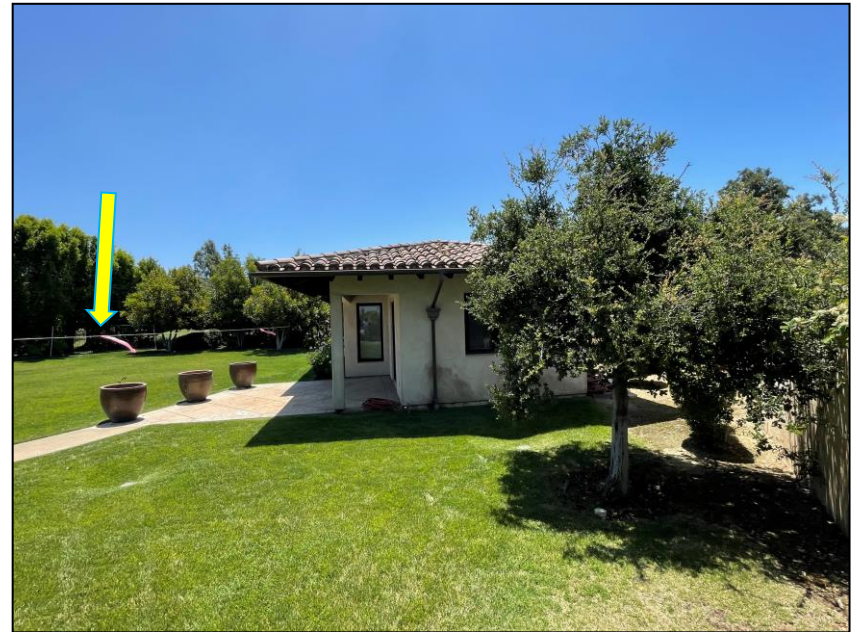
8. Photograph of a second coast live oak tree located approx. 30 feet SW of Oak Tree no.1 and approx. 20 feet west of the outside perimeter of the tennis court construction activities (yellow arrow is the perimeter of the tennis court). Photograph taken facing south. Note: this tree was not included in the original Oak Tree Report and will need to be added to the revised Oak Tree Report.
