## OAK TREE REPORT

**26300 Rondell Street Project**

Date: April 27, 2015  
Revised Date: June 8, 2015  
LNDG Project No.: 200-545

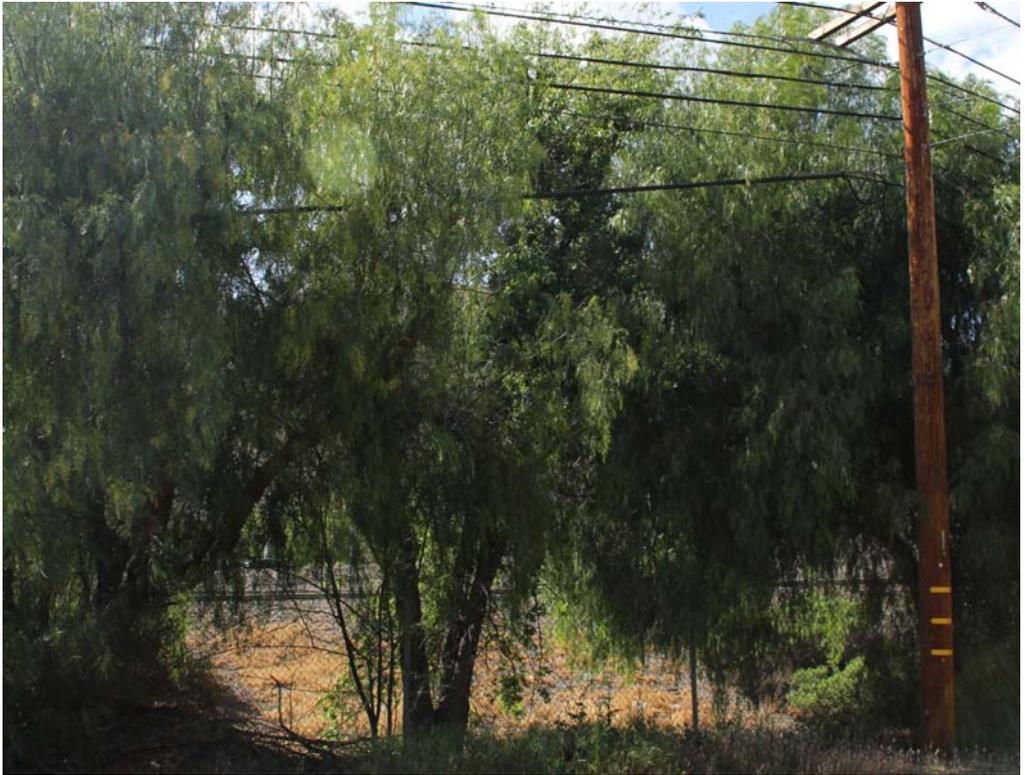
<b>Tree #</b>	<b>Reason for Encroachment</b>
1	This tree will be encroached on the east side of the trunk by the edge of the proposed pavement, 10 feet from the trunk. The grading operation and construction of the parking lot will take the encroachment a few feet closer to the trunk. The new pavement will be at grade so the impact to the tree should be minor. The estimated area of encroachment will be approximately 3,400 square feet or 43% of the area of the protected zone. Pruning will be limited to that root pruning necessary to grade and construct the parking lot.
2	This tree will be encroached slightly by the construction of the concrete v-ditch at the top of the proposed manufactured slope at the perimeter of protected zone. The area of the encroachment will be approximately 400 square feet, 5% of the area of the protected zone. The extent of the excavation for the v-ditch will be 40 feet from the trunk. Pruning will be limited to that root pruning necessary to grade and construct the v-ditch.

Oak tree 1 facing northwest.

- v. Oak trees do not usually require supplemental watering but in during the current drought, the irrigation of tree 1 may be recommended because of the anticipated impact to its root system.
- vi. If grading is completed other than during the rainy season, dust deposited on the foliage of oaks must be hosed off so that the growth processes of the tree are not disrupted.

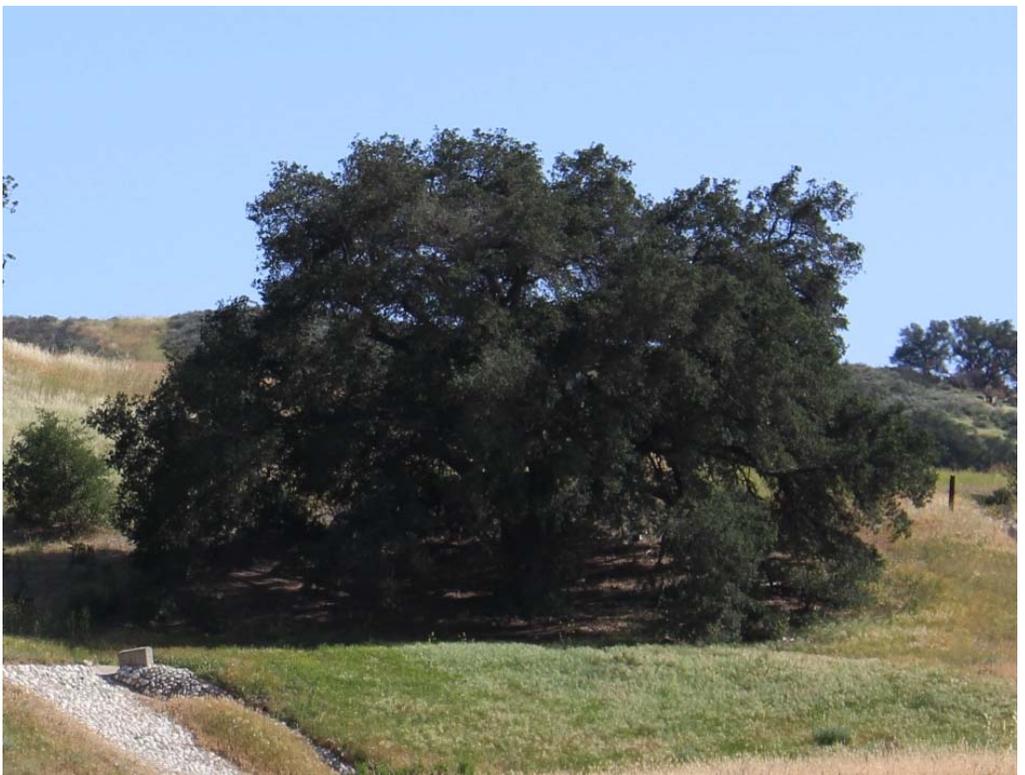
Oak tree 2 facing southeast.

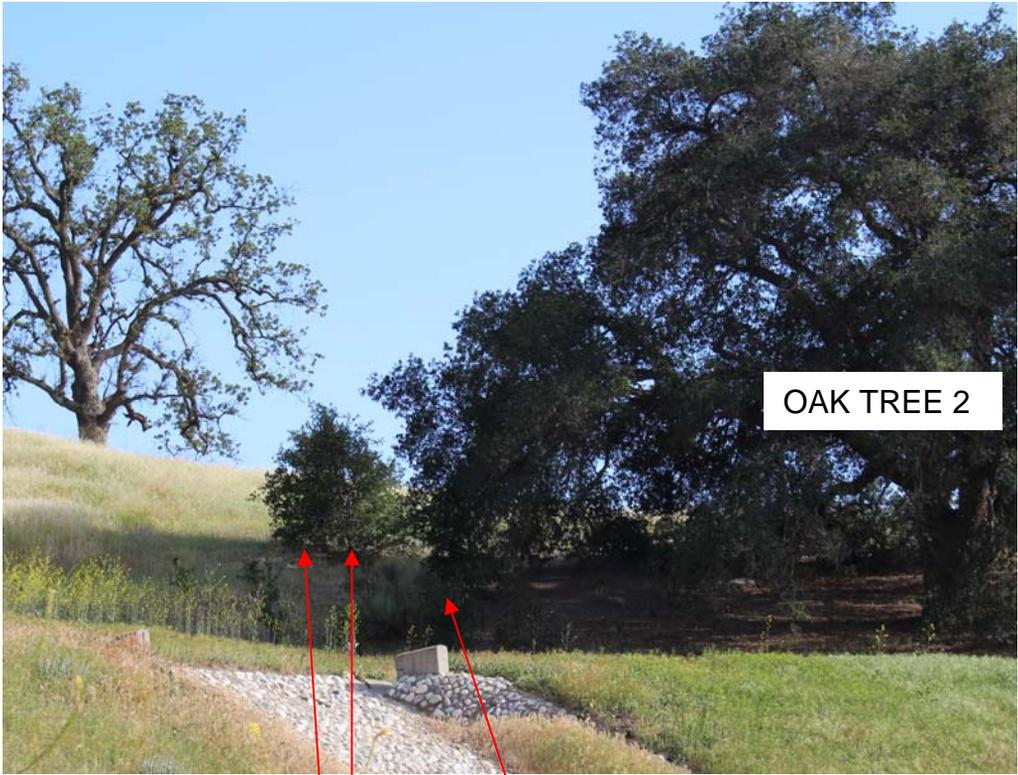
Oak trees 3,4, and 5 facing southeast.

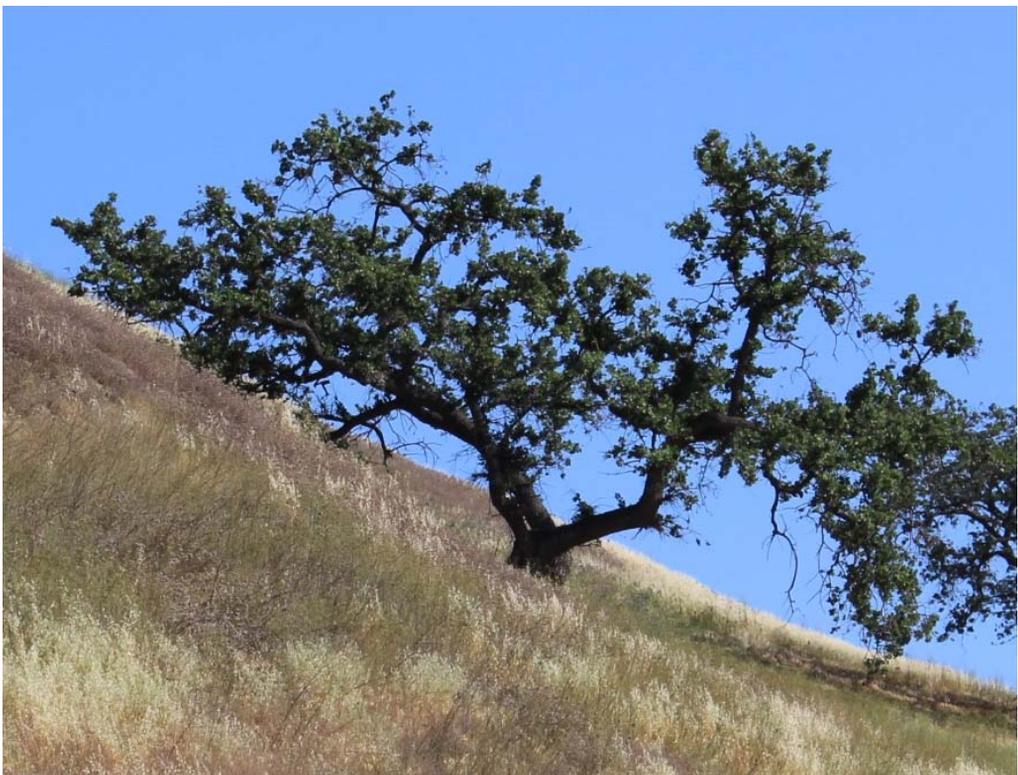
Oak tree 6 southeast.

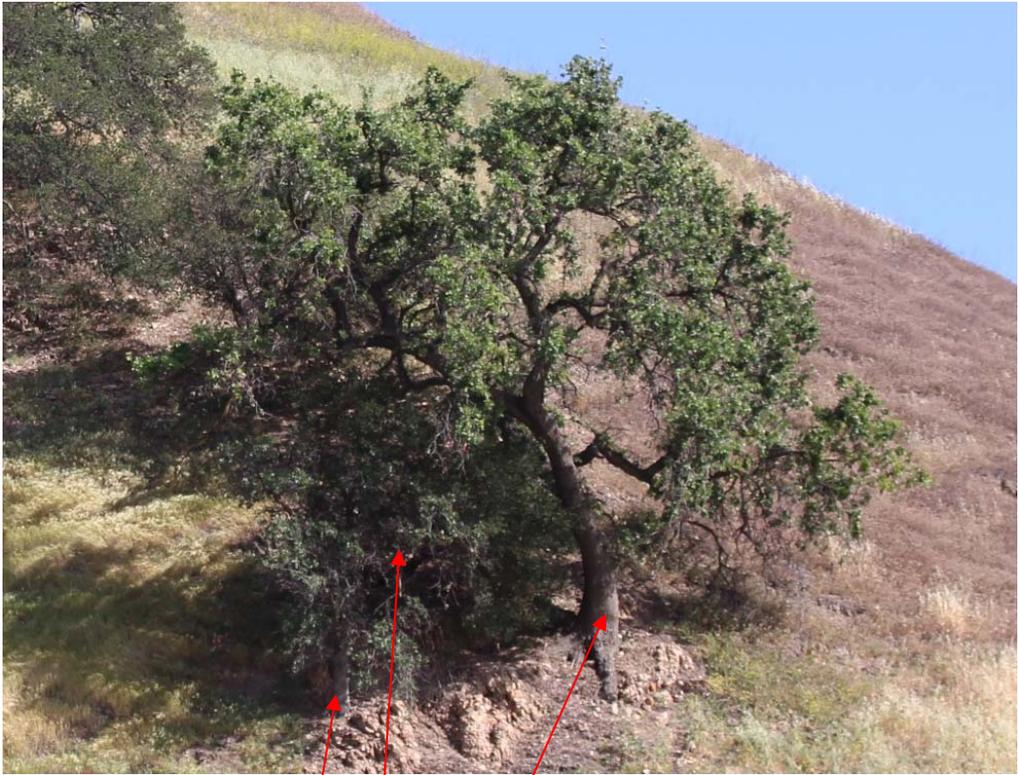
7	A proposed deflection wall is proposed that will be constructed approximately 35 feet for the trunk. The area of this construction will be 650 square feet, approximately 8% of the area of the protected zone. Pruning will be limited to that root pruning necessary to excavate for the wall footing and swale.

Oak trees 9,8, and 7 facing southeast.

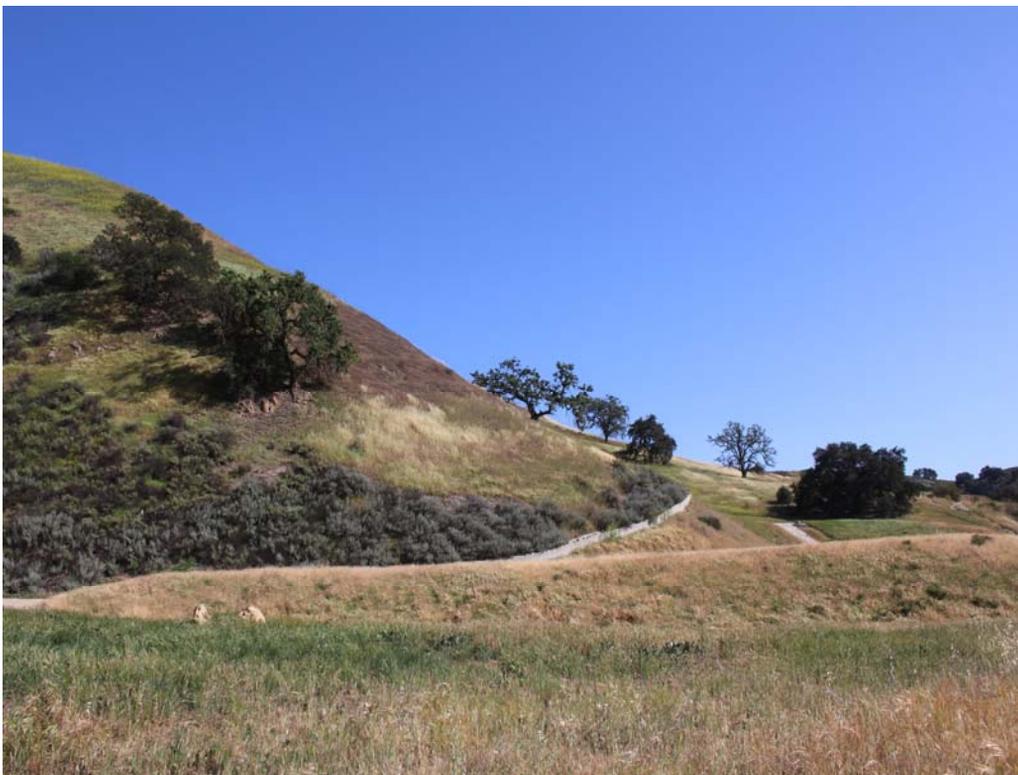
Oak trees 9 to 2 and other trees beyond range of project, facing southeast.

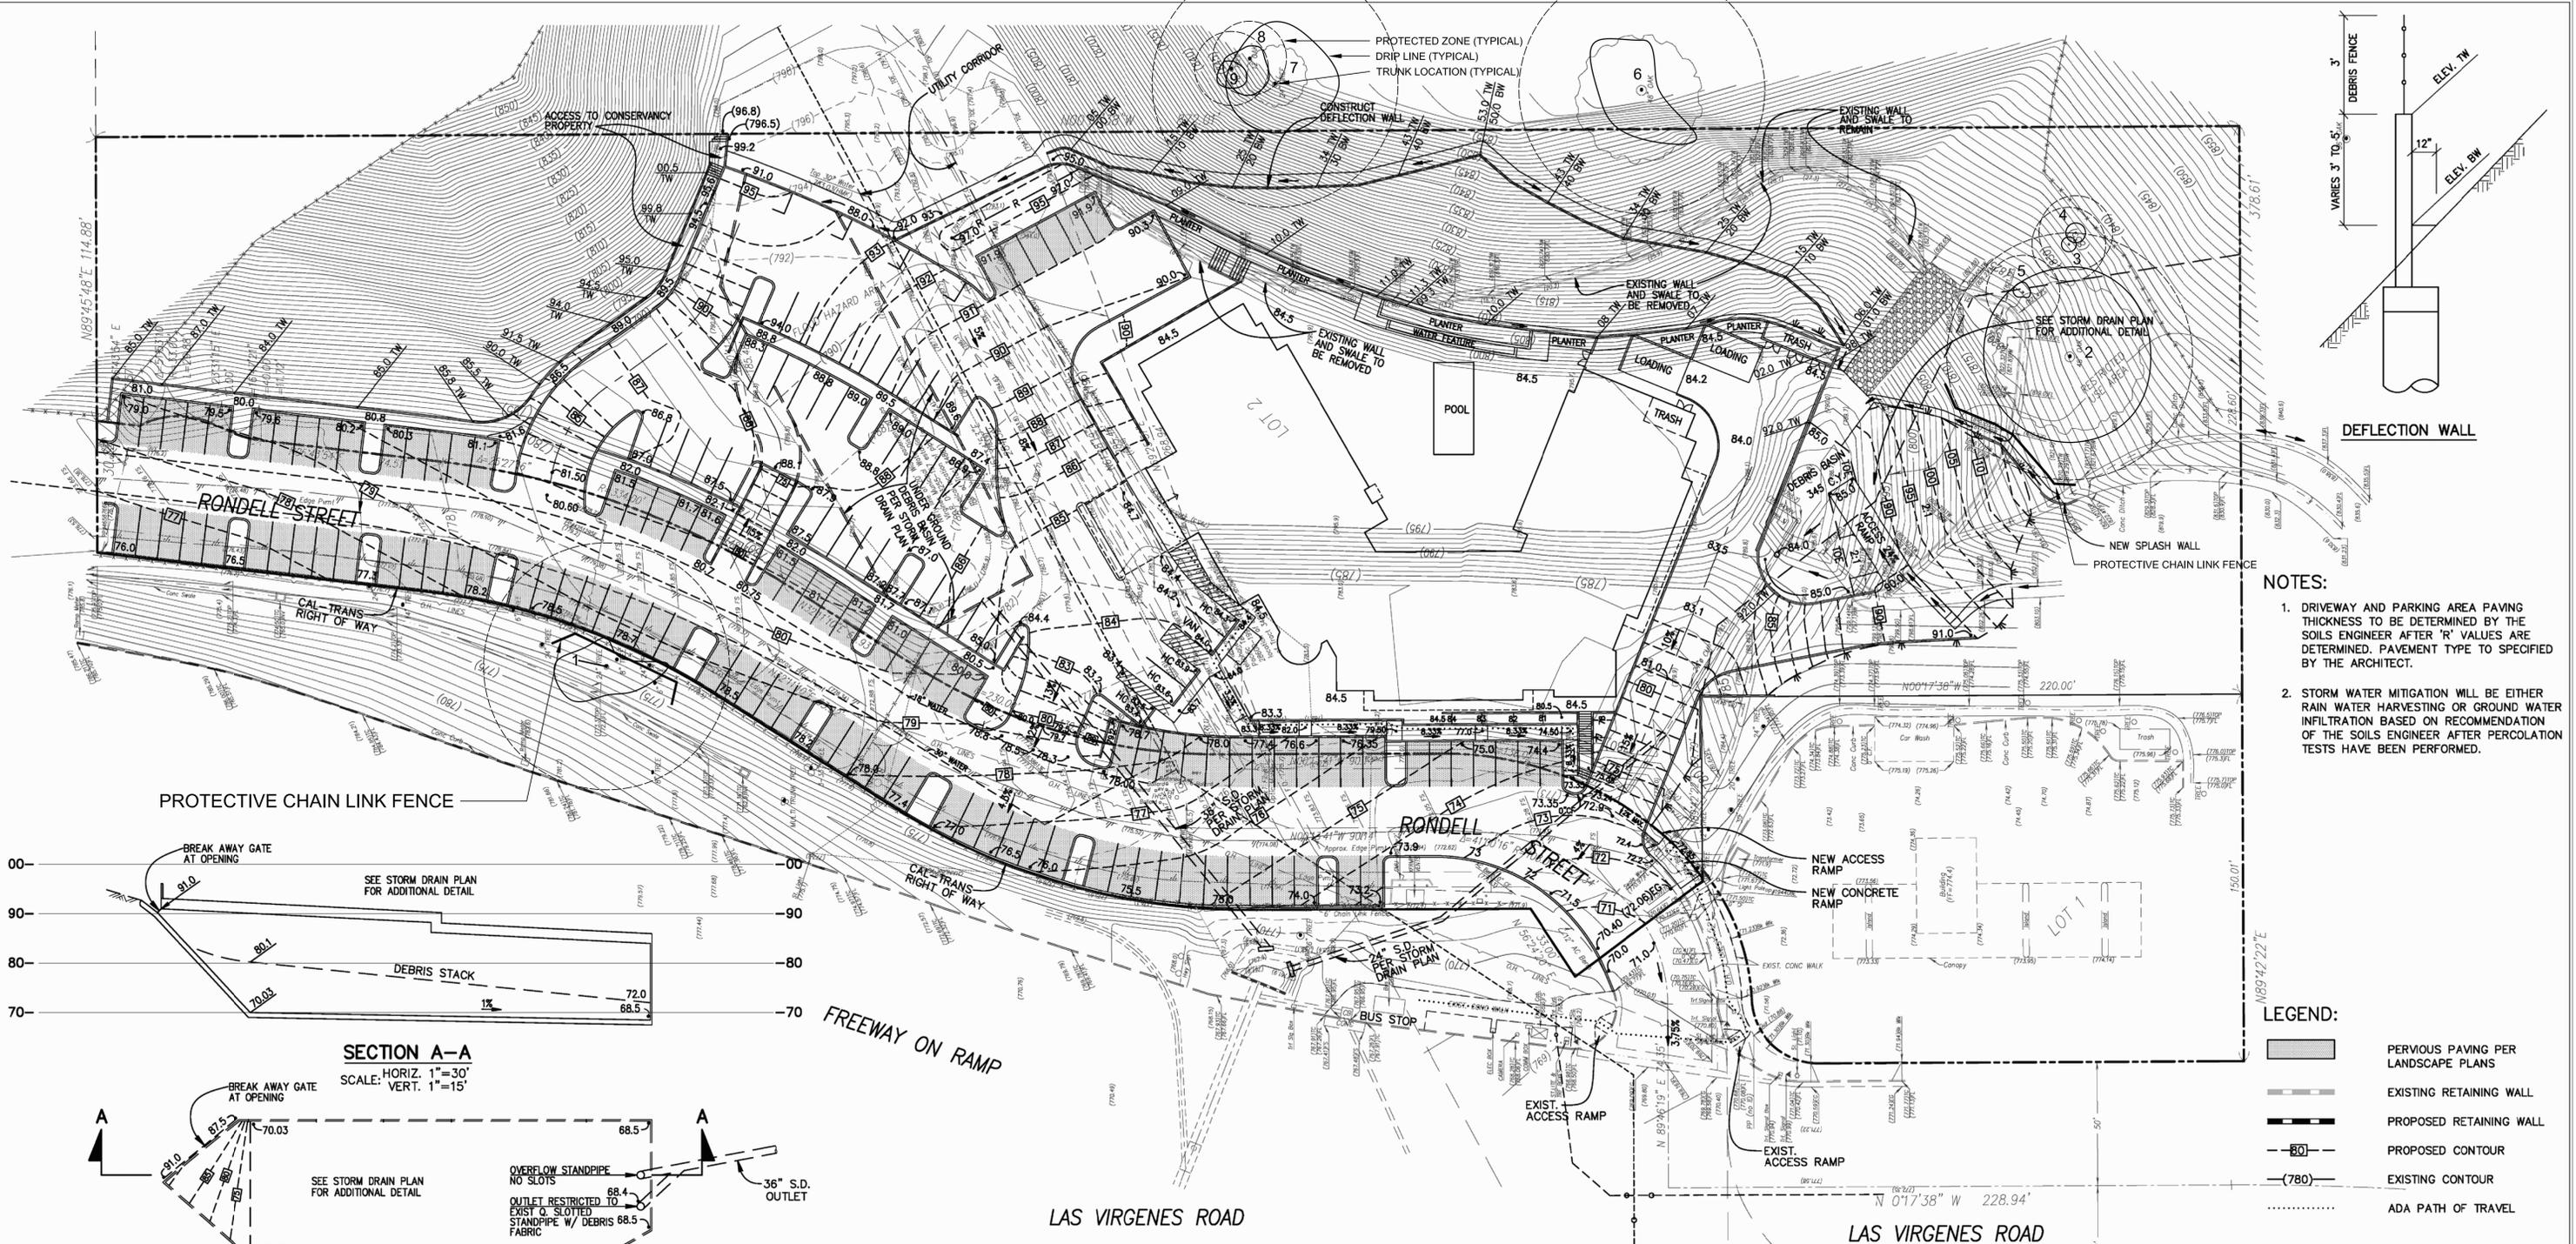
- A. Oak trees 1 and 6 – 9 are located outside of the property line of this project. Only trees 1, 2 and 7 will be encroached by grading at the perimeter of the site development. No oak trees will be removed.
- B. The following 3 trees will be encroached by the project:

- C. Drip lines on the **OAK TREE LOCATION MAP** graphically represent the dripline measurements made in the field.
- D. Oak trees 1, 2, 6 and 7 are heritage trees.

See “General Oak Tree Protection” above for the intent of the fencing plan. The oak trees that are to be preserved on the site shall be kept fenced during the construction operation (as shown on the Oak Tree Location Map) with a 5-foot high, temporary, chain-link fence for protection at all times when construction activities are taking place. The chain-link fence must be in place prior to the commencement of grading. The fence shall remain during all phases of construction. Damaged fencing shall be immediately replaced or repaired.
