MEMORANDUM

January 22, 2024

Subject: Permit Peer Review Memo Letter Report of the submitted Oak Tree Report for Land Development at 23616 Valley View Road, Calabasas, California

Oak Tree Report Review for 23616 Valley View Road, Calabasas

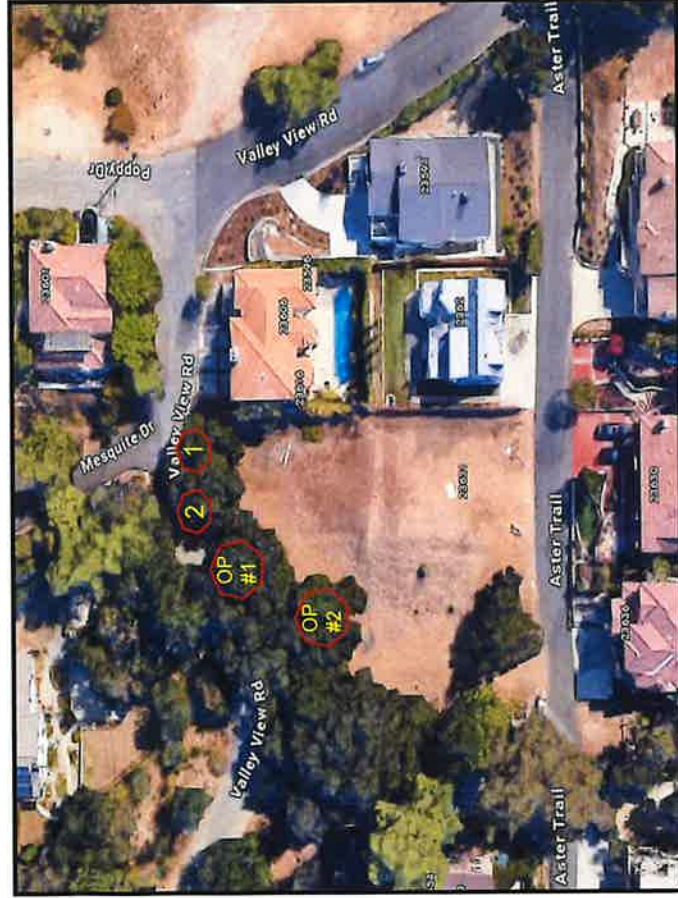
1. Aerial photograph of on-site and off-site adjacent coast live oak trees located near the 23616 Valley View Road property. Note, OP #2 is identified as an approximate location of one additional off-site coast live oak tree.

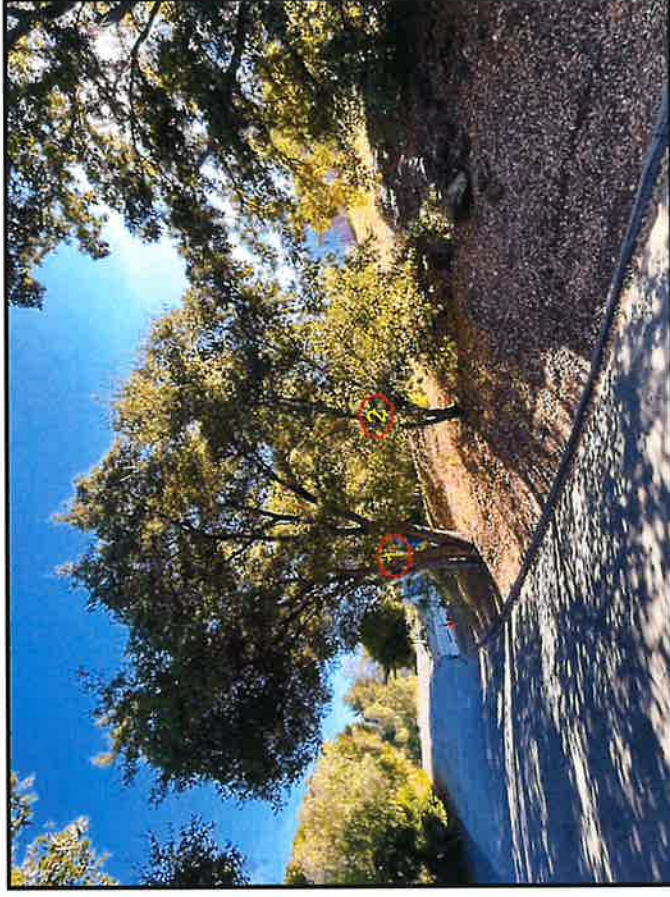
2. Overview photograph of on-site coast live oak trees nos. 1 and 2 located in the northern portion of 23616 Valley View Road along Valley View Road. Photograph taken facing east.

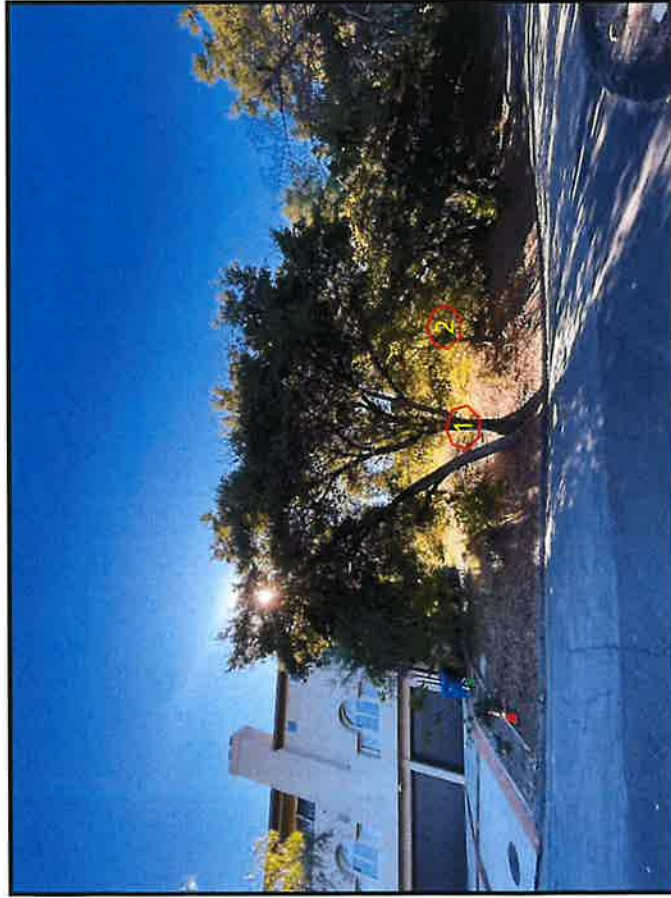
3. Overview photograph of on-site coast live oak trees nos. 1 and 2 located in the northern portion of 23616 Valley View Road along Valley View Road. Photograph taken facing south.

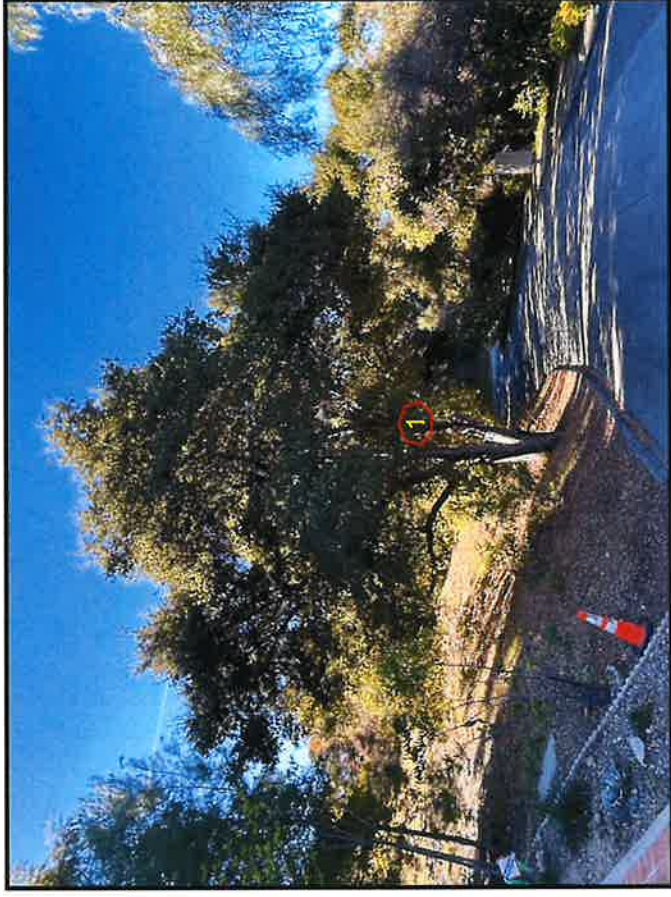
4. Overview photograph of on-site coast live oak tree no. 1 located in the northern portion of 23616 Valley View Road along Valley View Road. Photograph taken facing west.

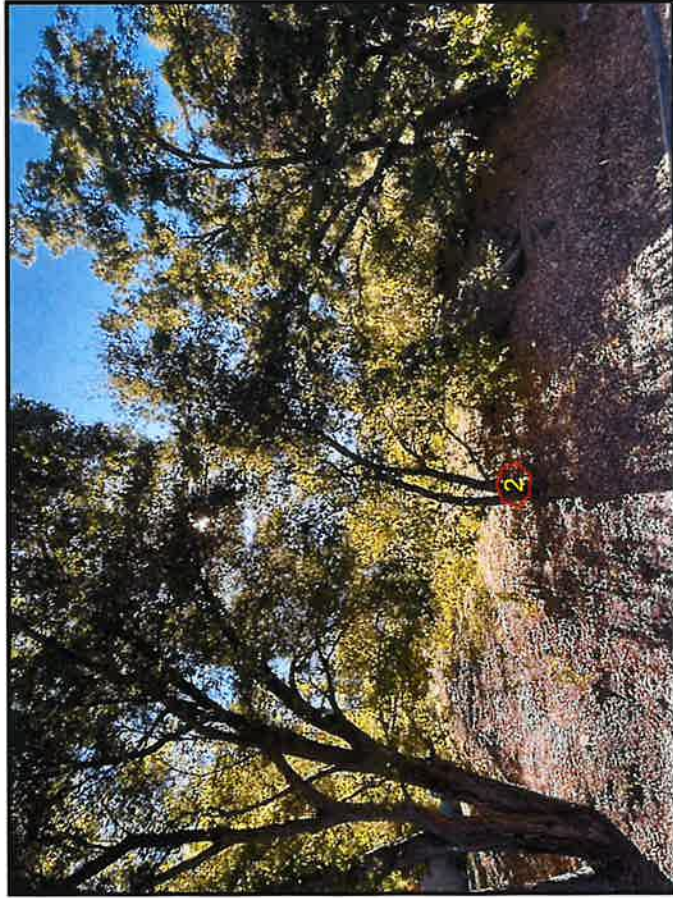
5. Overview photograph of on-site coast live oak tree no. 2 located in the northern portion of 23616 Valley View Road along Valley View Road. Photograph taken facing south.

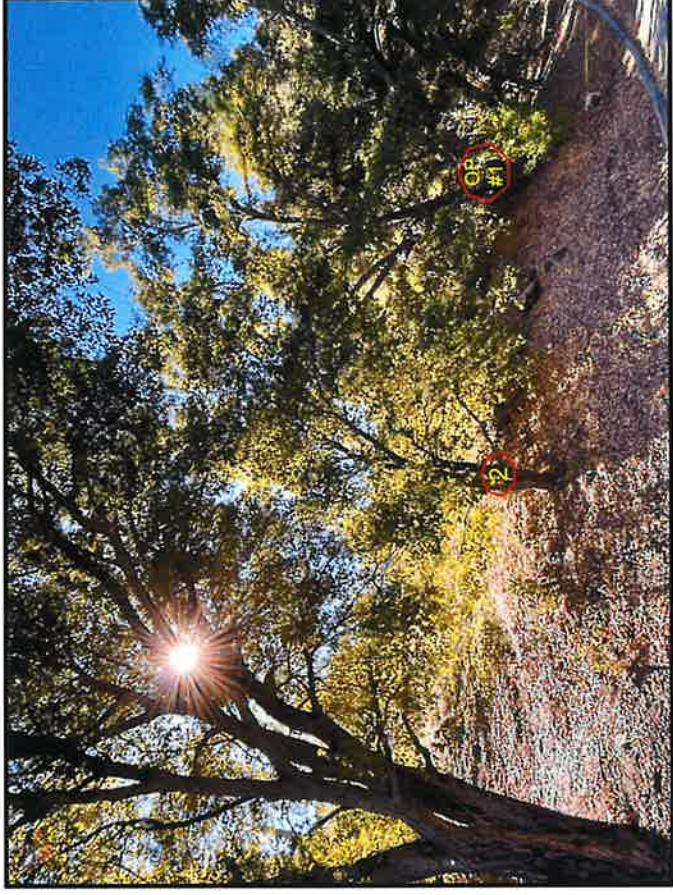
6. Overview photograph of on-site coast live oak tree no. 2 and off-site #1 located in the northern portion of 23616 Valley View Road along Valley View Road. Photograph taken facing west.

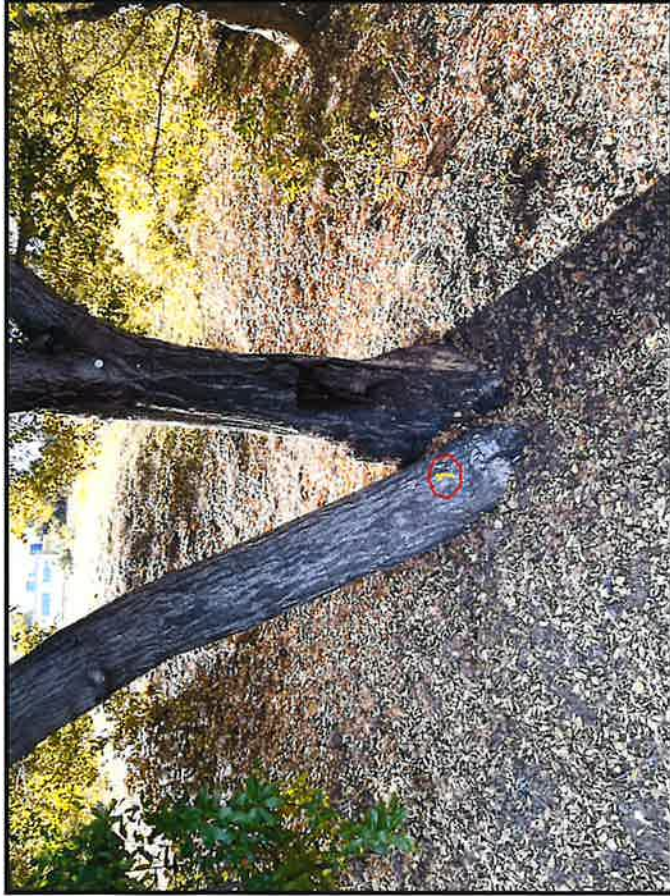
7. Overview photograph of the base of on-site coast live oak tree no. 1 located in the northern portion of 23616 Valley View Road along Valley View Road. Photograph taken facing south.

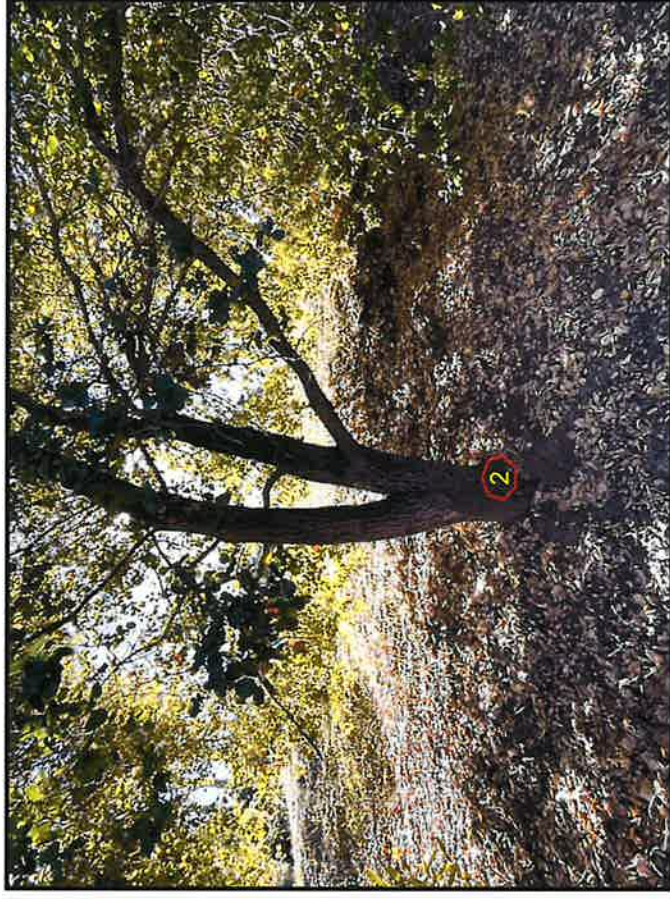
8. Overview photograph of the base of on-site coast live oak tree no. 2 located in the northern portion of 23616 Valley View Road along Valley View Road. Photograph taken facing south.

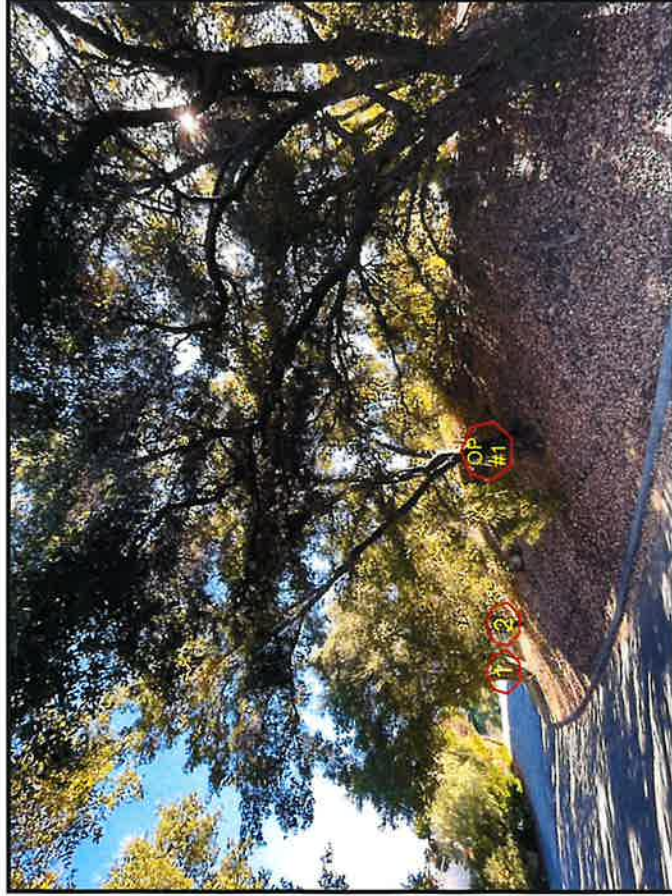
9. Overview photograph of on-site coast live oak tree nos. 1 and 2, as well as off-site tree #1 located along Valley View Road. Photograph taken facing southeast.

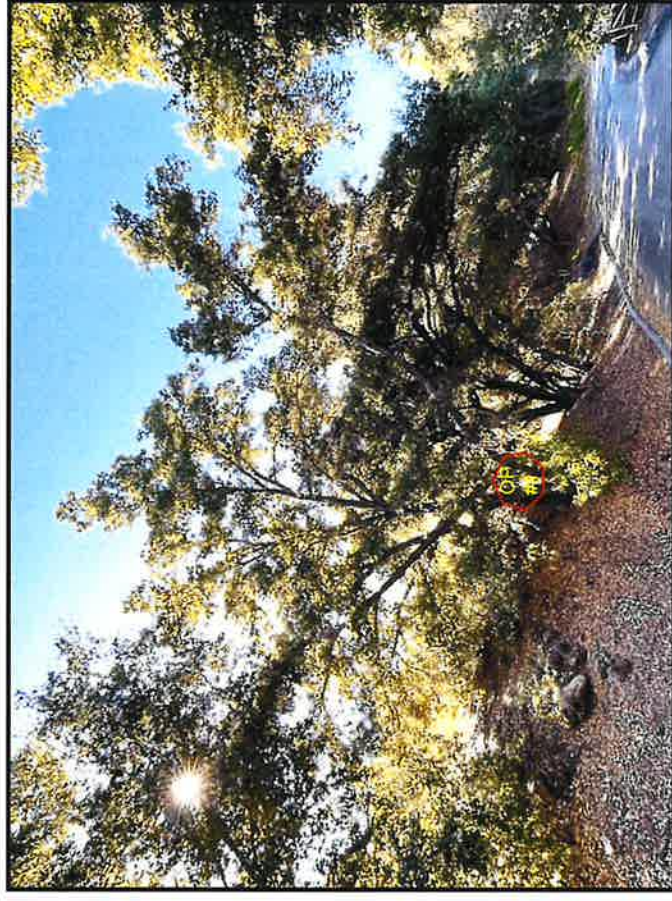
10. Overview photograph of off-site tree #1 located along Valley View Road. Photograph taken facing southwest.

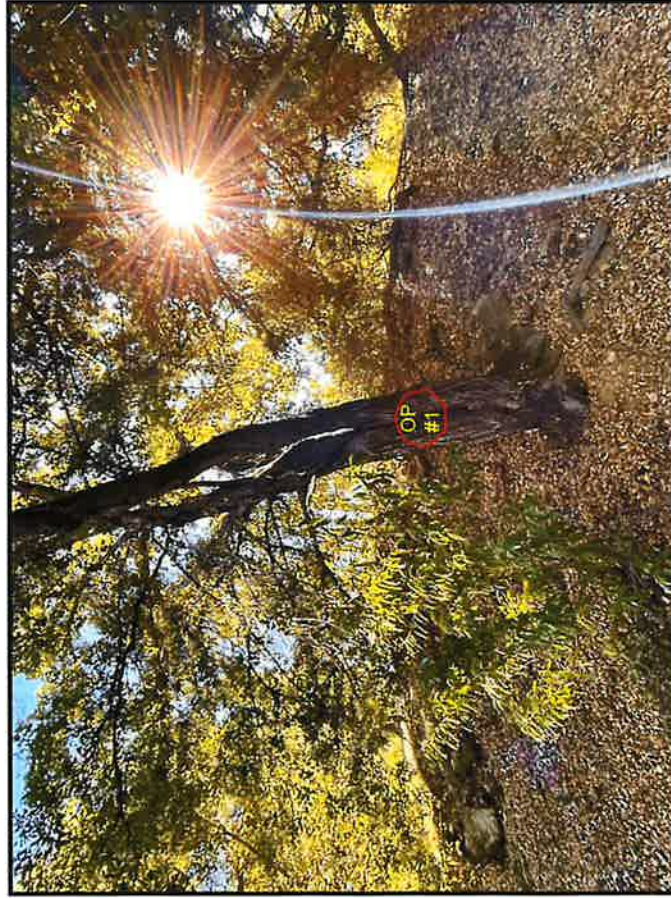
11. Overview photograph of the base of off-site coast live oak tree no. 1 located west of the proposed entrance to 23616 Valley View Road, along Valley View Road. Photograph taken facing south/southeast.

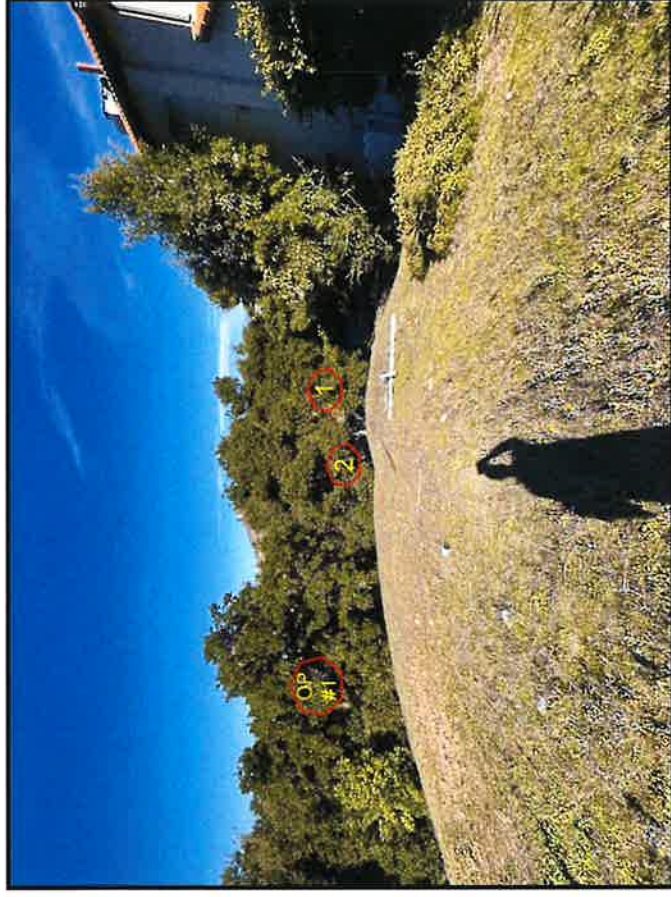
12. Overview photograph of on-site coast live oak tree nos. 1 and 2, as well as off-site tree #1 located along Valley View Road. Photograph taken facing north.

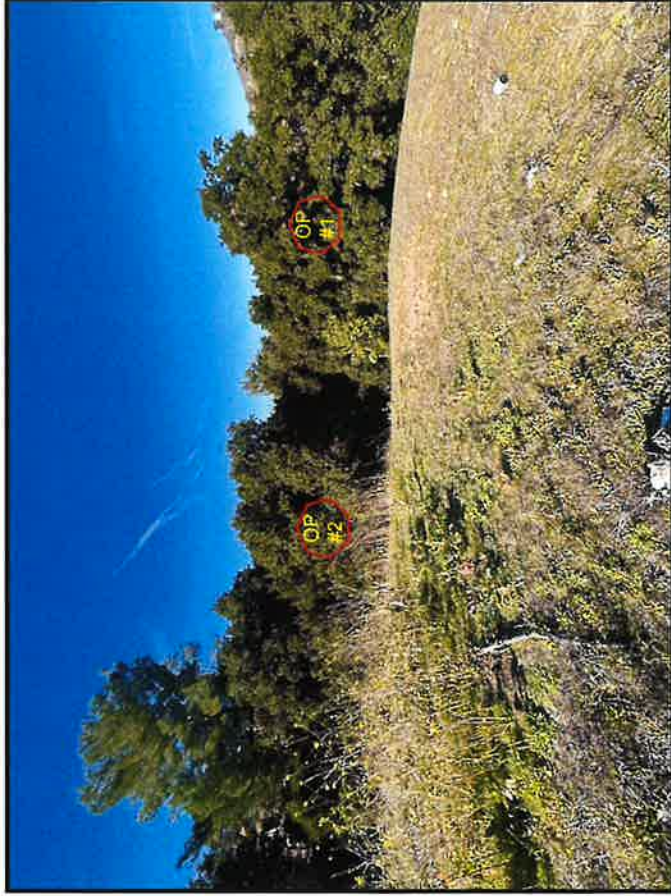
13. Overview photograph of off-site coast live oak tree no. 1, as well as the approximate location of off-site tree no. 2, which is located along the west property line of the 23616 Valley View Road property. Photograph taken facing northwest.

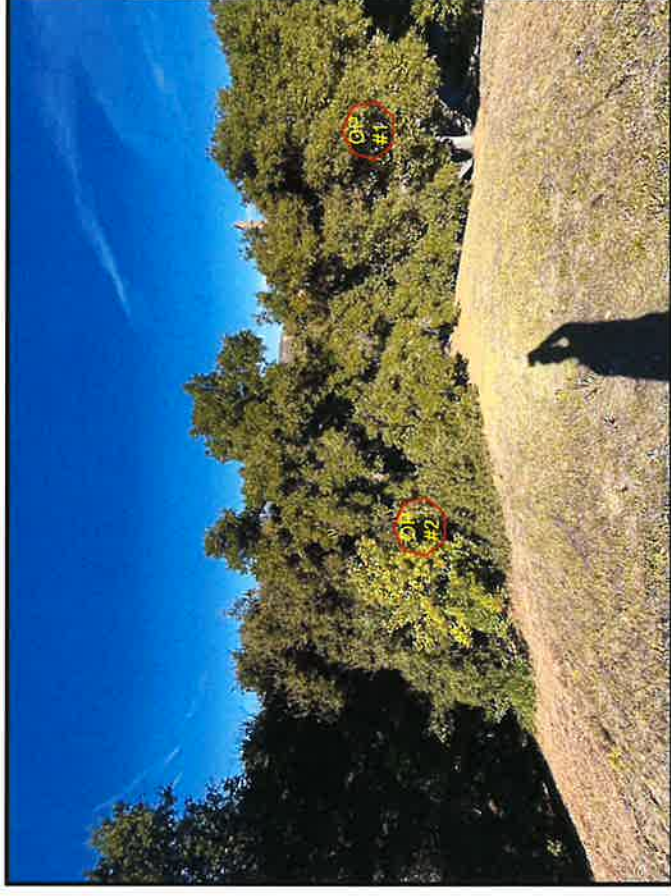
14. Overview photograph of off-site coast live oak tree no. 1, as well as the approximate location of off-site tree no. 2, which is located along the west property line of the 23616 Valley View Road property. Photograph taken facing northwest.

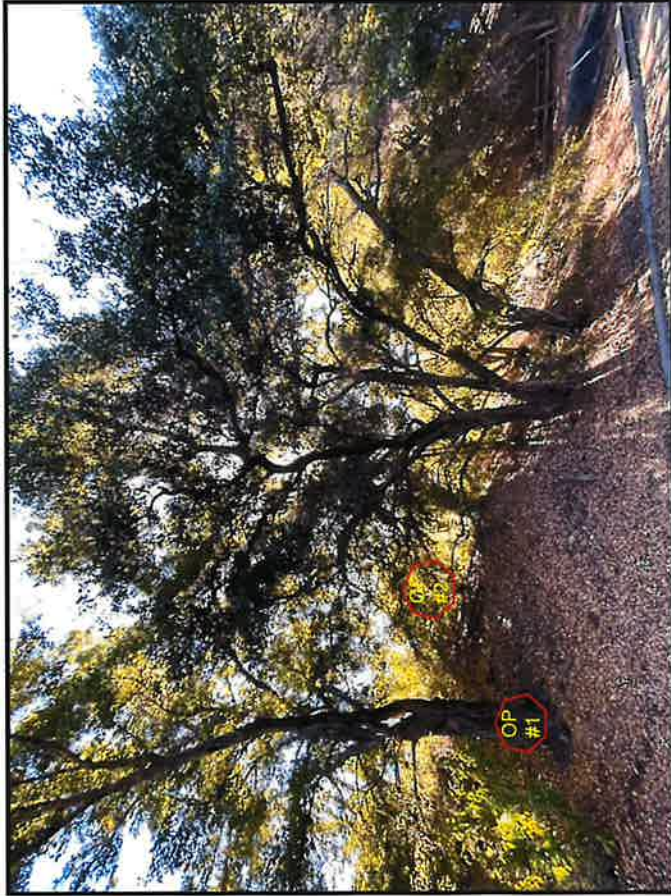
15. Overview photograph of off-site coast live oak tree no. 1, as well as other nearby off-site coast live oak trees, including the locations of off-site tree no. 2 which shall be added to the report. Photograph taken facing south.

1. For the one (1) additional off-site tree, a tree description and observations section shall be included in the Oak Tree Report in accordance with 'Section VII. – Oak Tree Report, Part 2 'Format for Report', Items a through m, of the City of Calabasas Oak Tree Preservation and Protection Guidelines. Each of the trees identified in the oak tree report shall include a descriptive summary of the tree species, tree diameter, height, canopy cover, health and vigor rating, existing tree environment, physical structure, horizontal evaluation, tree vigor, etc.

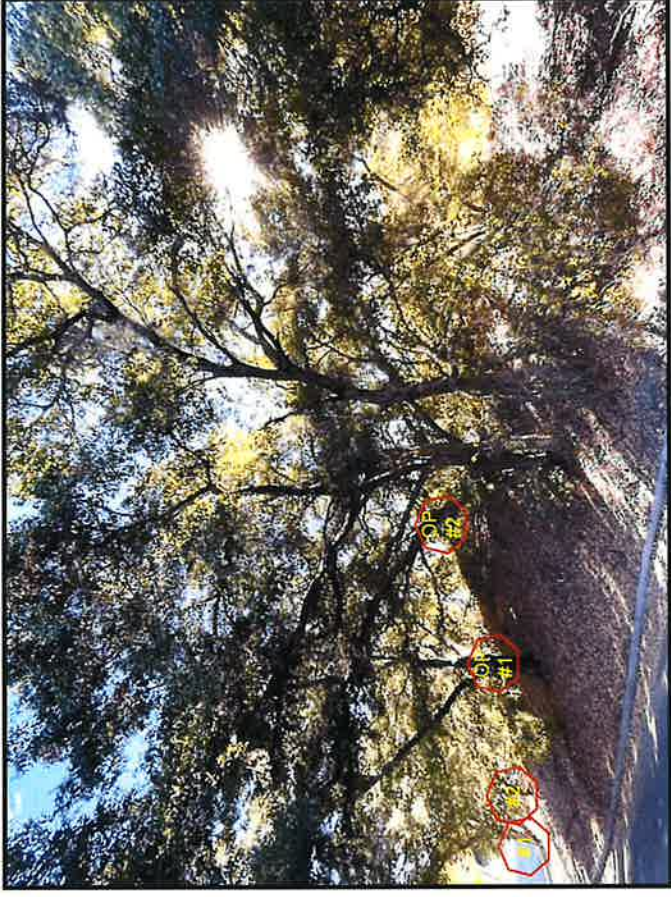
16. Overview photograph of coast live oak tree nos. 1 and 2 and OP #1 in relationship to the additional off-site tree no. 2. Photograph taken facing southeast.

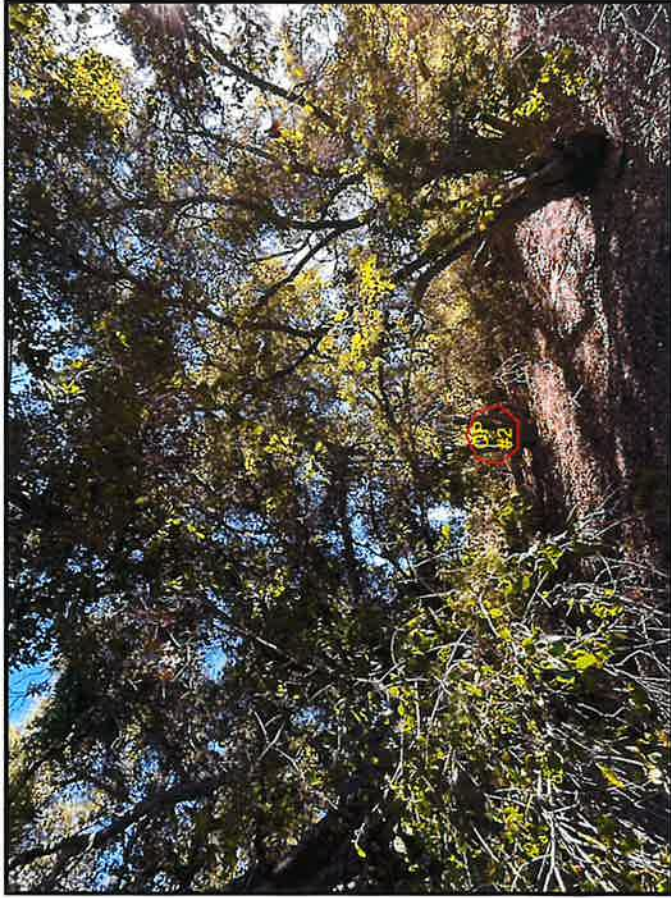
17. Overview photograph of off-site coast live oak tree no. 2. Photograph taken facing southeast. It should be noted that off-site tree no. 2 is located adjacent to the western property line of 23616 Valley View Road.
