Oak Tree Report

Single-Family Residence and Accessory Dwelling Unit

4440 Park Aurora

April 24, 2024

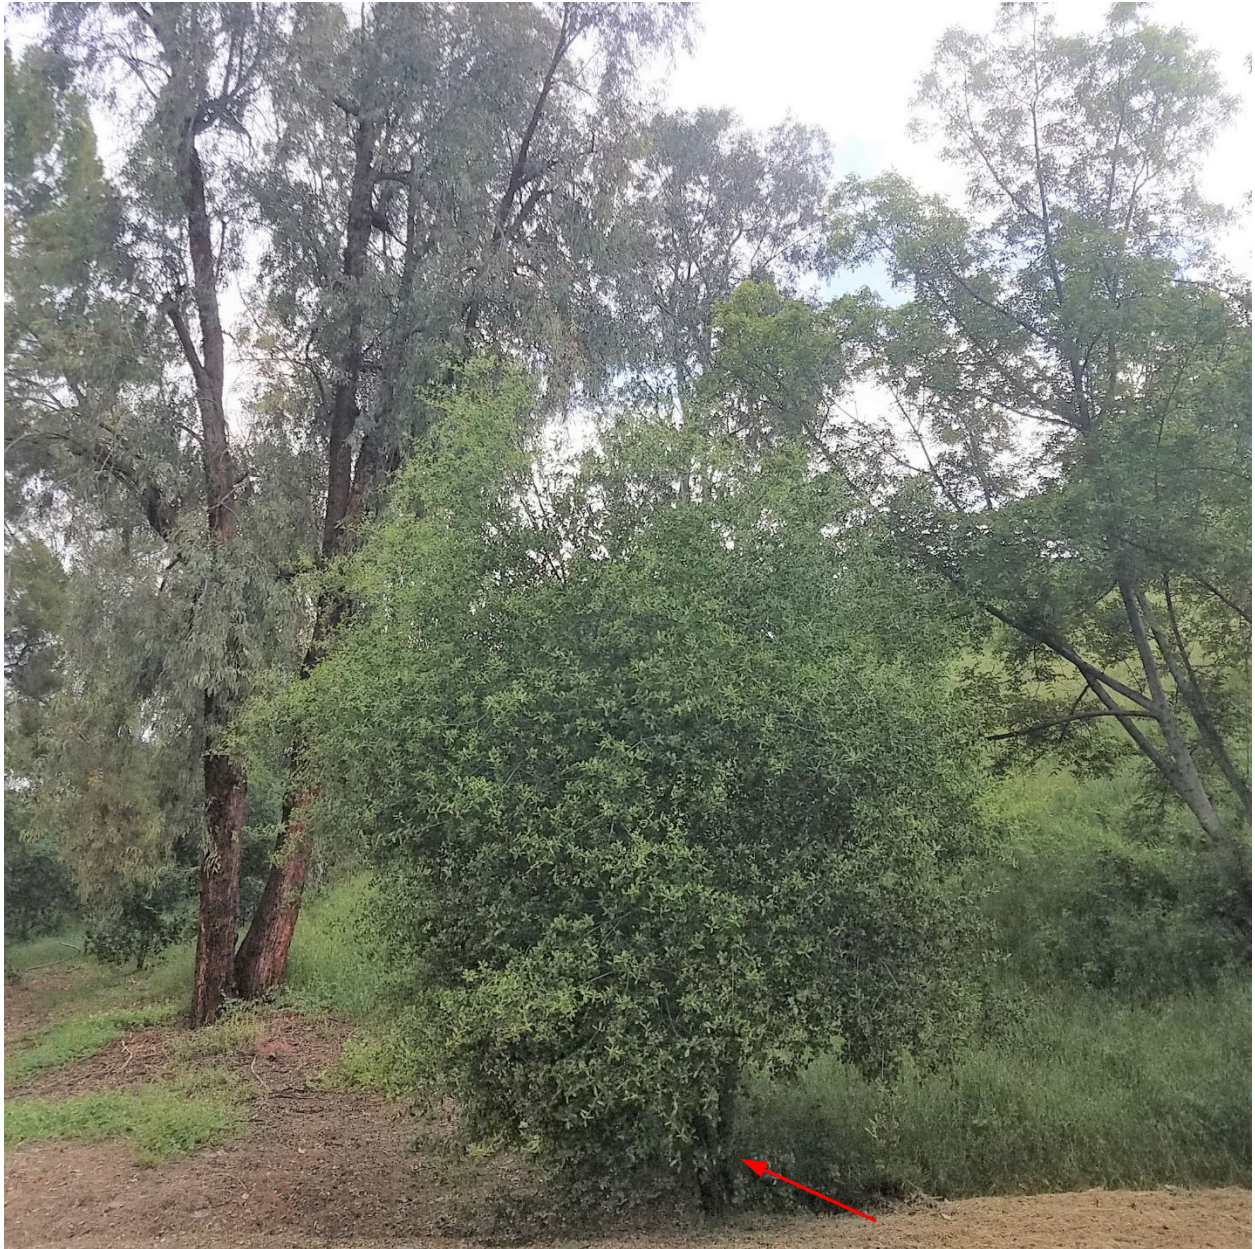
APPENDIX B - PHOTOGRAPH

The oak tree located within the immediate vicinity of the proposed construction exhibits normal foliage color and density with no signs of insects or disease. Its condition is Excellent, as noted on Table 1 in Appendix C. The tree exhibits co-dominant trunks and scaffold limbs.

Tree #70 – This mature coast live oak is located within the northeasterly corner of the site. Using the BMP, the recommended TPZ for a mature coast live oak of this size is approximately 5.2 feet.

Construction of a 6-foot high wood fence would occur within 8.6 feet of the trunk on its easterly side, outside its dripline but within the protected zone. The encroachment would amount to 7% of the tree's protected zone.

Holes for the fence posts should be dug by hand and their locations adjusted to accommodate any roots encountered that are 2 inches in diameter and over. The excavation for the posts should be performed with hand tools under the direct observation of this office to ensure that roots are not damaged during the excavation.

1. The approved tree permit must be on-site during construction activities. The Permittee shall provide a copy of the permit and performance standards to all responsible parties who will be performing work on the site.
2. Temporary protective fencing shall be installed prior to the start of any grading, demolition, or construction to prevent the area beneath the tree from being utilized as laydown space for equipment, materials, and debris.
3. Unanticipated damage to the protected tree or areas within its protected zone is to be reported to the project arborist within 24 hours.
4. No vehicles, equipment, materials, spoils, or other items should be used or placed within the protected zone of the protected tree at any time, unless necessary to perform specifically approved work.
5. Locate wash-out retention areas as far away from the tree's protected zone as possible.

6. Monitor the tree semi-annually for symptoms of decline such as small or wilting leaves, thinning foliage, defoliation, epicormic shoots, poor annual twig growth, twig and branch dieback, or attack by borers or other opportunistic pests.

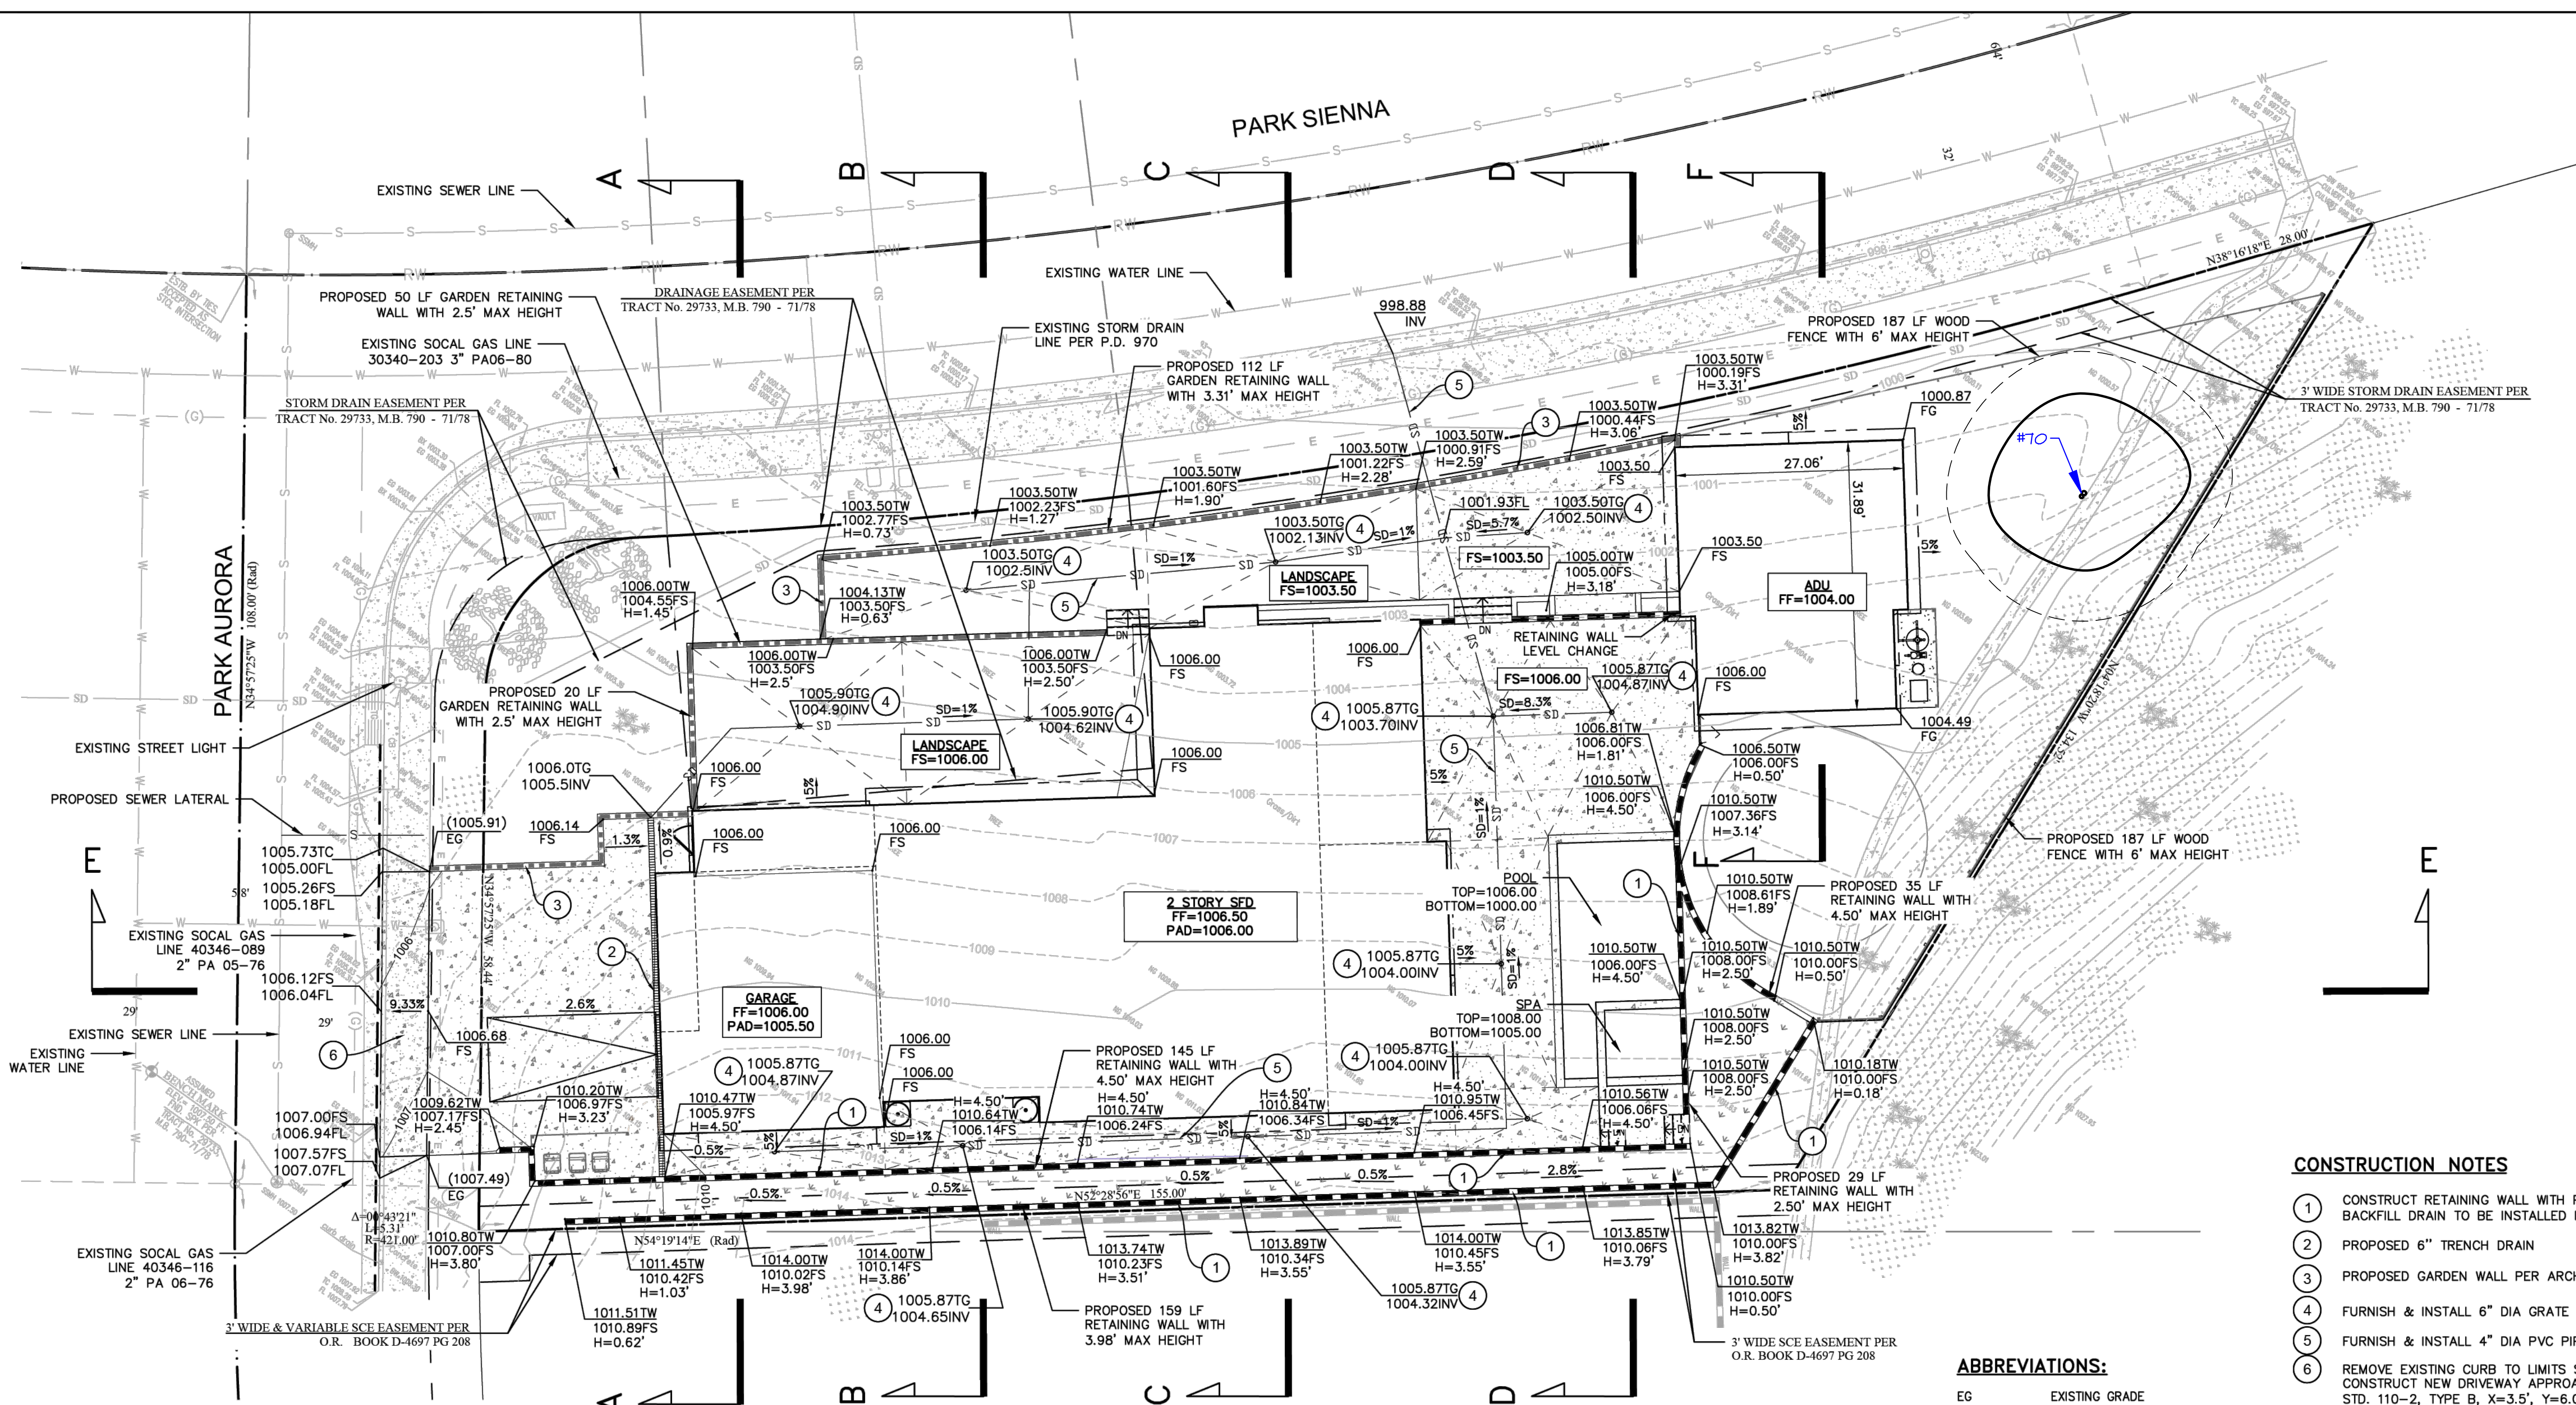
APPENDIX D – OAK TREE LOCATION MAP

As shown on the Oak Tree Location Map in Appendix D, the single protected oak tree is located within the northerly corner of the site, near Park Sienna, where the property lines form an approximately 43-degree angle.

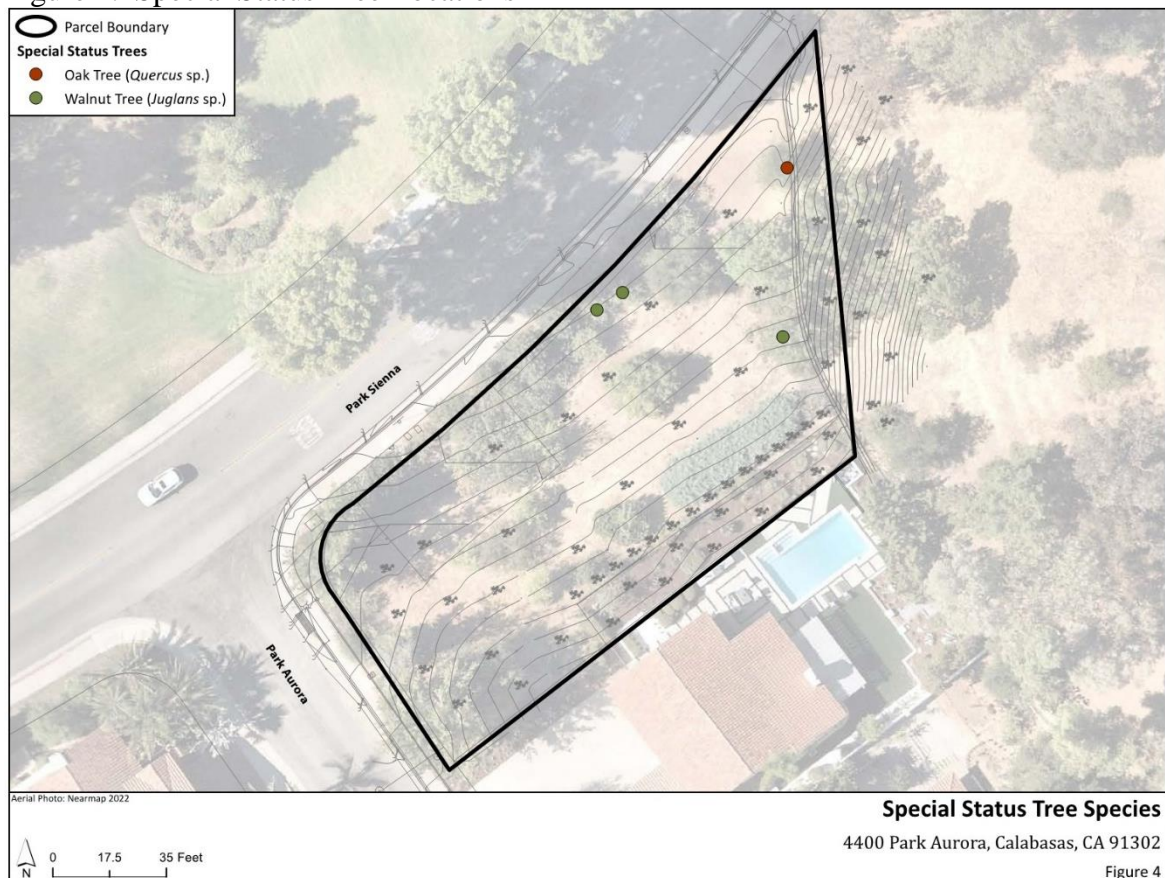
Figure 4. Special Status Tree Locations

The subject parcel has three such walnut trees (Figure 4). Two are in the hedge of Oleanders along Park Sienna and are part of the Urban Developed cover of the region, most probably regrowing from the underground burl or persisting root system. A third resprout occurs along the brow ditch of the eastern property line and will probably break the concrete as it grows.

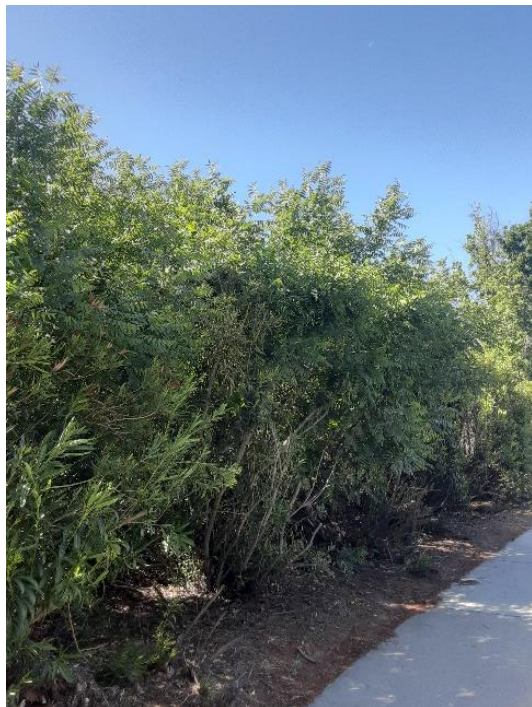
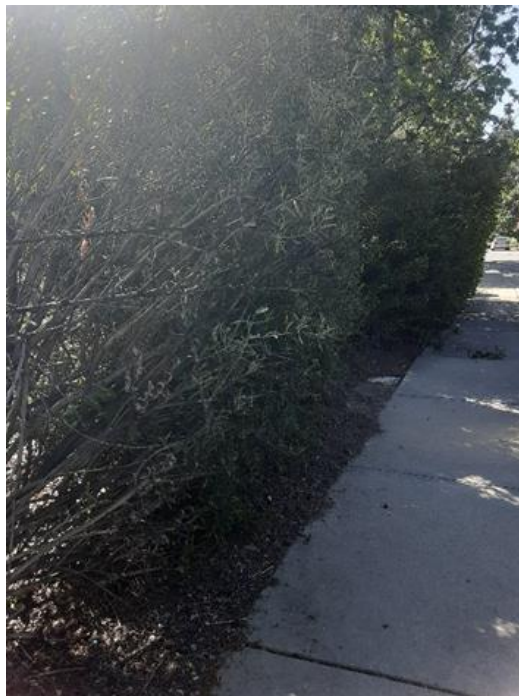
Hedge along Park Sienna with two walnut “trees”

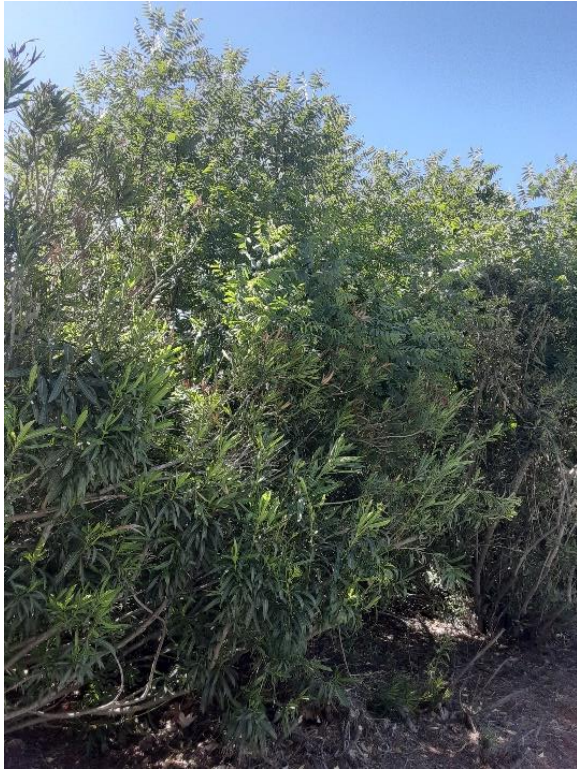
Walnut "trees" in Oleander hedge
