# **OAK TREE REPORT**

**Calabasas Kia**

Date: March 31, 2023

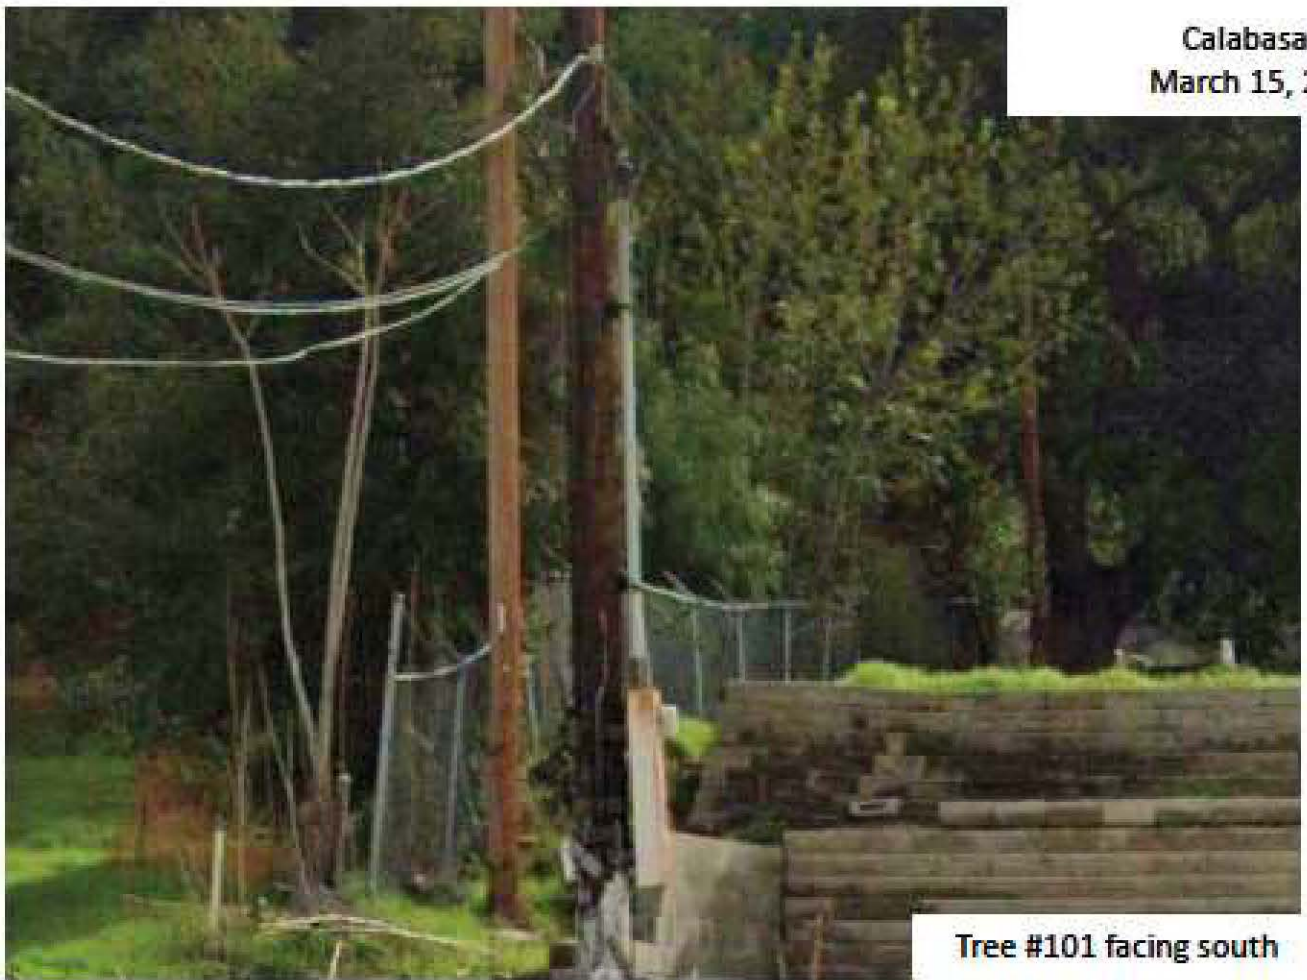
Tree #101 facing south

**Oak tree #101** – This tree is on the property line and must be removed to build the 5-foot retaining wall, 5 feet from the proposed building.

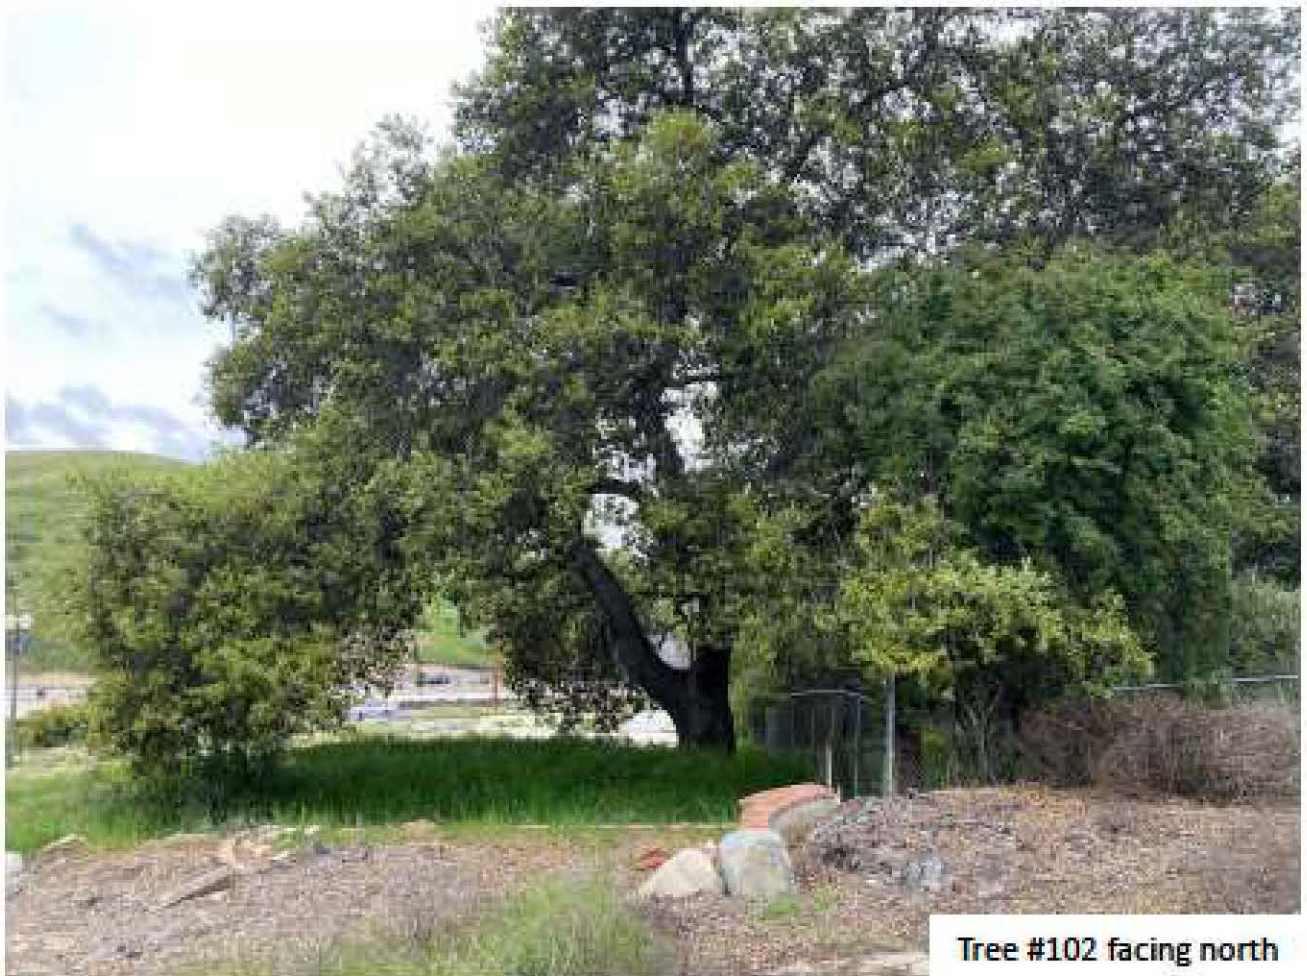
Tree #102 facing north

**Oak tree #102** – This heritage tree is located 2 feet from the proposed building and must be removed.

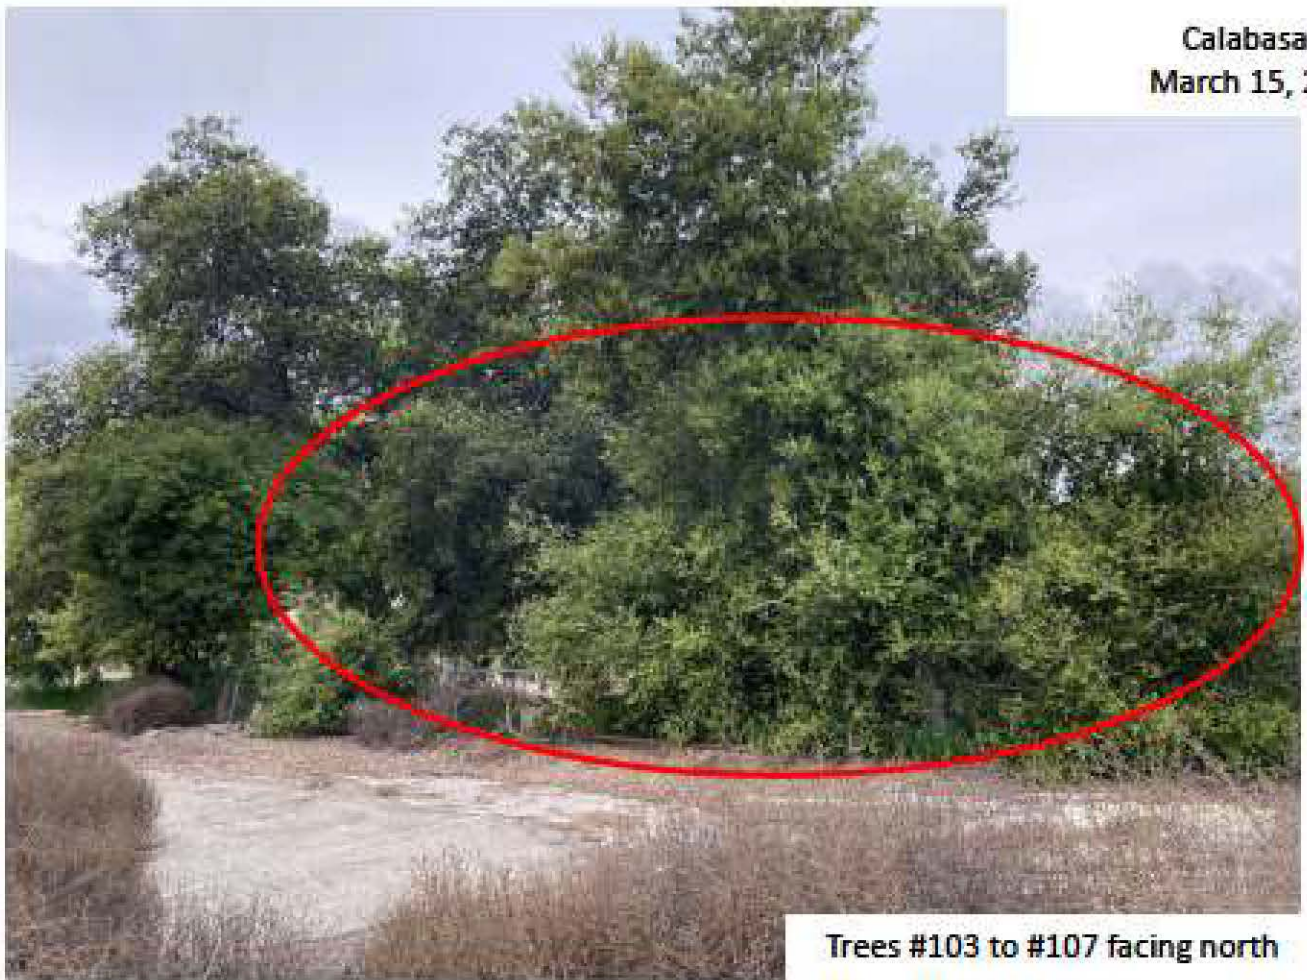
Trees #103 to #107 facing north

**Oak trees #103, #104, #105, #106, and #107** – 5 young oak trees are located along the property line and an existing retaining wall. All the trees are 10 feet from the proposed 3-foot retaining wall. Excavation for the retaining will be no closer than 5 feet from the trunks encroaching roughly 10 to 15 percent of the PZs. These trees will be preserved and protected.

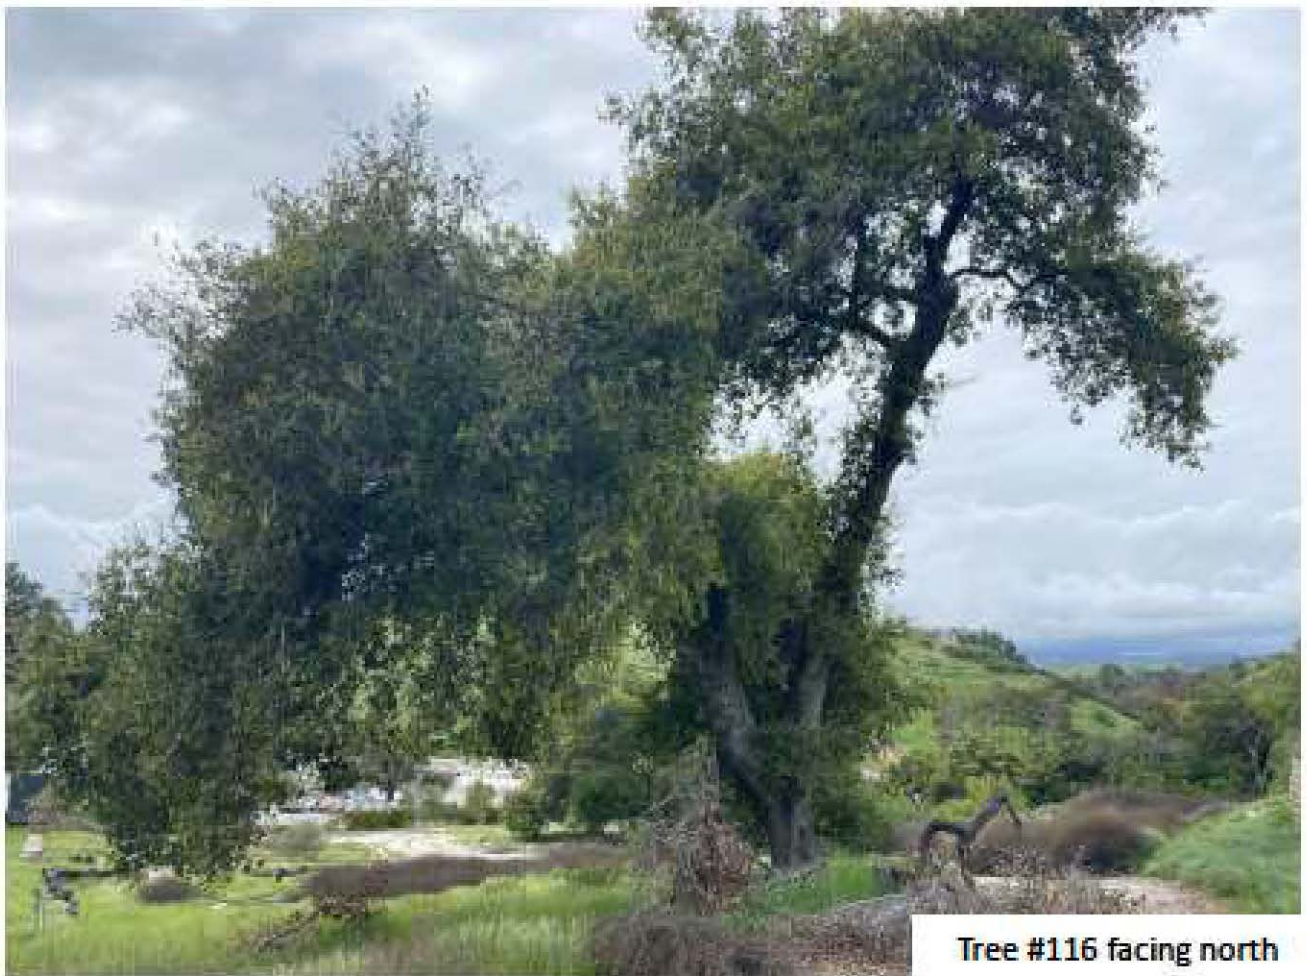
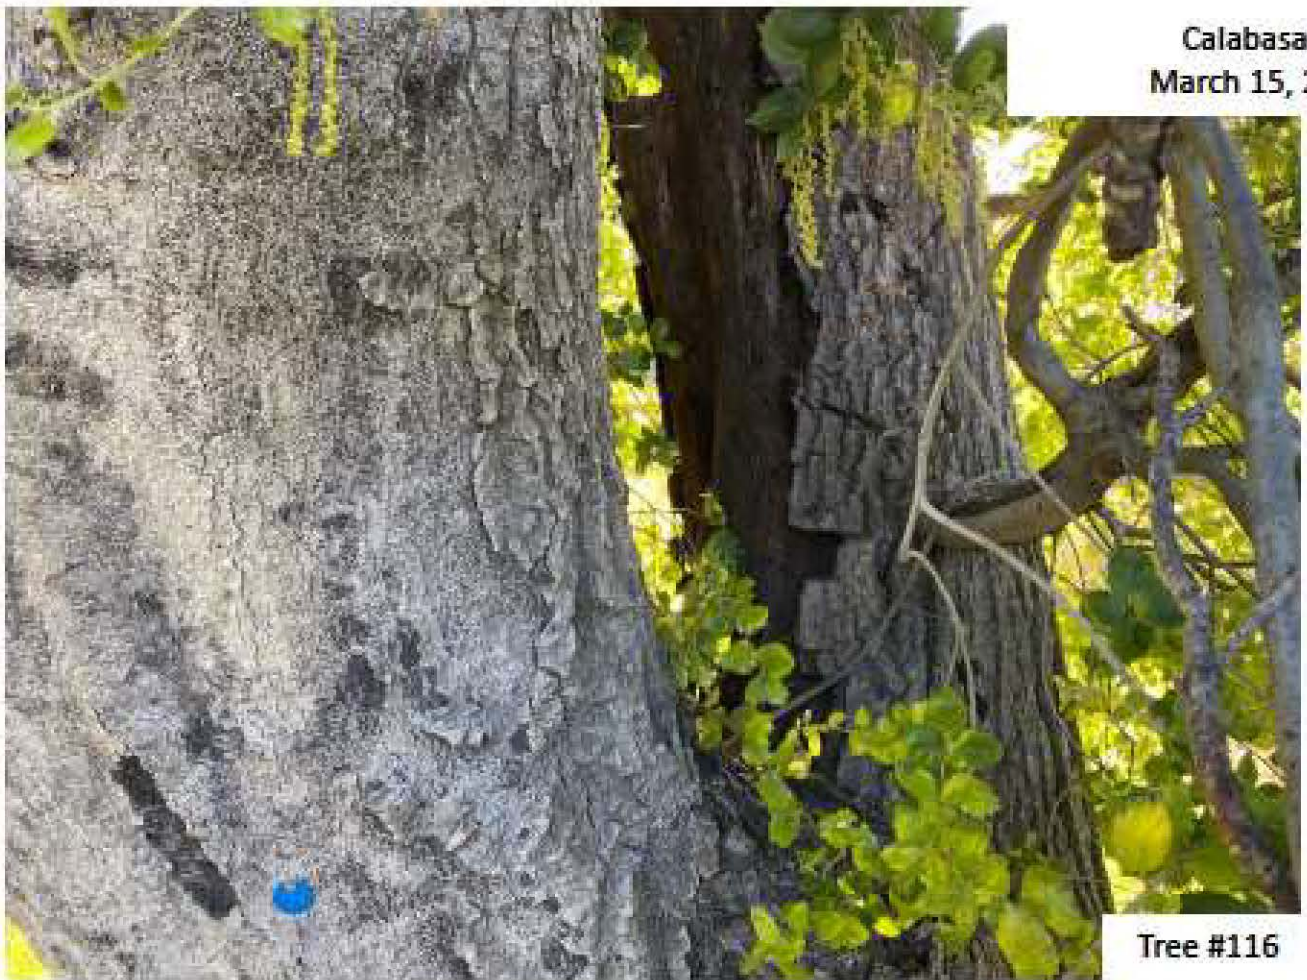
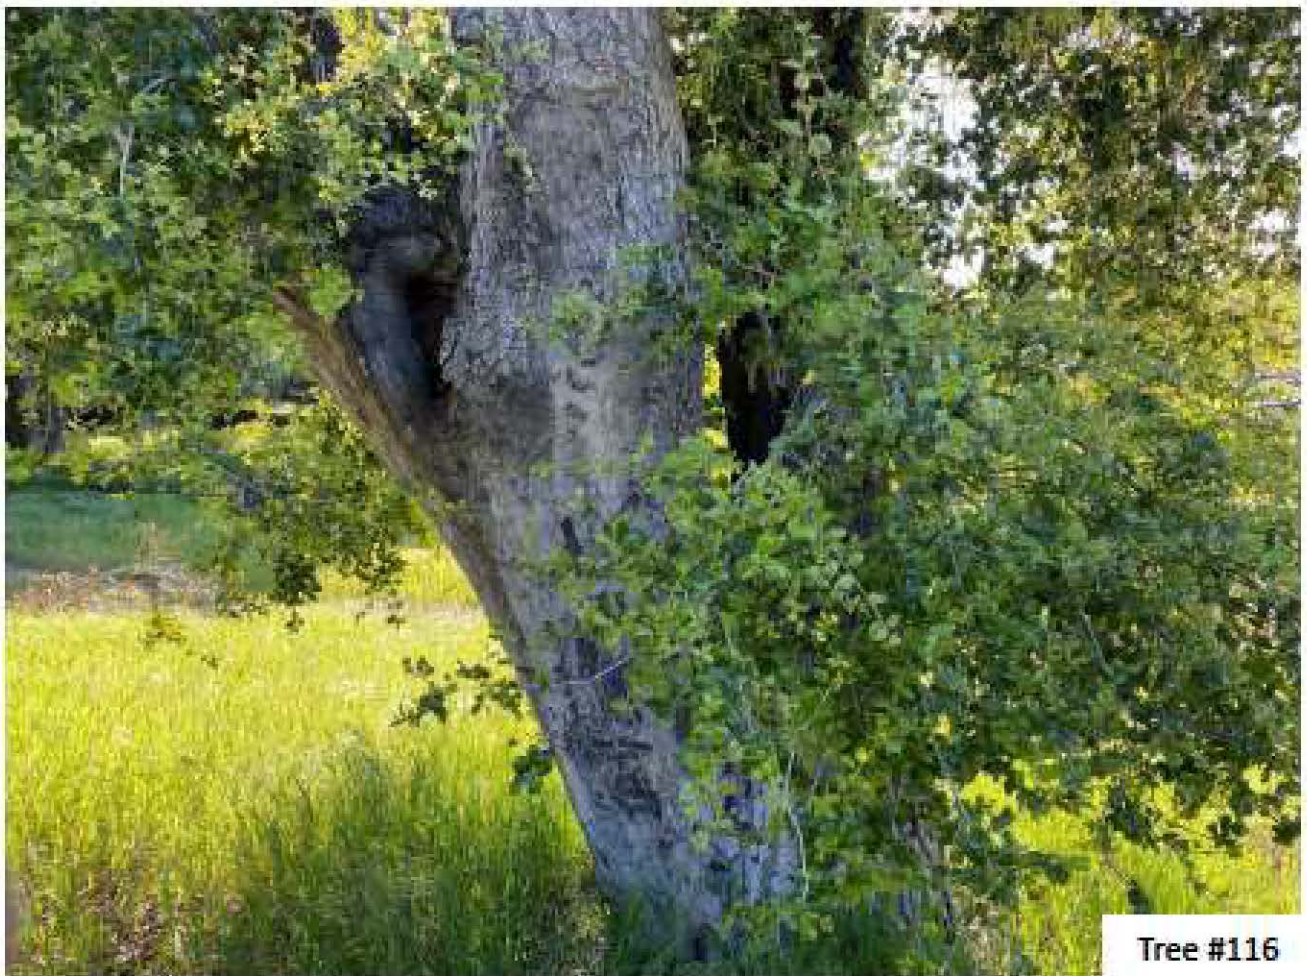
Tree #116 facing north

**Oak tree #116** – This tree will be encroached by grading for a parking lot, a debris basin, and an access road to the debris basin. Roughly half of the PZ area will be encroached by grading. Part of the access road is an existing length of a paved road within the PZ. This will be a potentially harmful encroachment due to the removal of existing roots although there will be no encroachment closer than 25 feet from the trunk. This tree is declining structurally and should be evaluated later to determine whether drastic pruning should be done to make it safer. I recommend fencing this tree permanently to restrict access to it or remove it if, with further assessment, it is determined likely to fail and strike a target. This tree should be preserved and protected. No pruning required.

encroachment if it handled properly. Of the 21 oak trees proposed to be encroached by the project, only 2, #116 and #149 will be encroached so extensively that the damage may harm the trees. It is fortunate that the 2023 rains have made the existing trees healthier. Maintaining this good health, in particular, maintaining good soil moisture, will allow the trees to tolerate the encroachments as they recover.

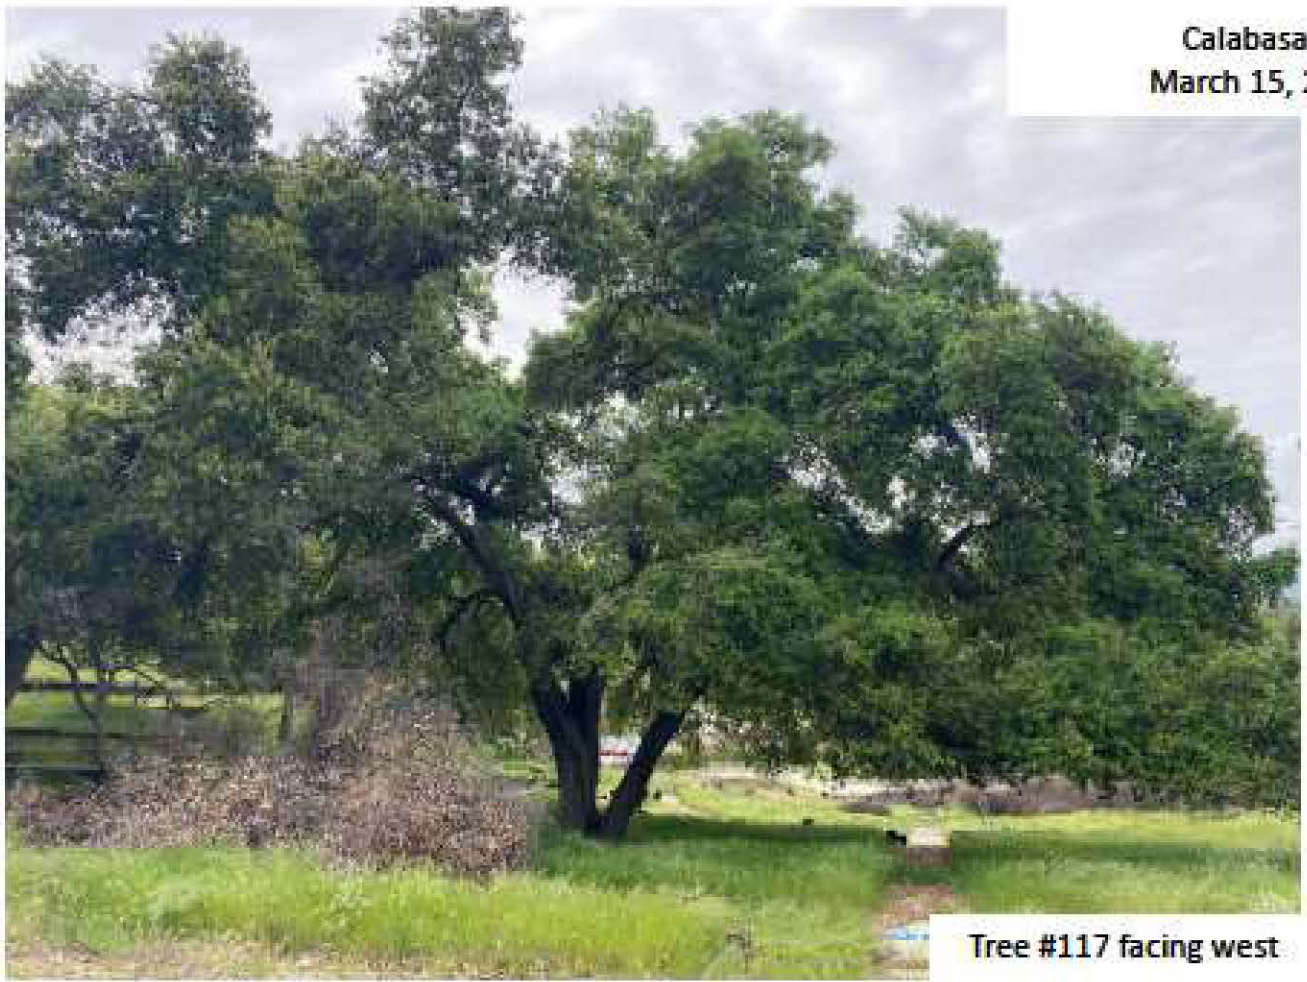
Tree #117 facing west

**Oak tree #117** – This tree will be encroached by grading for a parking lot and a manufactured slope. Roughly 25 percent of the PZ area will be encroached by grading. This will be a potentially harmful encroachment due to the removal of existing roots although there will be no encroachment closer than 16 feet from the trunk. This is a healthy tree and the manufactured slope will be a significant encroachment but only on the north side of the tree. This tree should be preserved and protected. No pruning required.

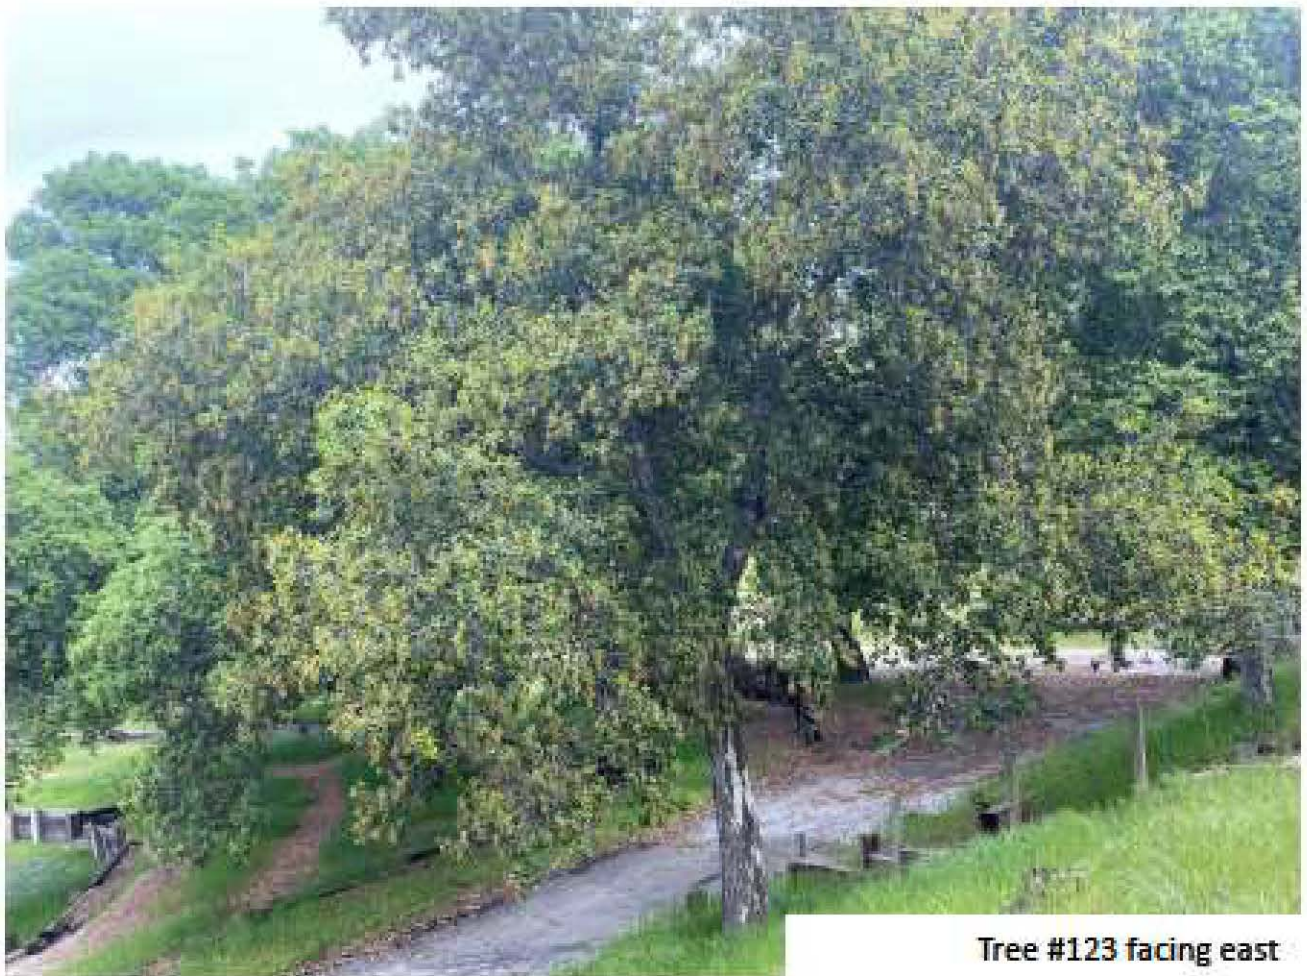
Tree #123 facing east

**Oak tree #123** – This tree will be encroached by the manufactured slope to grade the parking lot, impacting 30 percent of the PZ. The v-ditch at the limit of grading will be no closer than 5 feet from the trunk. This will be a significant encroachment that can be managed. This tree will be protected and preserved, and no pruning will be needed.

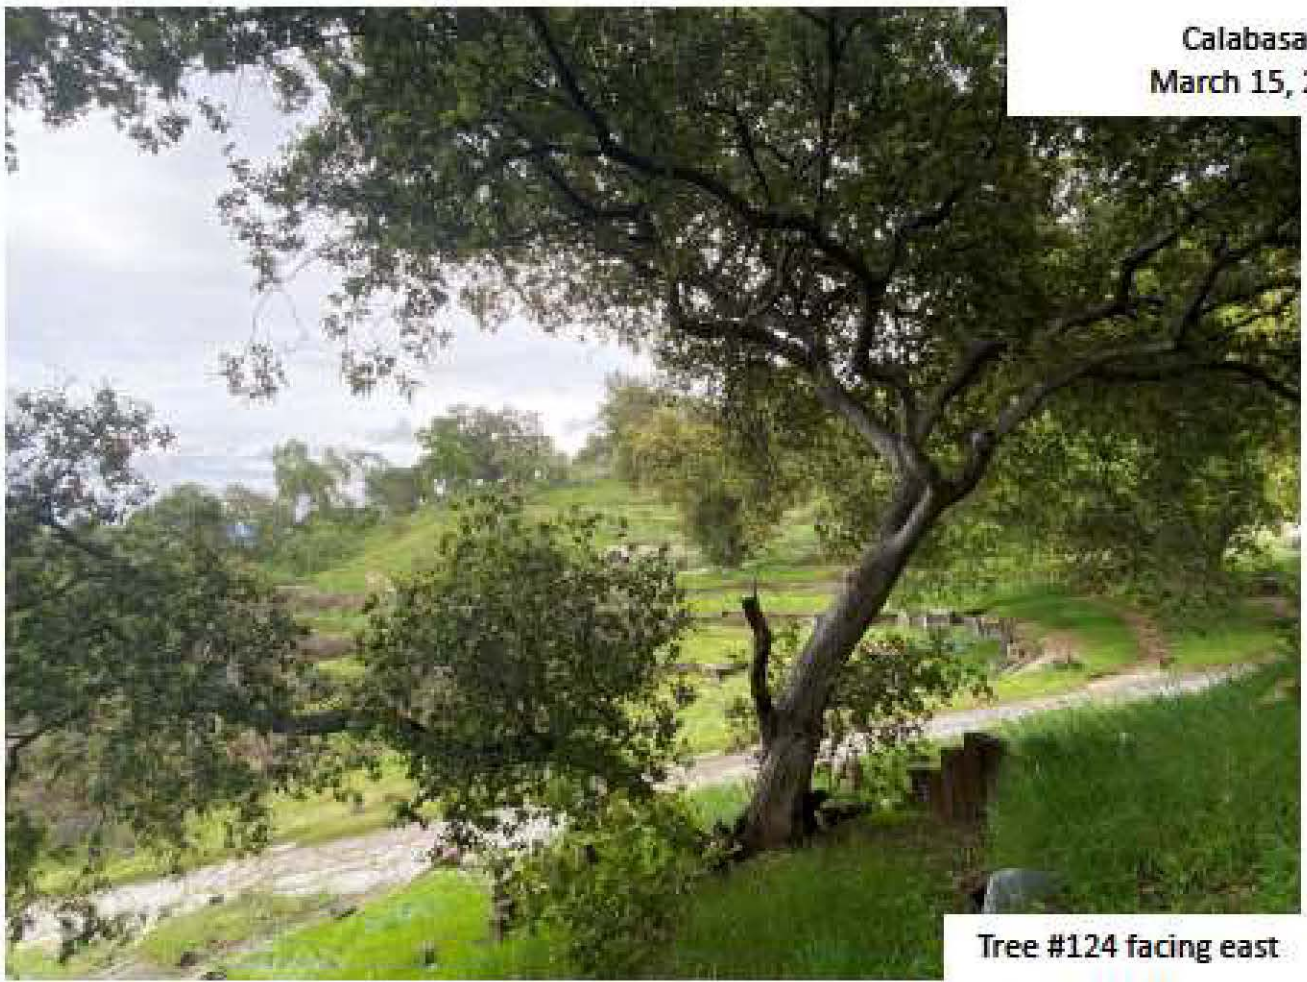
Tree #124 facing east

**Oak trees #124, #125, #126, #127, #130, and #131** – These trees are all located on the north side of the grove that occupies the slope that arises from the more level area that will be developed. These 6 oak trees, 4 of which are heritage trees, will be encroached by the manufactured slope needed to create the building pad and parking lot below it. The v-ditch will be the closest encroachment.

#124 – encroaches 35 percent of the PZ, no closer than 17 feet from the trunk.

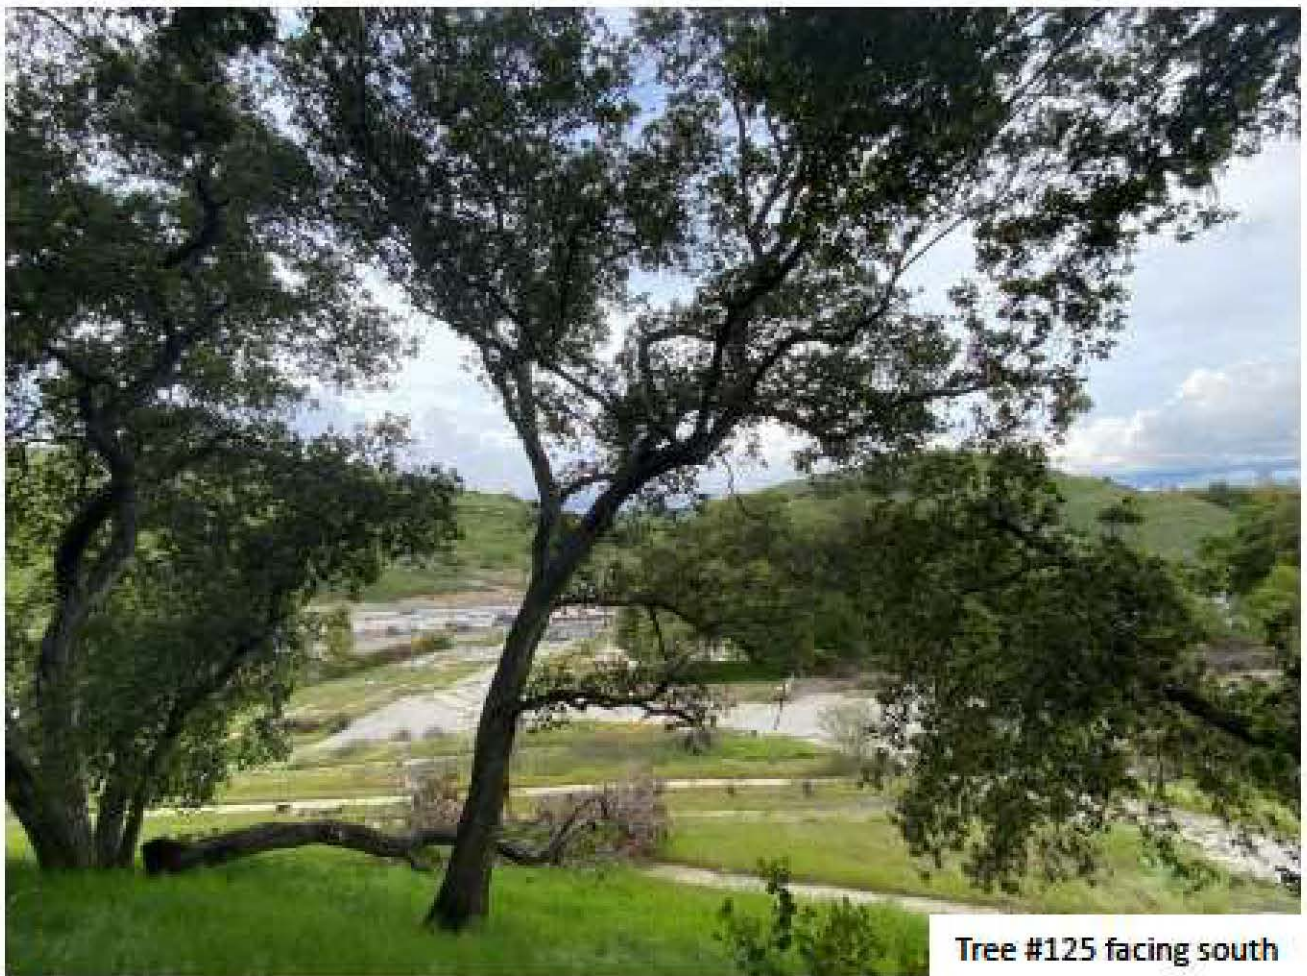
Tree #125 facing south

#125 – encroaches 21 percent of the PZ, no closer than 17 feet from the trunk.

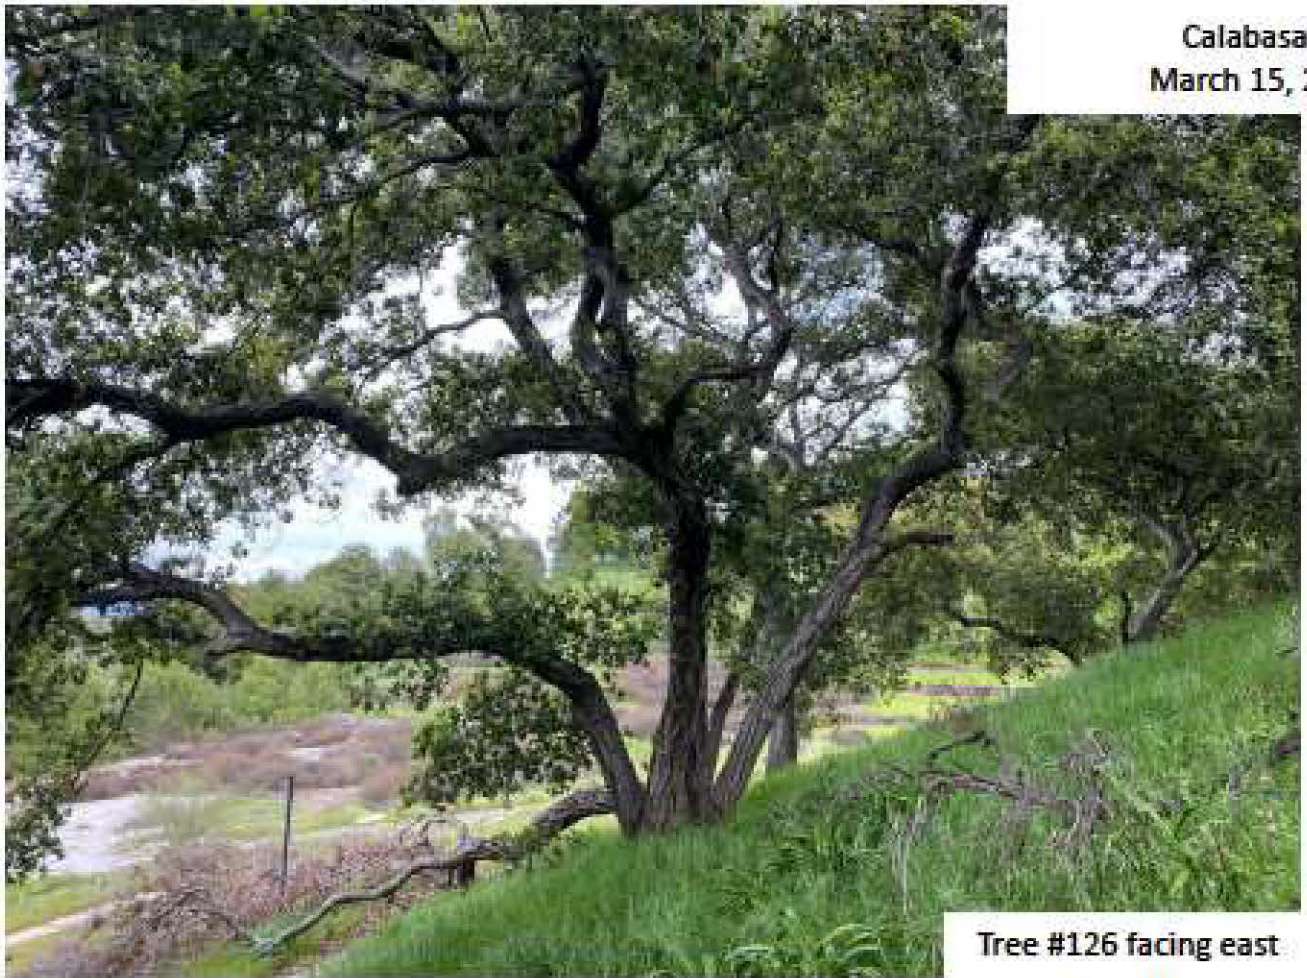
Tree #126 facing east

#126 – encroaches 30 percent of the PZ, no closer than 17 feet from the trunk.

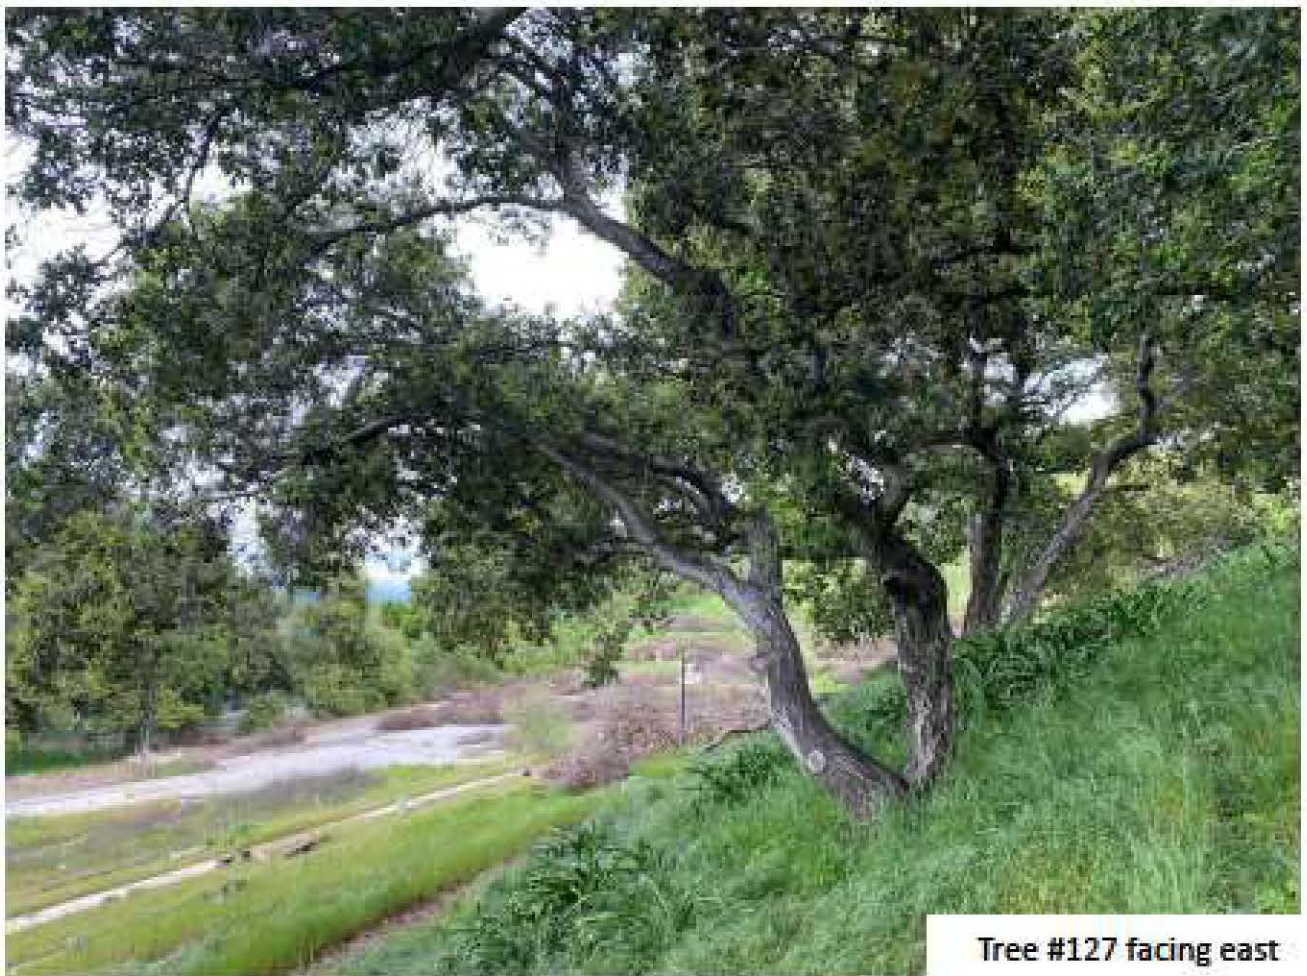
Tree #127 facing east

#127 – encroaches 25 percent of the PZ, no closer than 18 feet from the trunk.

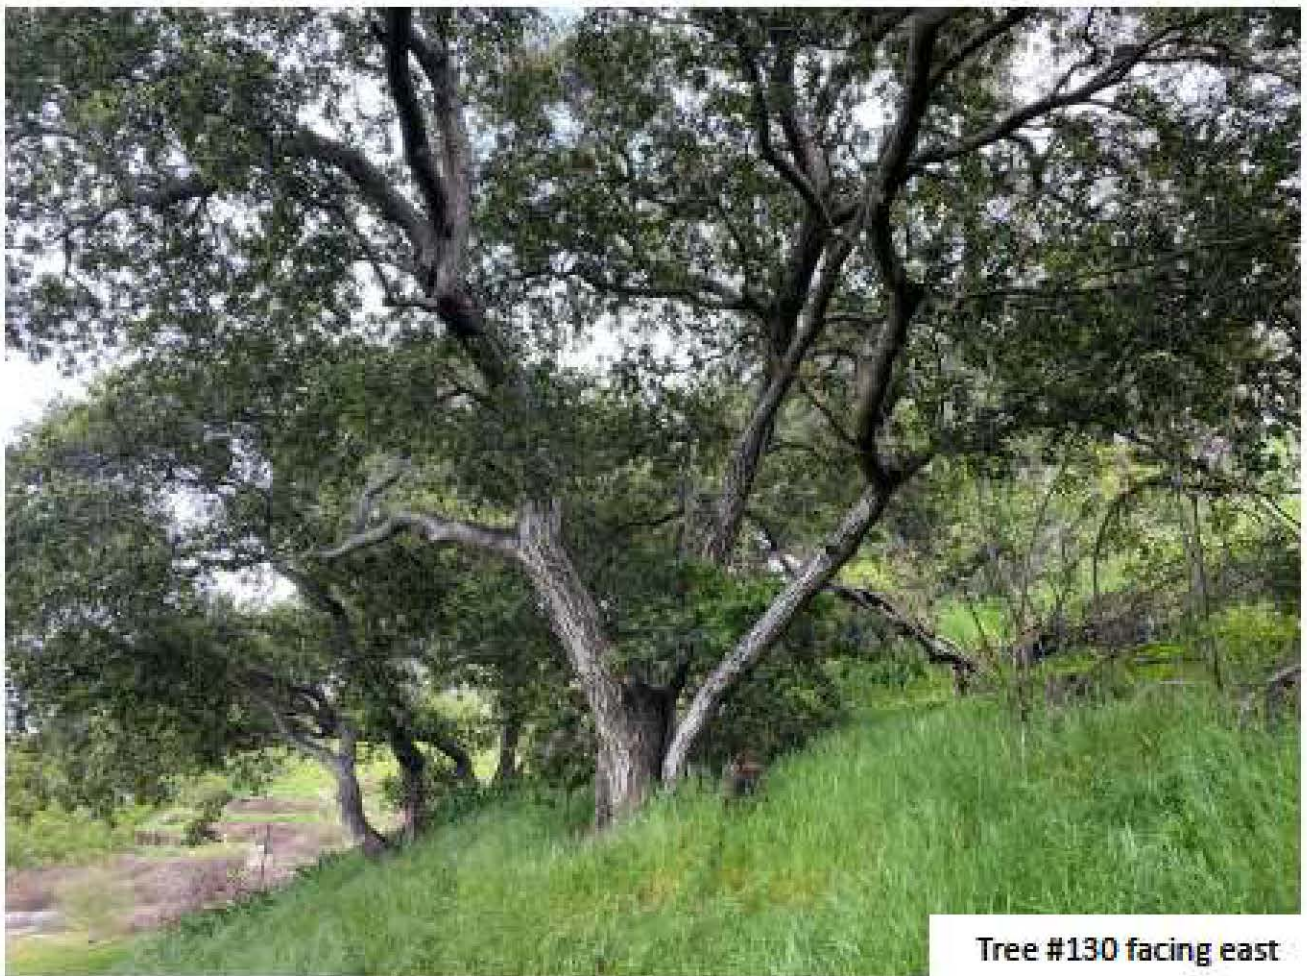
Tree #130 facing east

#130 – encroaches 12 percent of the PZ, no closer than 28 feet from the trunk.

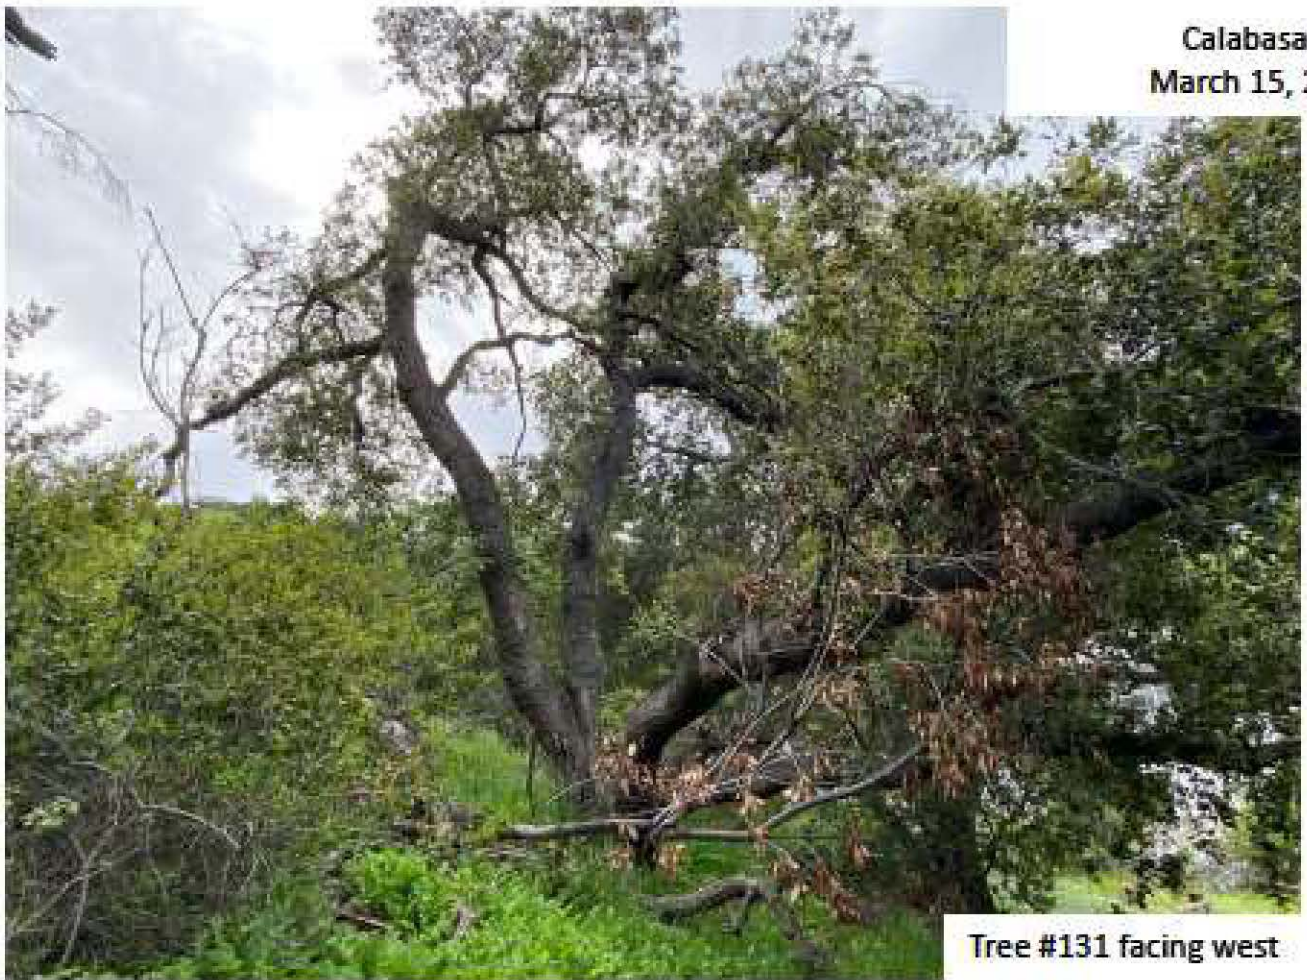
Tree #131 facing west

#131 – encroaches 5 percent of the PZ, no closer than 39 feet from the trunk.

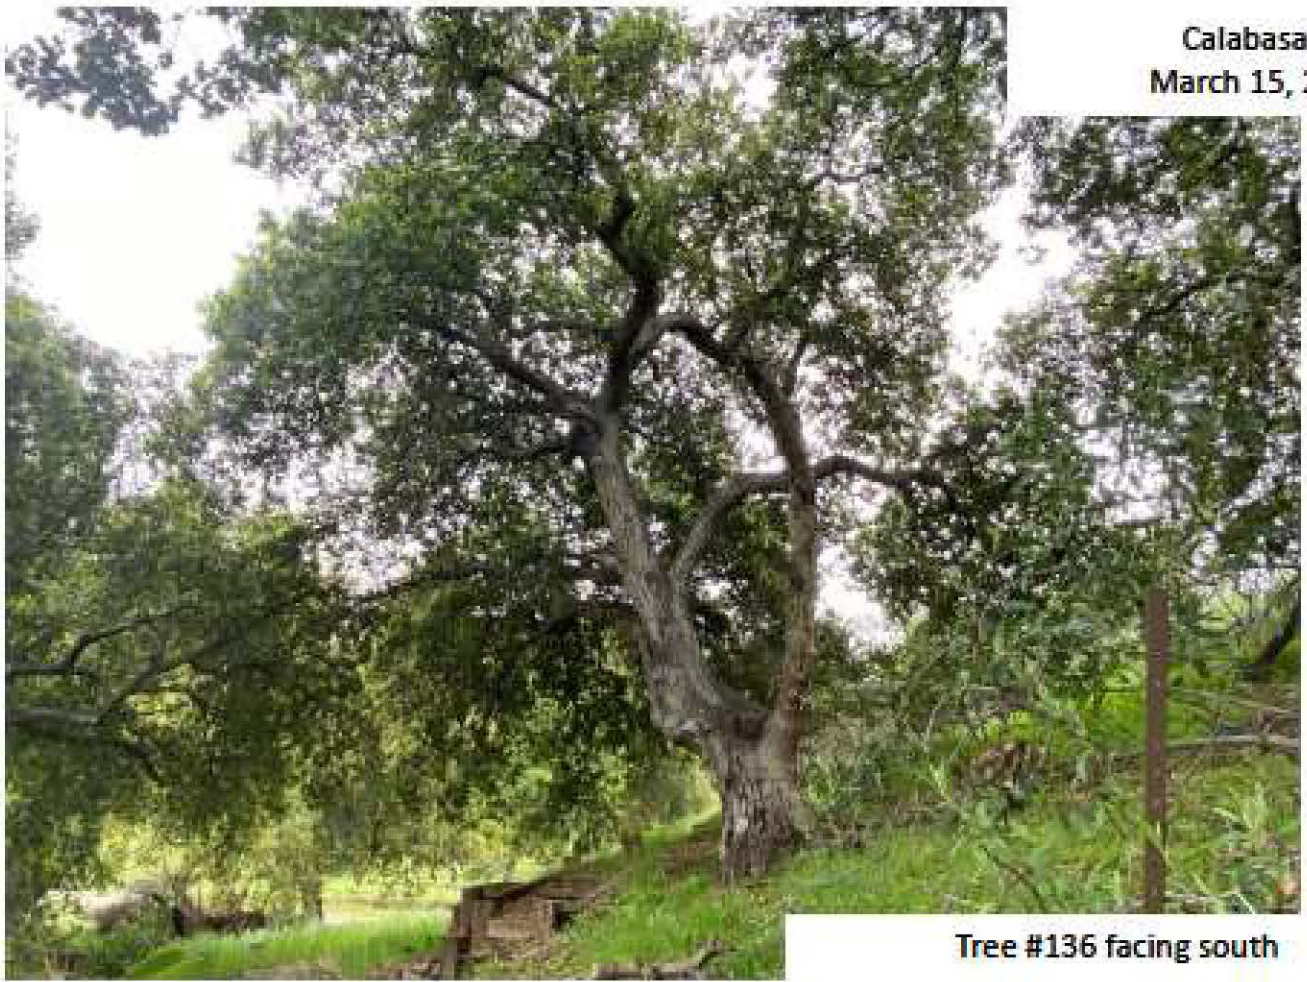
Tree #136 facing south

**Oak tree #136** – This tree will be encroached by the v-ditch above the manufactured slope which will impact 3 percent of the PZ and will be no closer than 48 feet from the trunk.

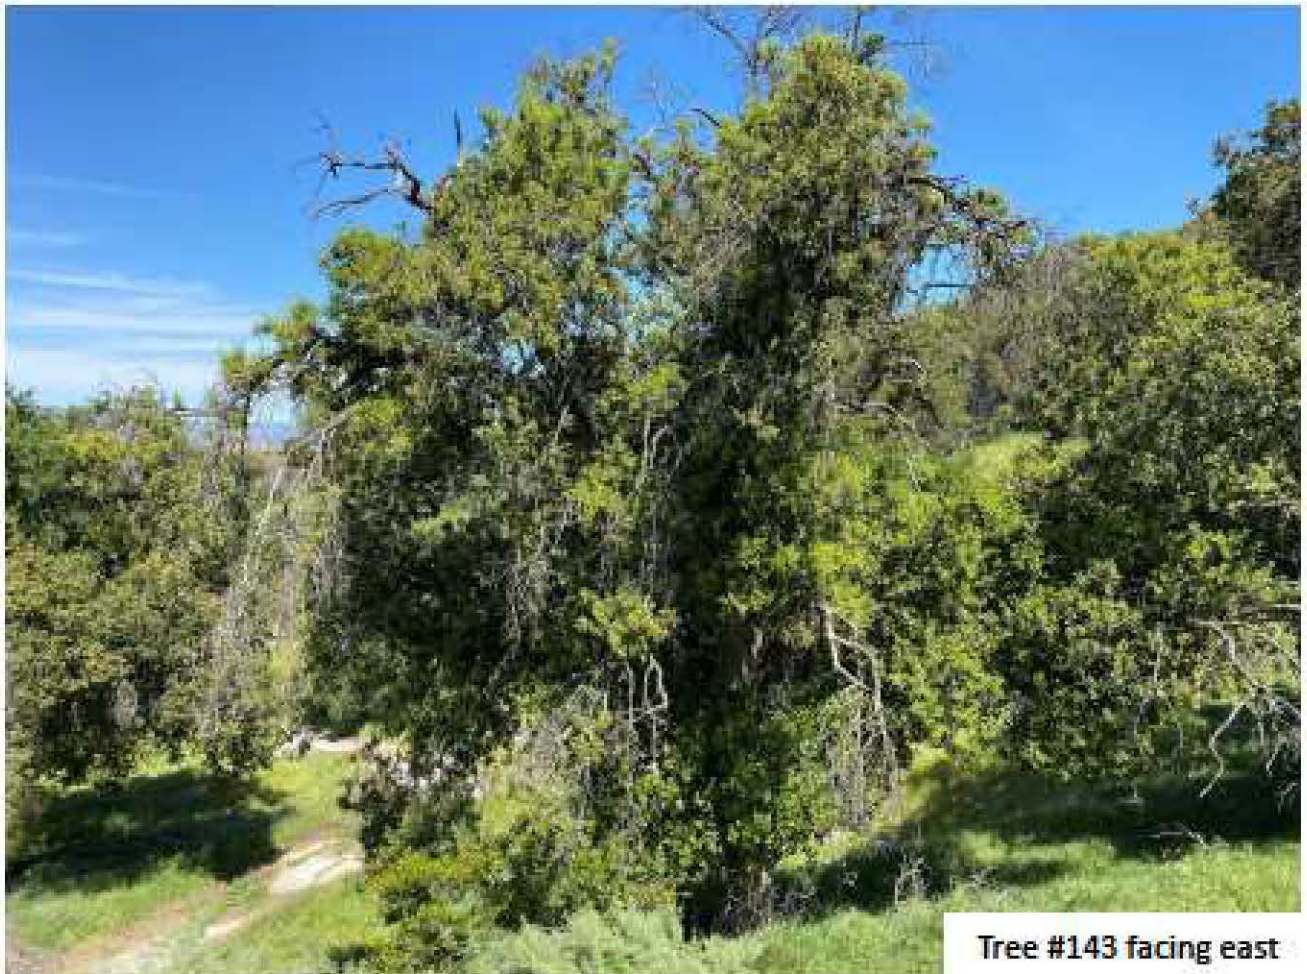
Tree #143 facing east

**Oak tree #143** – This tree will be encroached by a drainage channel that begins near this tree, 34 feet from the trunk and encroaching 4 percent of the PZ.

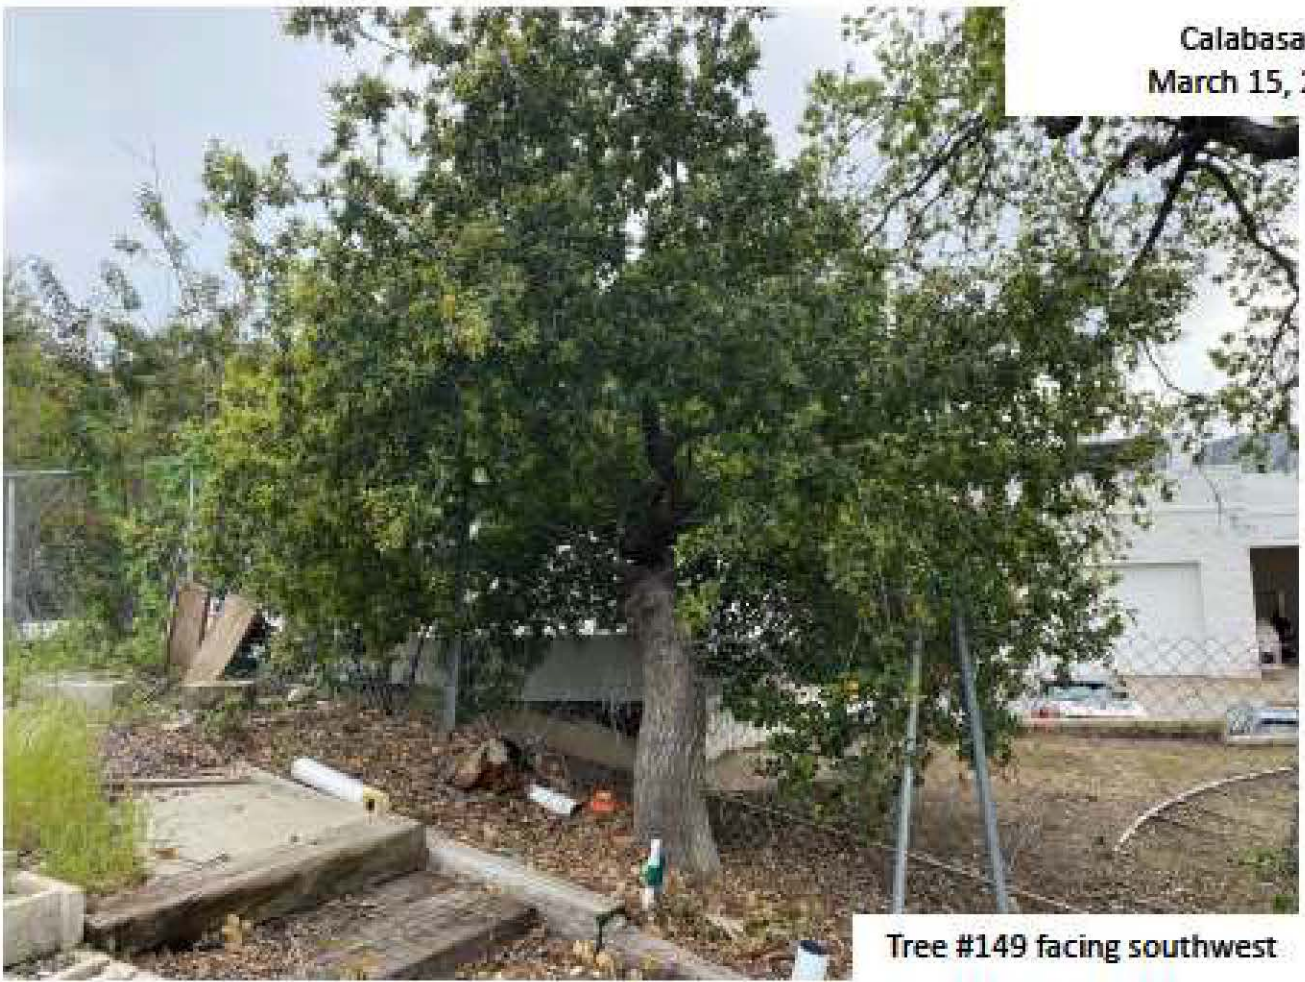
Tree #149 facing southwest

**Oak tree #149** – This tree will be encroached by a 4-foot retaining wall, 5 feet from the trunk. This is a severe encroachment that will jeopardize the health of this tree, impacting 50 percent PZ. The drain line shown on the plan will be aligned away from the trunk.
