# **OAK TREE REPORT**

**Calabasas Kia**

Date: March 31, 2023

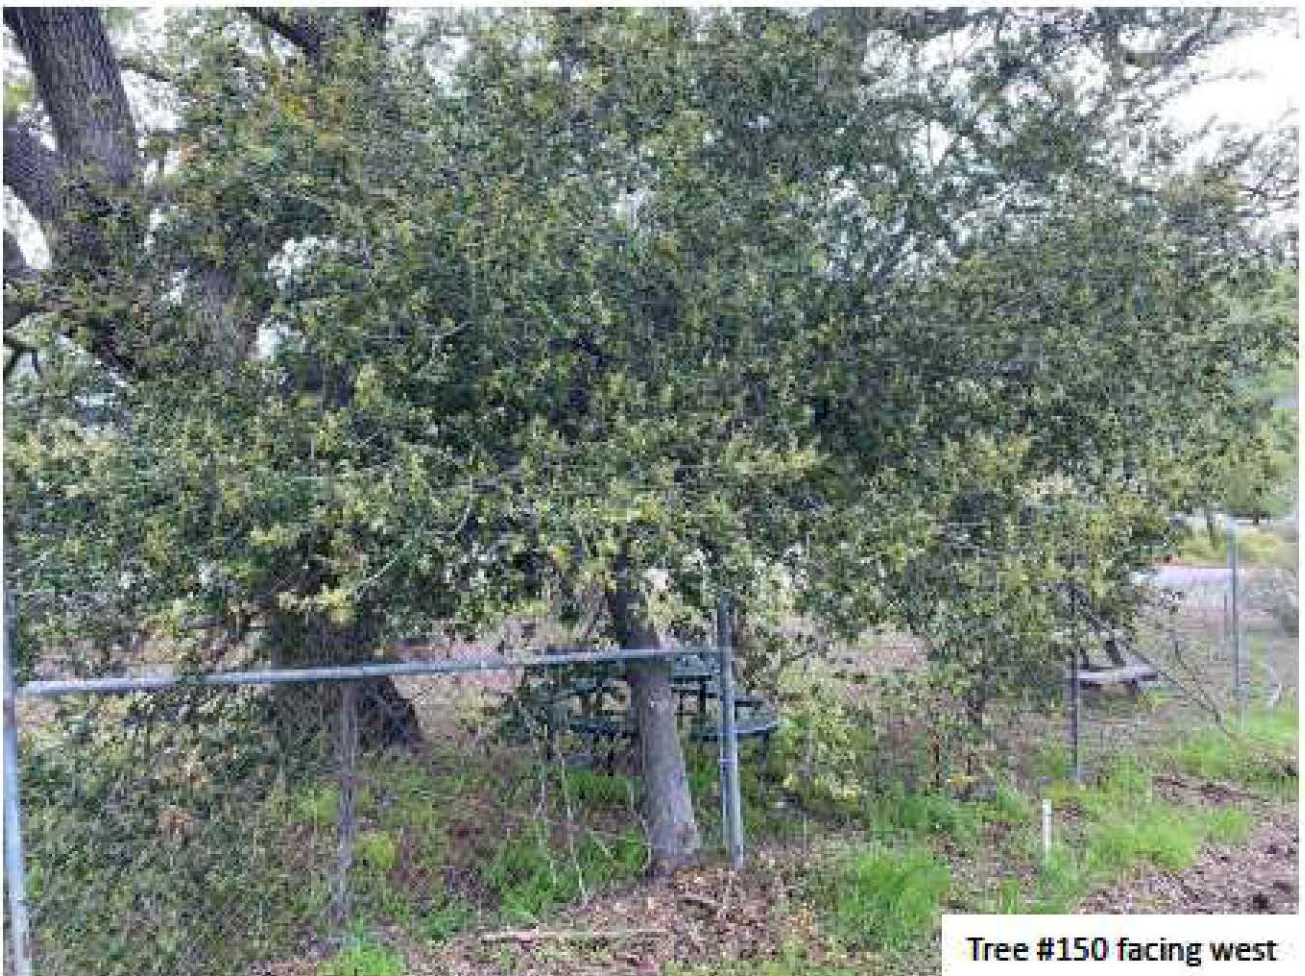
Tree #150 facing west

**Oak tree #150** – This tree is located on the west property line, 2 feet from a proposed 6-foot retaining wall. The excavation for the wall will require the removal of this tree.
