A Project report:

Las Virgenes Creek Restoration Project

Healing a Stream

By: Alex Farassati, Ph.D.
Calabasas Environmental Services Supervisor

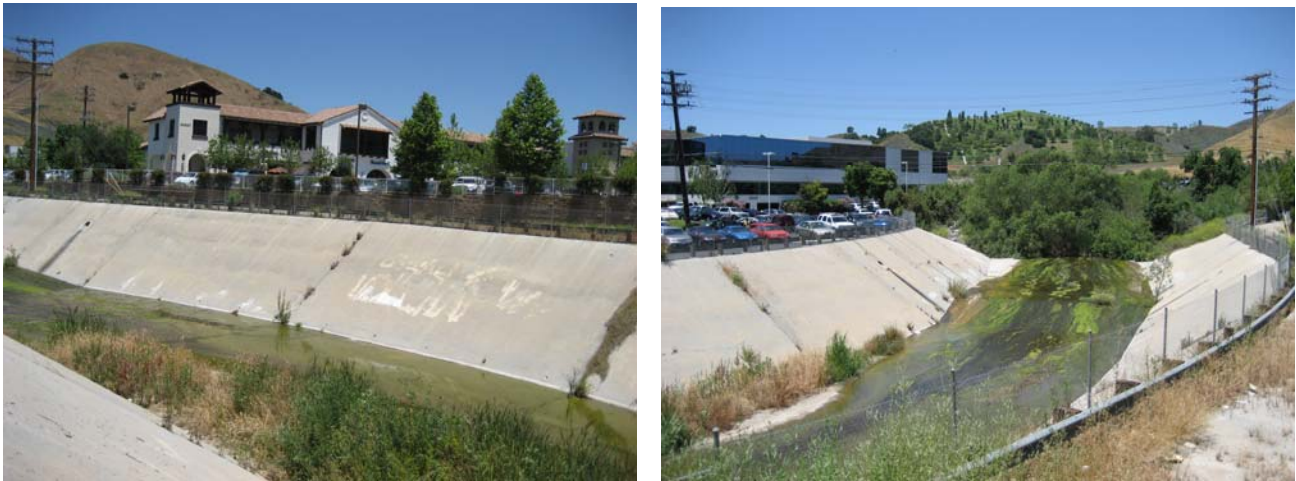
Concrete Channel built in 1977

In 1977, approximately 440 linear feet of Las Virgenes Creek between Highway 101 and the Agoura Road Bridge was lined with concrete, severely disrupting the wildlife corridor and removing all viable riparian habitats from this once thriving natural creek segment. Cemented-in flood channels have zero habitat value, no water cleansing and generate thermal pollution. The concrete channel removed vegetation and disturbed the creek's natural meander through the landscape.

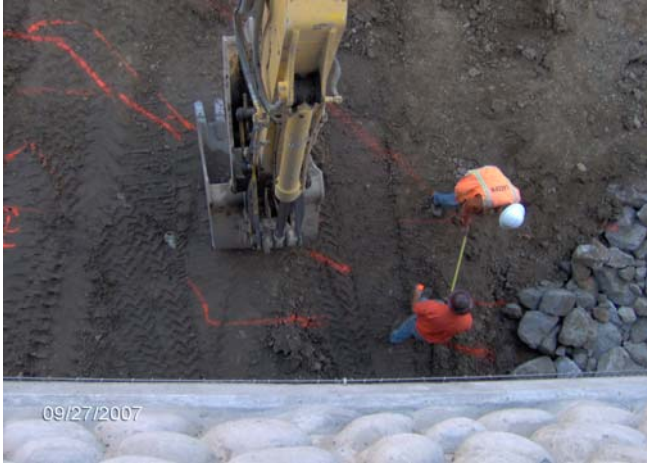
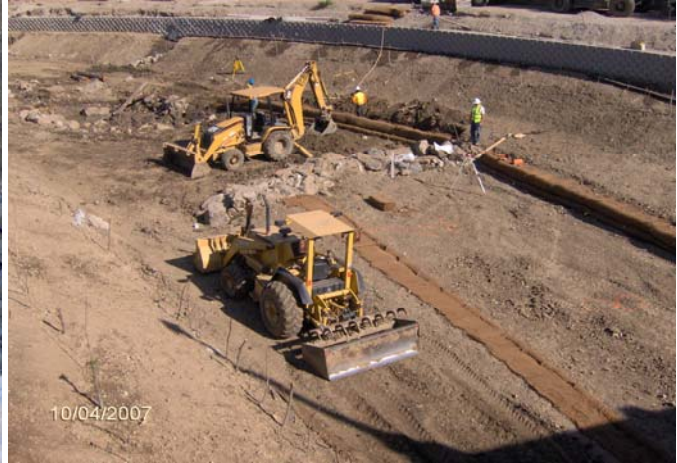
At the same time, City staff worked closely with the design engineer to respond quickly to any design changes that were required in the field. An example of this was a cut off wall that was to be installed under the bridge. The original design called for a cast in place concrete wall to protect the center bridge footing. However, the contractor encountered unforeseen poor soil conditions which made the existing design extremely difficult to construct. The result was a field design change that was implemented within a day. The solution called for grouted riprap to be used instead of the concrete wall. This field change maintained the original design concept and expedited construction.

The design called for a concrete cut off wall to be constructed. Due the muddy conditions, this was proving to be very tough. As a result, City staff and the design engineer and came up with a quick and inexpensive design change. The cut off wall design was to be replaced with a grouted riprap. As it turned out the concrete apron under the bridge was not structural but rather ascetics. It was placed to continue the uniform look of the channel.

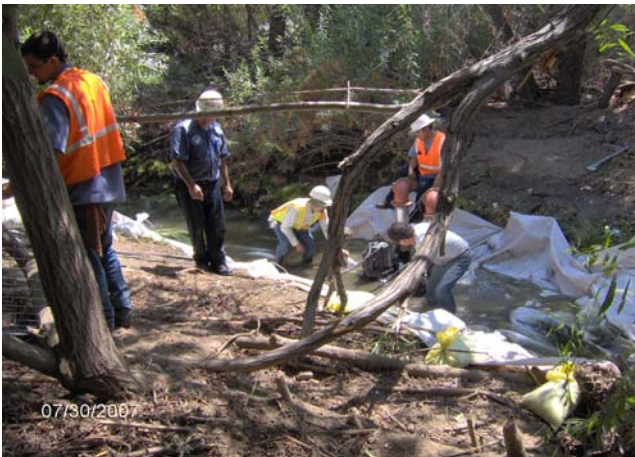
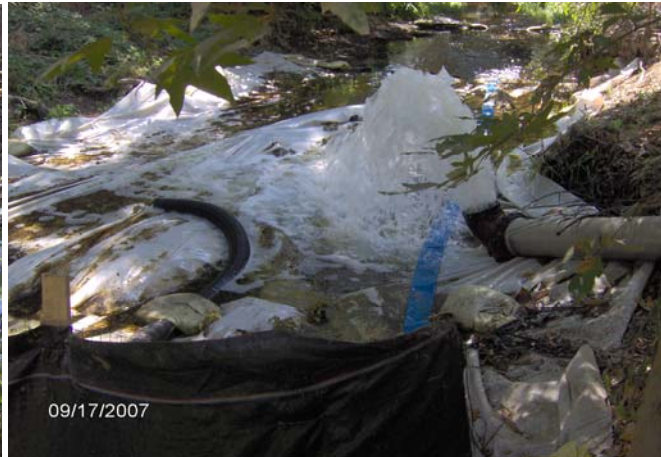
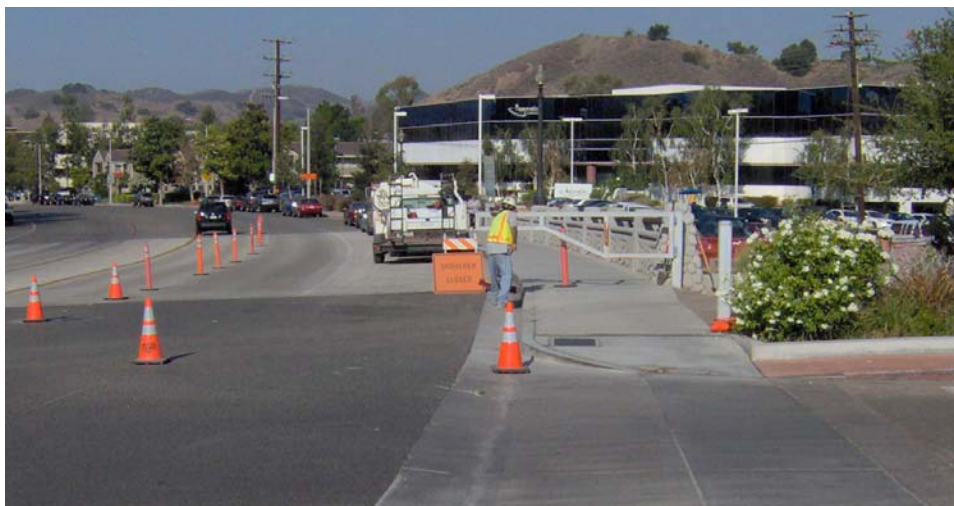
Sediment control in the creek and leaving the job site was a very important issue. A water shed of 12 square miles creates flows in the channel all year long. In order for the channel to be demolished and reconstructed, the stream water needed to be captured and then pumped downstream. To achieve this, a settling pond and silt fences were constructed to allow any suspended particles to be deposited so as to not affect water quality downstream. In addition, the contractor would sweep the street after each truck that left the site, and took pride in the fact that he left the job site cleaner than they found it.

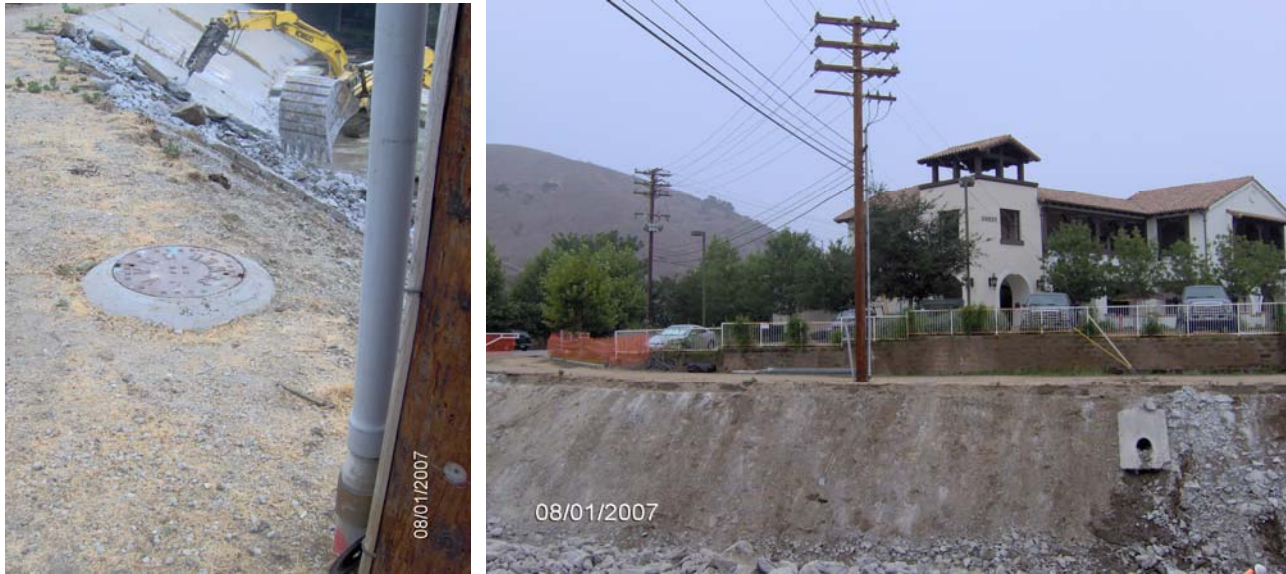
There were a few noteworthy events that occurred within the project site. The first is that despite the project only being 440 feet long, there are three utility lines that run through the project site. At the upstream end of the project there is a water and wastewater main located under the creek, and a power line runs over it. The water main is located just above the limits of the concrete channel. However, the wastewater main ran under a concrete portion of the channel. The contractor took special care not to damage the sewer when removing the concrete channel lining over the top of it.

After the concrete removal the sewer line was inspected and it suffered no damage. Fortunately, the power pole was located on the bank and due to its elevation was not at risk of being hit by the excavators that were working in the channel. However, one of the power poles did hamper debris removal because it forced the dump trucks to have to use the downstream entrance, which exited directly onto a busy road.

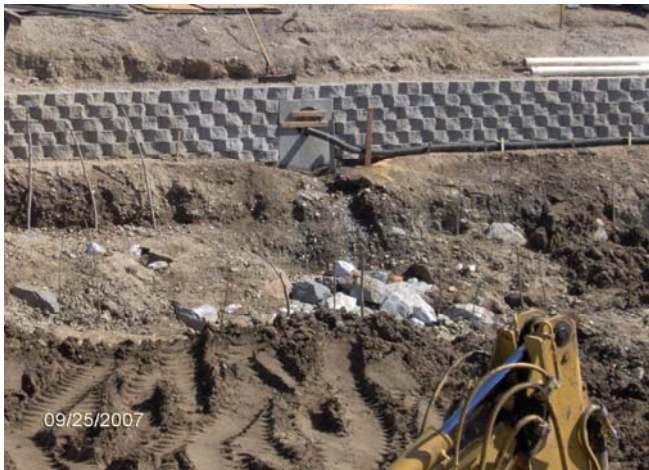
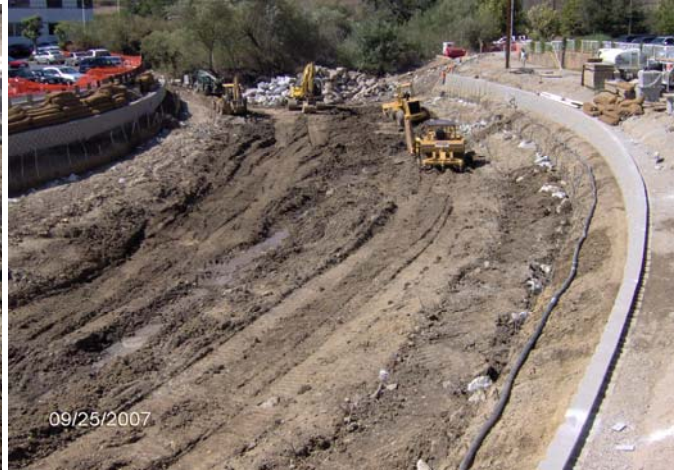
The design called for a five foot trench to be dug on both sides on the channel parallel to the sides for the entire length of the channel. This trench would be filled with large two to four ton boulders that would keep the channel from wandering due to stream bed erosion. Once the boulders were placed, willow stakes were placed around the boulders, followed by smaller rock and finally dirt in a process

called “chinking”. In order for the willows to root they needed to be watered. The contractor blocked the outlet on the east side and placed a 4 inch diameter corrugated pipe in the outlet and channeled the water into the pipe. The contractor ran the pipe along the top of the slope above the willow stakes and then perforated the pipe at regular intervals which allowed the water too slowly leak into the trench and keep the willow stakes wet. Thus we managed to utilize all of the wasted water coming from the shopping center parking lot.

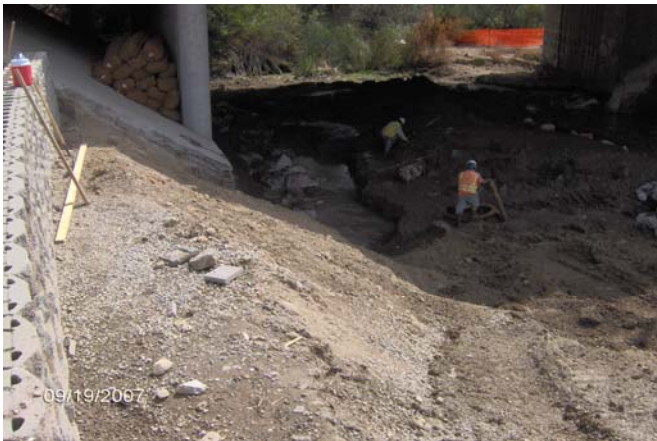
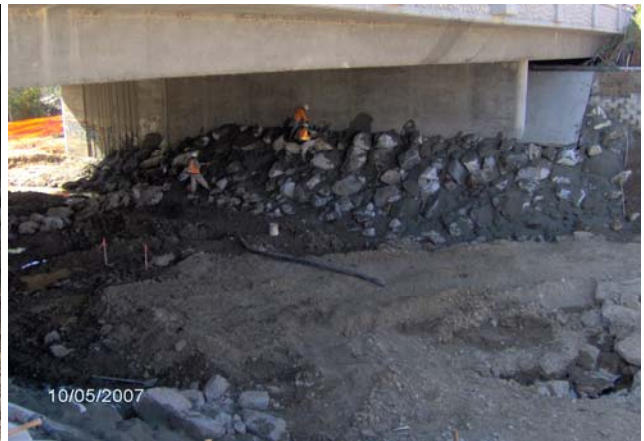
The water table was incredibly high on this project. In fact, the only thing keeping the water from surfacing was a two foot thick layer of gravel that was laid down during the initial construction of the channel. Any water that was not captured by the diversionary dam was using the gravel layer as a French drain to make its way downstream. Once the contractor had disturbed this gravel bed, the water surfaced, and created a serious problem at the downstream end of the construction site where it turned the soil conditions to mud. However, it created an opportunity to employ a little ingenuity and value engineering.
