Las Virgenes Creek Restoration Project-Phase II

Community Workshop
August 6, 2015

VEGETATION MANAGEMENT & DEBRIS REMOVAL PLAN
 LAS VIRGENES CREEK RESTORATION PROJECT - PHASE II
 CALABASAS, CA

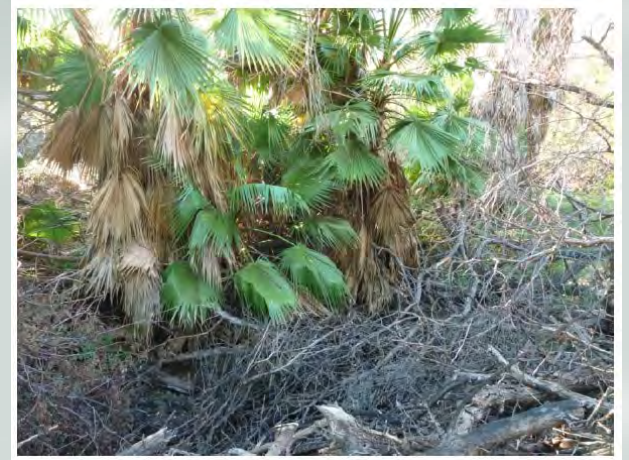
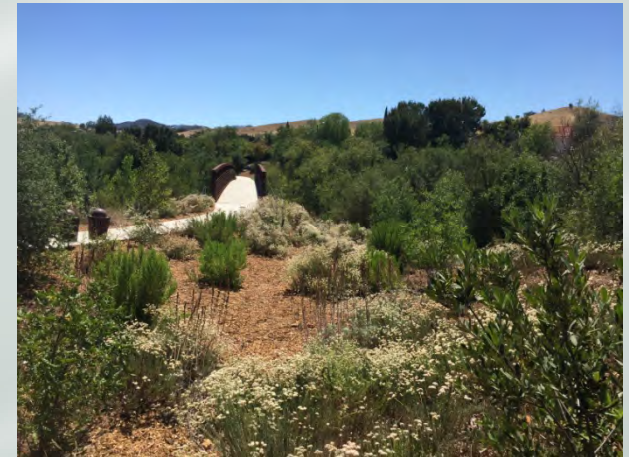
1. Habitat Restoration and Erosion Control

- Debris/rubble removal
- Removal of non-native invasive species
- Thinning of limbs that block flood flows and trail clearance
- Repair of erosion sites
- Replant with native riparian species

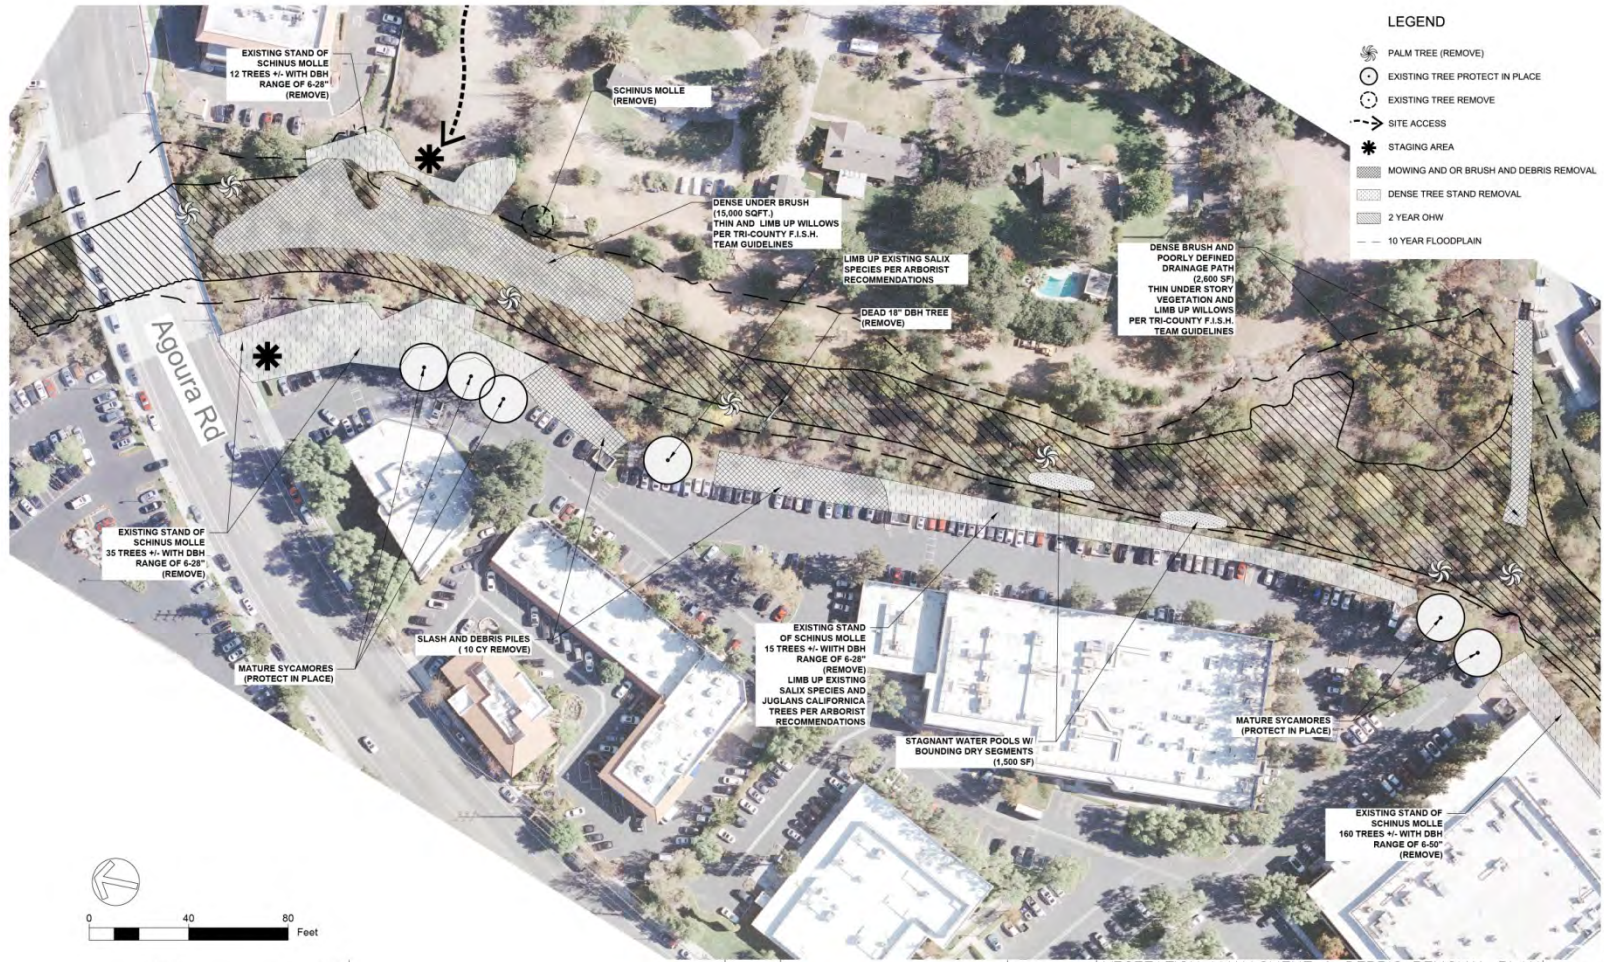
SHEET NO.
 2
 OF 1 TBD

VEGETATION MANAGEMENT & DEBRIS REMOVAL PLAN
 LAS VIRGENES CREEK RESTORATION PROJECT – PHASE II
 CALABASAS, CA
 PROJECT NO.1500058

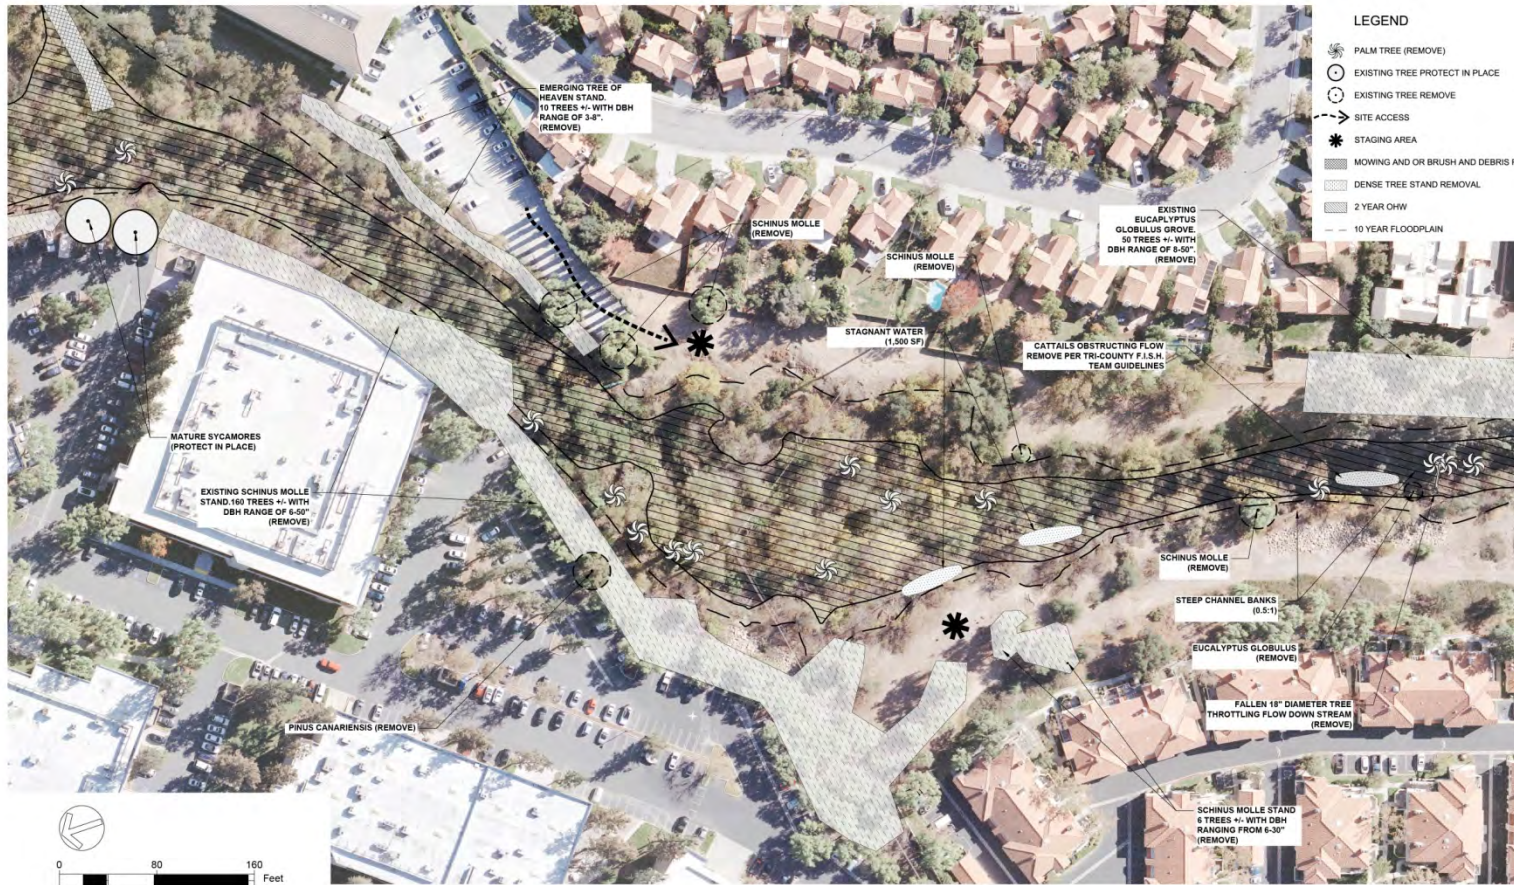
SHEET NO. 3
 OF 1 TBD
 CONTRACT NO.

VEGETATION MANAGEMENT & DEBRIS REMOVAL PLAN
 LAS VIRGENES CREEK RESTORATION AND PUBLIC ACCESS
 CALABASAS, CA
 PROJECT NO.1400174

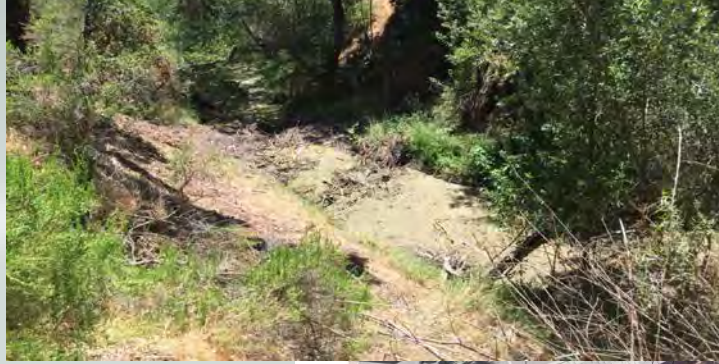
Vegetation debris to be removed for flood conveyance

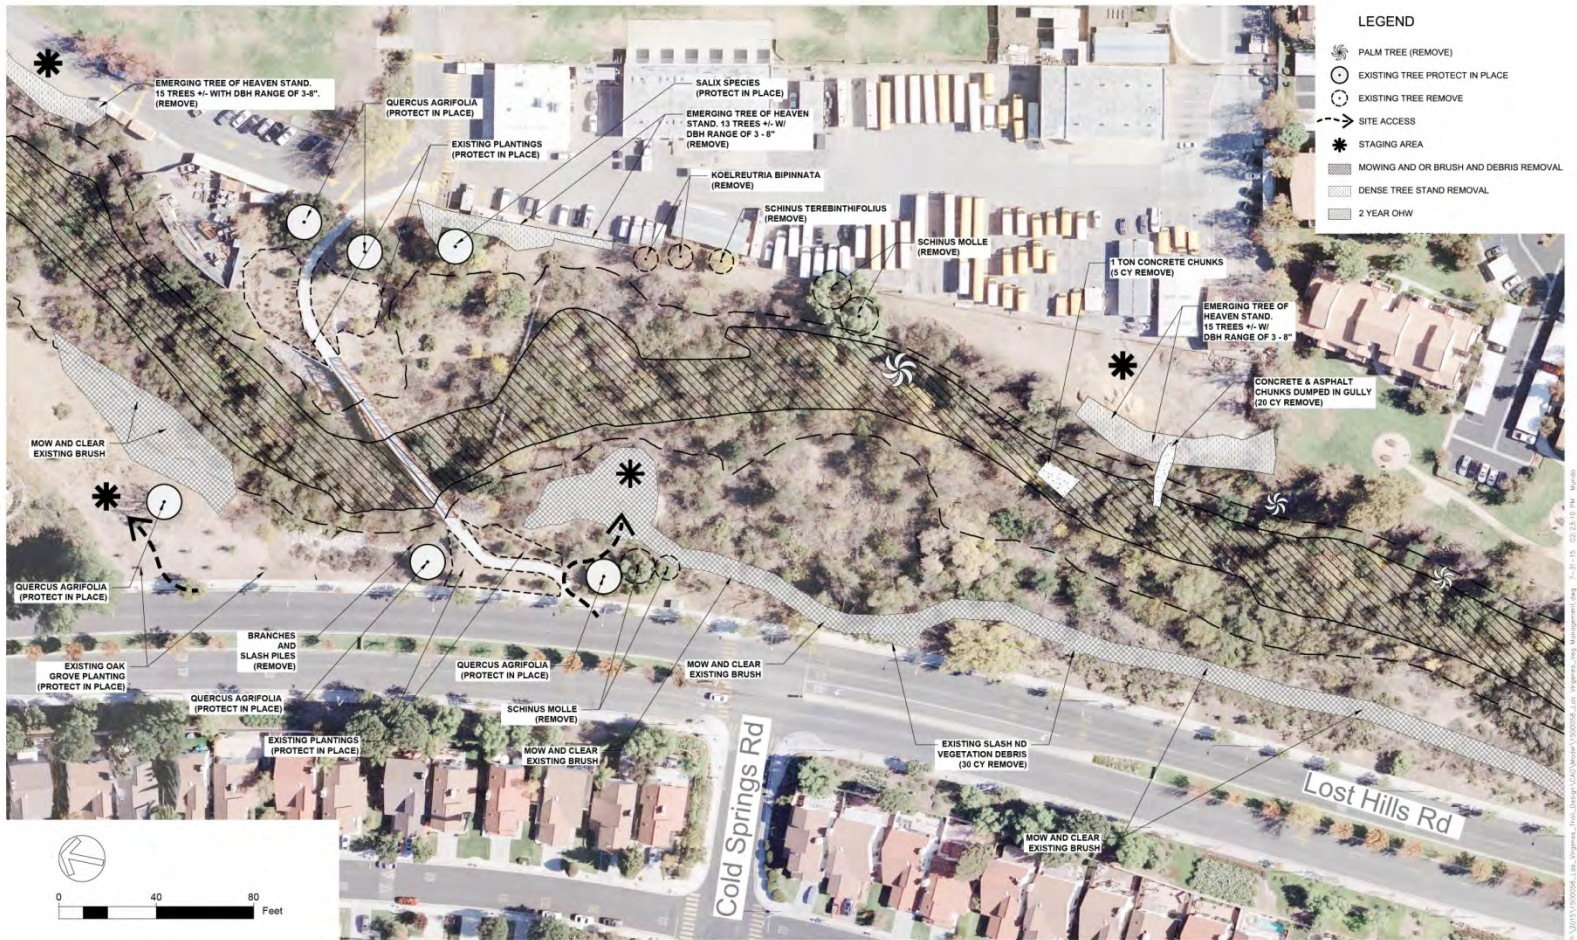
SHEET NO. 5
 OF : TBD

VEGETATION MANAGEMENT & DEBRIS REMOVAL PLAN
LAS VIRGENES CREEK RESTORATION AND PUBLIC ACCESS
 CALABASAS, CA

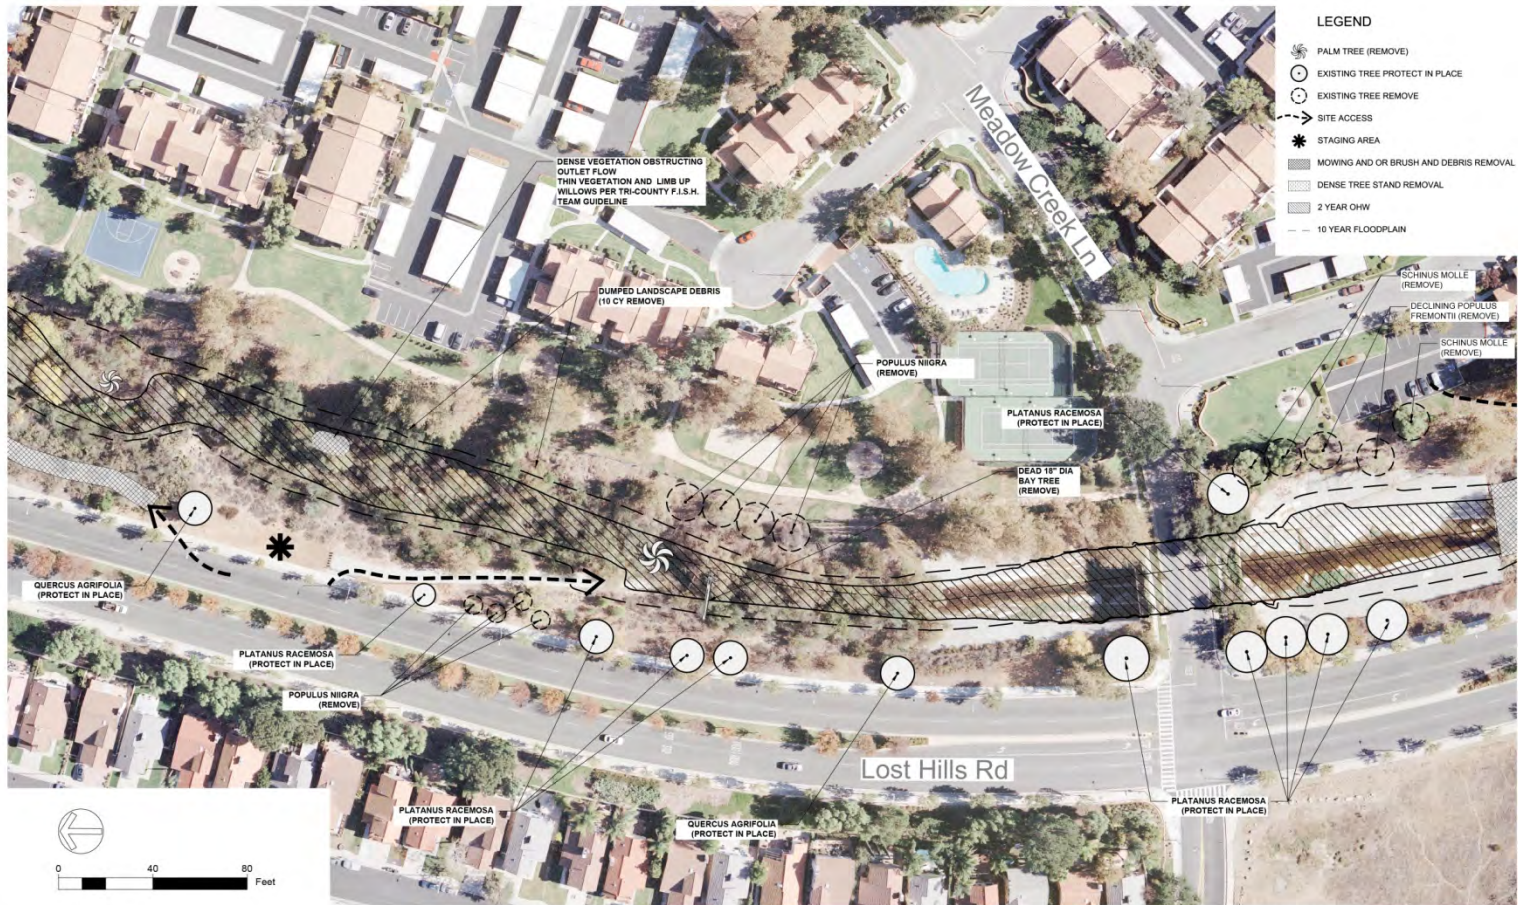
SHEET NO. 6
OF 1 TBD

VEGETATION MANAGEMENT & DEBRIS REMOVAL PLAN
LAS VIRGENES CREEK RESTORATION AND PUBLIC ACCESS
CALABASAS, CA

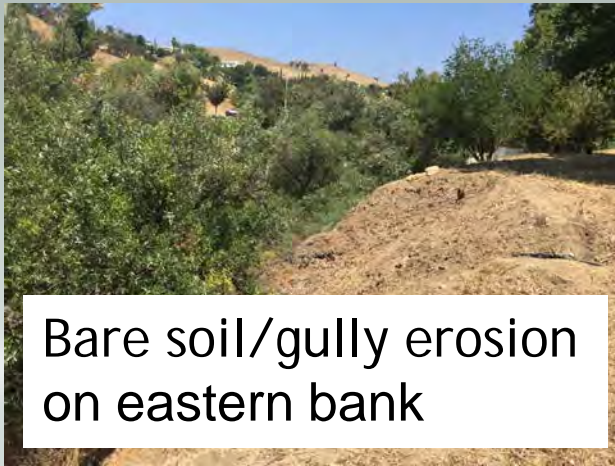
Bare soil/gully erosion on eastern bank

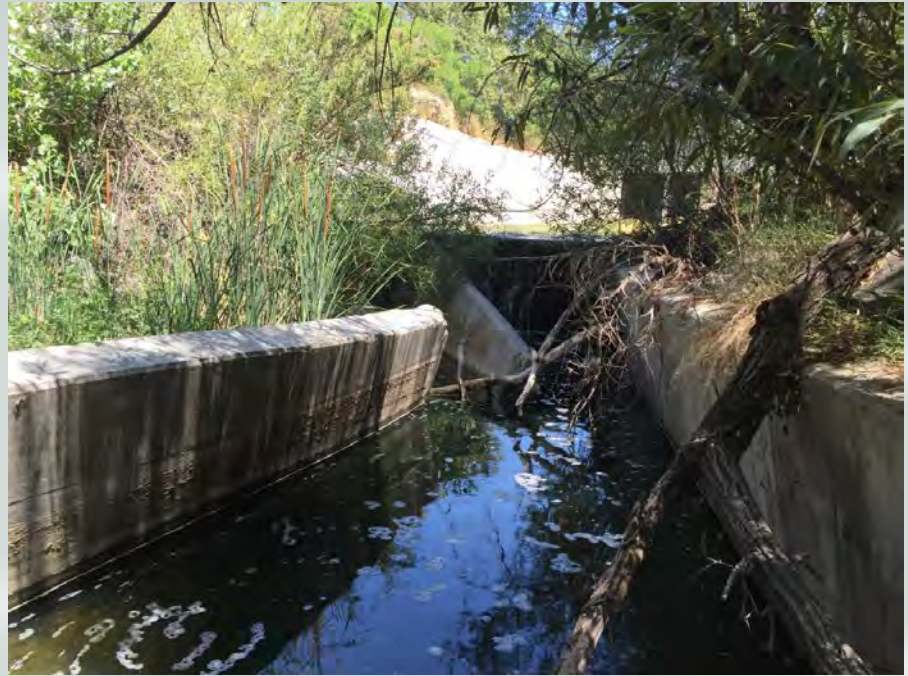
2. Fish Passage Improvements

- Remove failing wall south of Meadow Creek Lane, restore slope
- Install step pools for fish
- Install baffles on existing structure to allow fish movement
- Replant to provide shade to creek

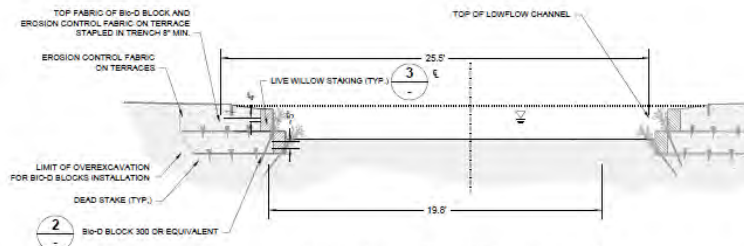
1 TYPICAL LOWFLOW CHANNEL CONSTRUCTION
NTS

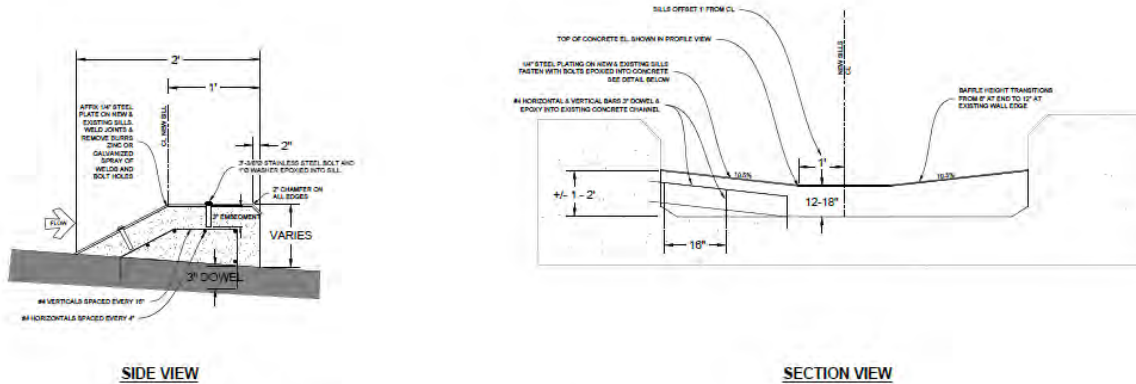
1 CONSTRUCTED RIFFLE AND GRADE CONTROL BAFFLE PLAN AND SECTIONS
NTS

2 CONCRETE FISH PASSAGE WEIR
NTS

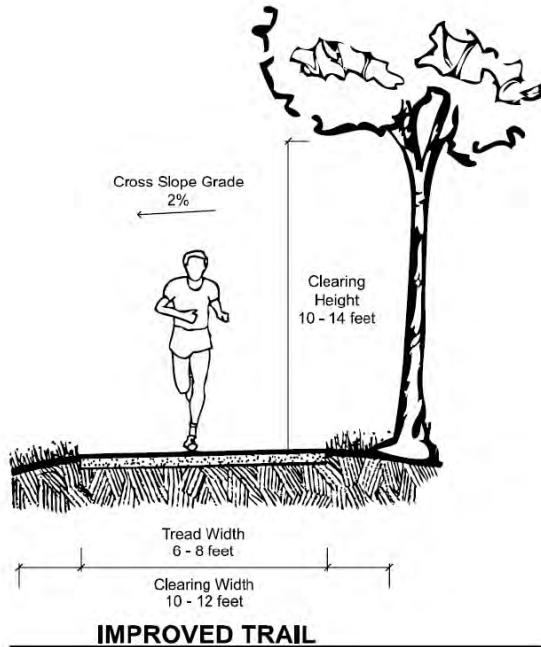
IMPROVED TRAIL

Tread Width	6 - 10 feet
Clearing Width	10 - 12 feet
Tread Surface	Crushed rock, decomposed granite or asphalt
Percent Grade	Grades should not exceed 10 percent
	<u>Desired Grade:</u> 0 to 5 percent
	<u>Maximum Grade:</u> 0 to 10 percent (sustained, 15 percent (shorter than 50 yards)
	<u>Cross Slope Grade:</u> 2 percent (maximum)
Clearing Height	10 – 14 feet to allow for equestrian use

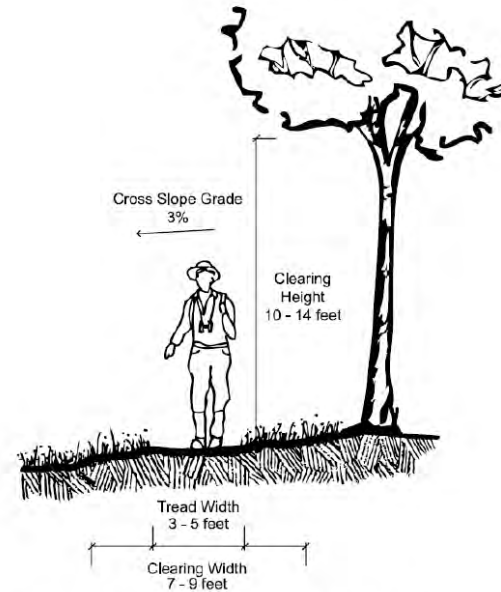
NATURAL (OPEN SPACE) TRAIL

Tread Width	3 – 5 feet
Clearing Width	7 – 9 feet
Tread Surface	Natural/native soil
Percent Grade	Grades should not exceed 10 percent
	<u>Desired Grade:</u> 0 to 5 percent
	<u>Maximum Grade:</u> 5 to 10 percent (sustained, 15 percent (shorter than 50 yards)
	<u>Cross Slope Grade:</u> 3 percent (maximum)
Clearing Height	10 – 14 feet to allow for equestrian use
