RAZNICK MIXED USE PROJECT

Initial Study / Mitigated Negative Declaration

Prepared for
City of Calabasas

July 2017

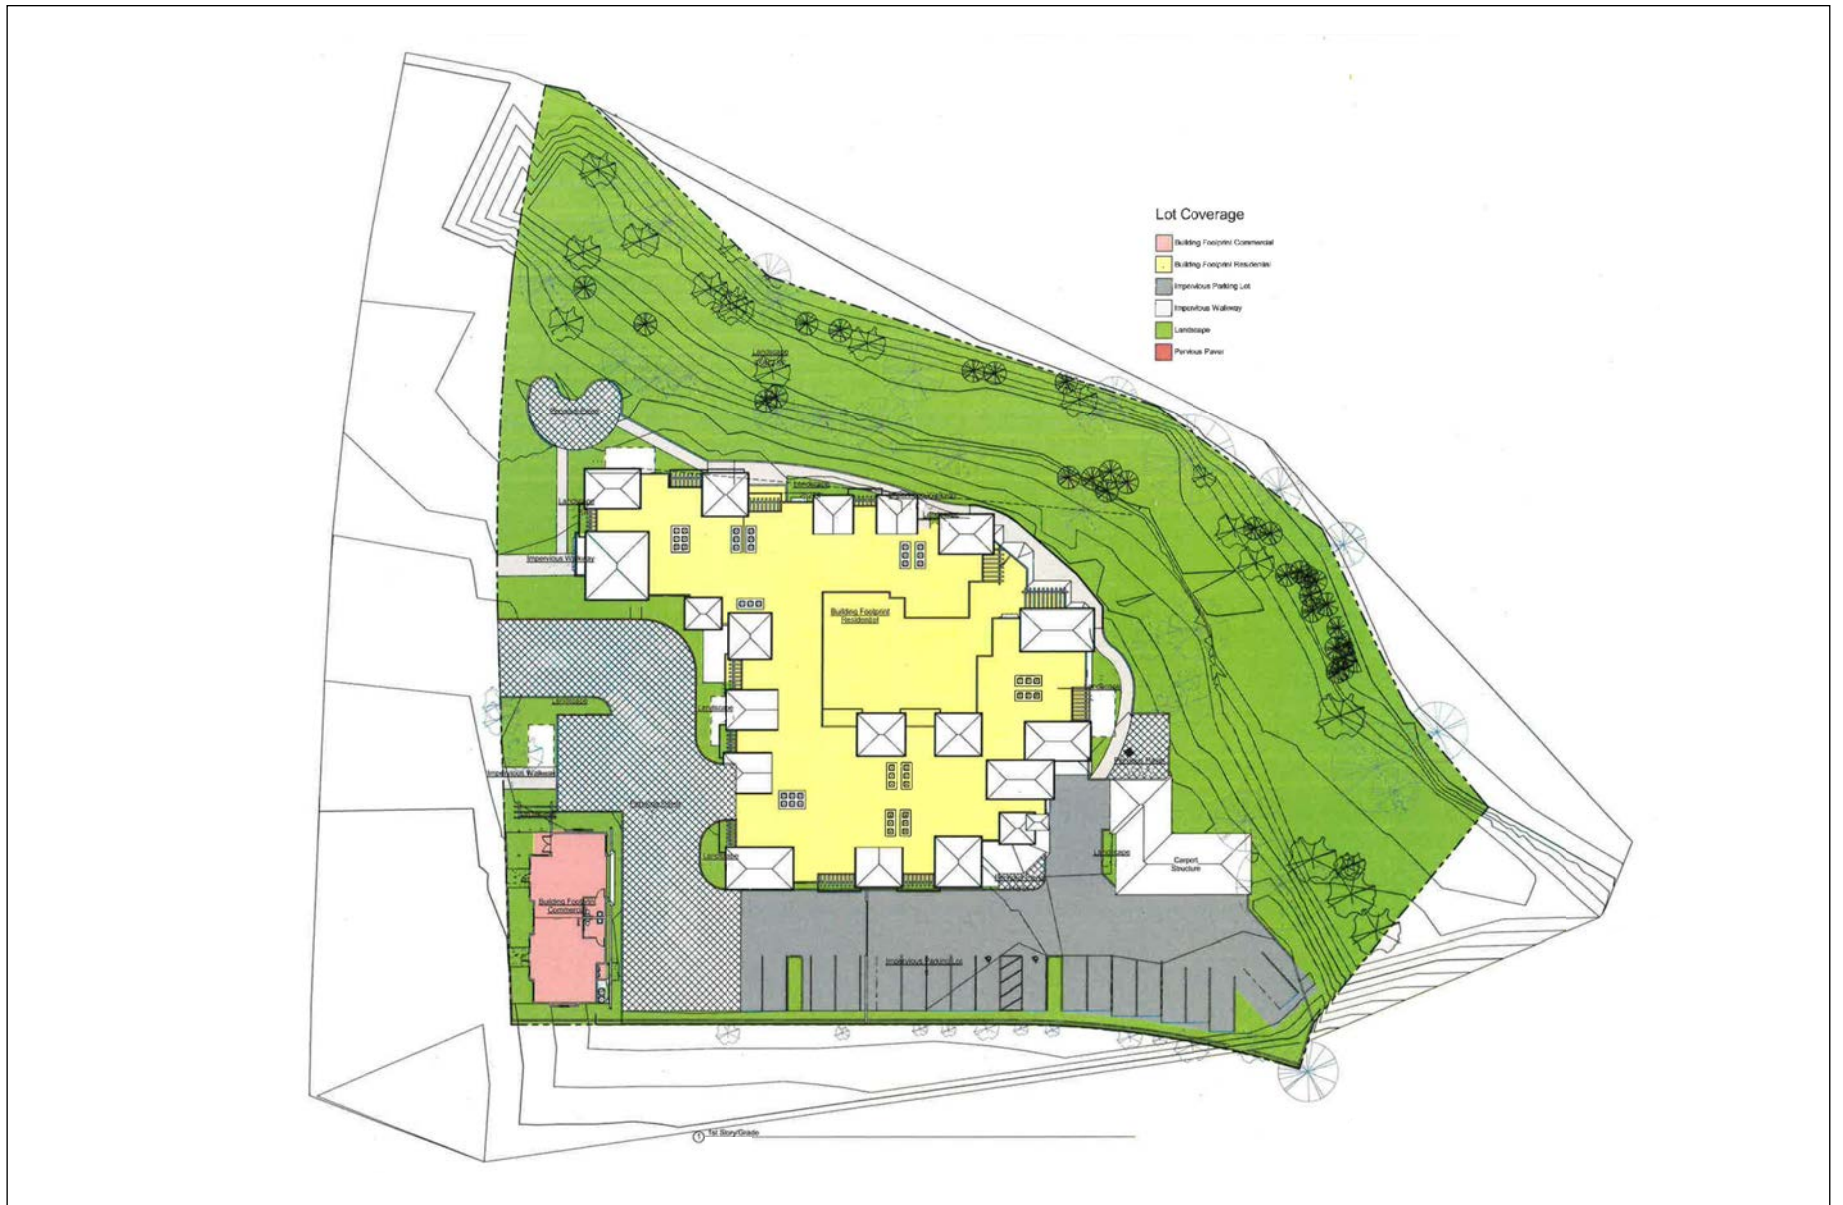
Park Sorrento . 140358.45

The proposed four-story apartment building would be approximately 43,000 SF and would include 42 age restricted (ages 55 or older) units surrounding a central outdoor courtyard. The ground floor of the apartment building would include two lobbies, mail room, office space, kitchenette, lounge area, recreation room, and a 38-stall parking garage. Apartment units would be located on the second through fourth floors, each with private balconies. The apartment building would consist of nine studio units, 21 one-bedroom units, and 12 two-bedroom units. Units would range in size from 703 SF to 1,046 SF. The proposed project would include five affordable housing units for very low income residents. The proposed stand-alone one-story commercial building would be located in the northwest portion of the project site. The approximately 1,620 SF building would consist of two commercial retail units. **Table 2-1** provides a square footage breakdown of the proposed residential and commercial components.

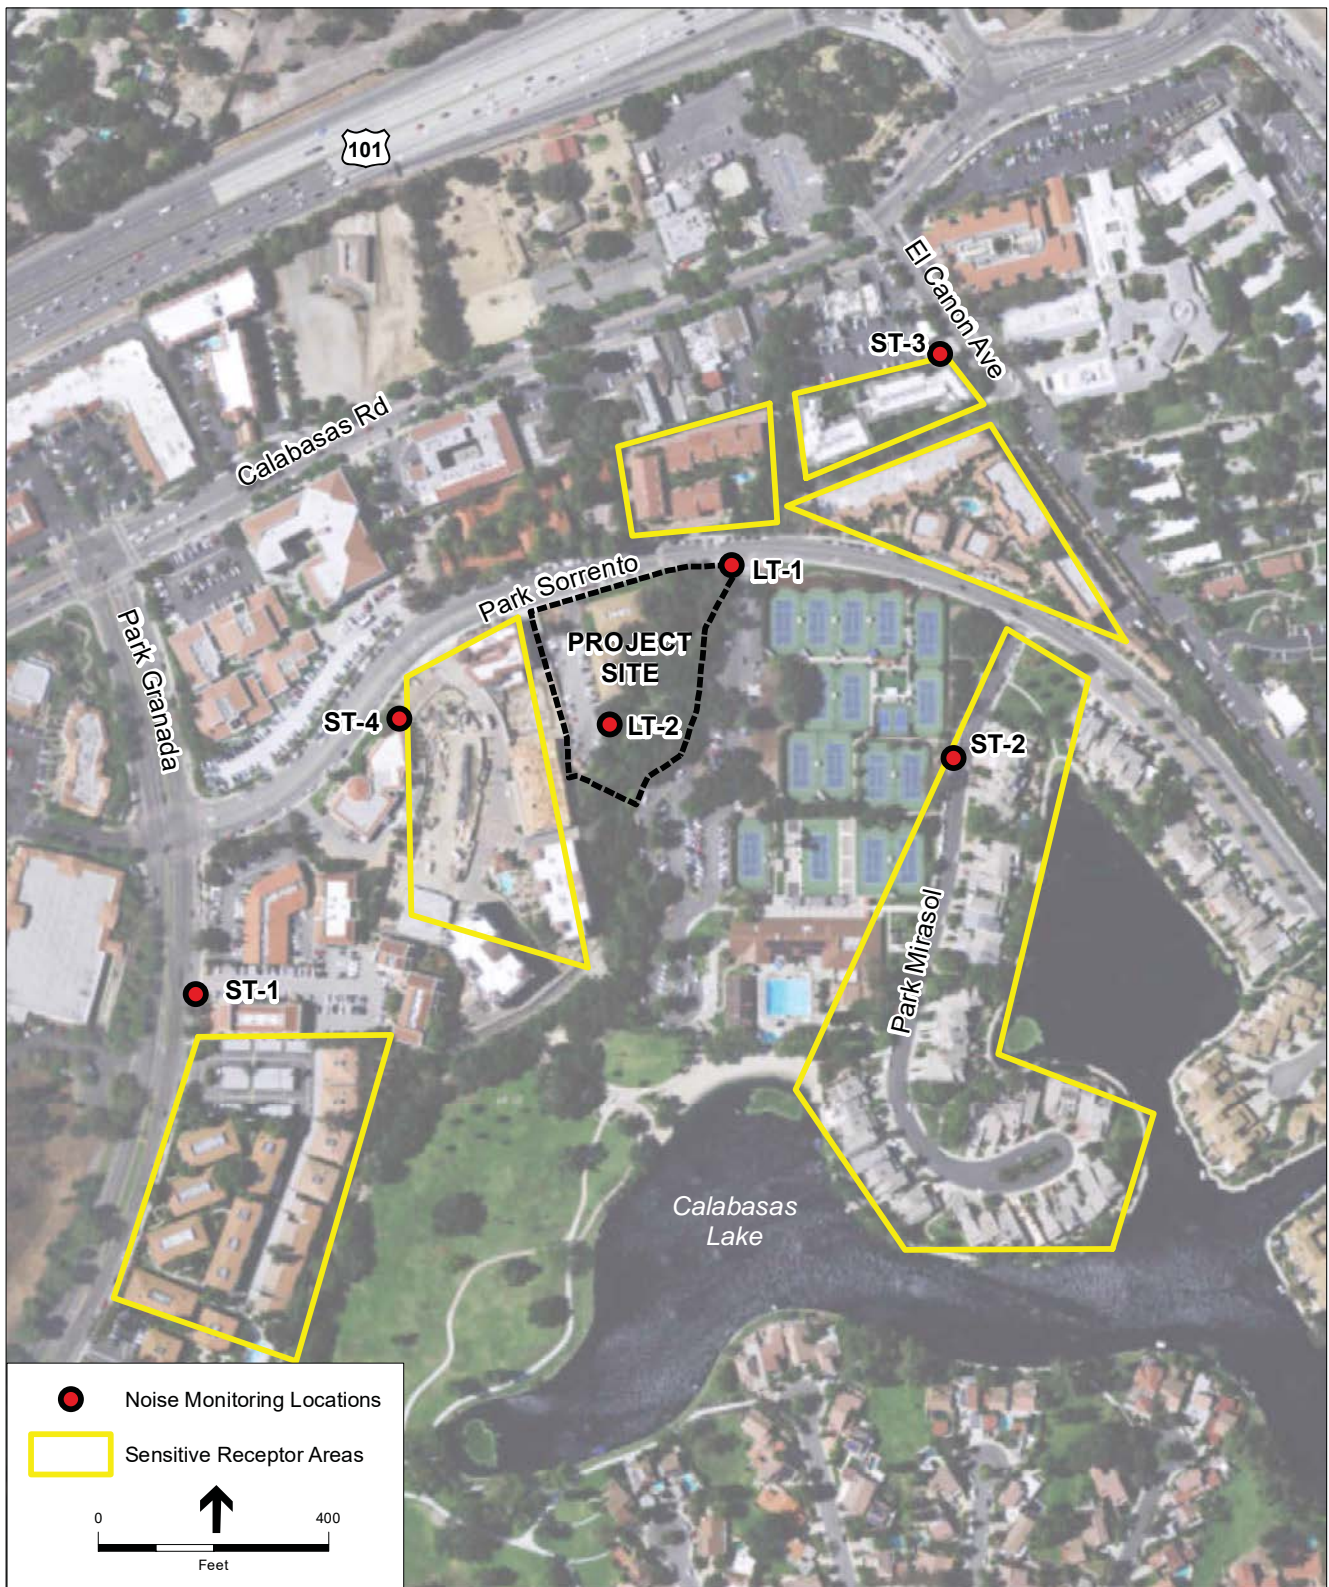
Park Sorrento . 140358.45

To quantify the existing noise environment of the project site, four short-term (15-minute) measurements were conducted during daytime hours on February 1, 2017, at Locations ST-1, ST-2, ST-3, and ST-4. Two long-term (24-hour) measurements were conducted on February 1-2, 2017 at Locations LT-1 and LT-2, as shown on **Figure 3-7**.

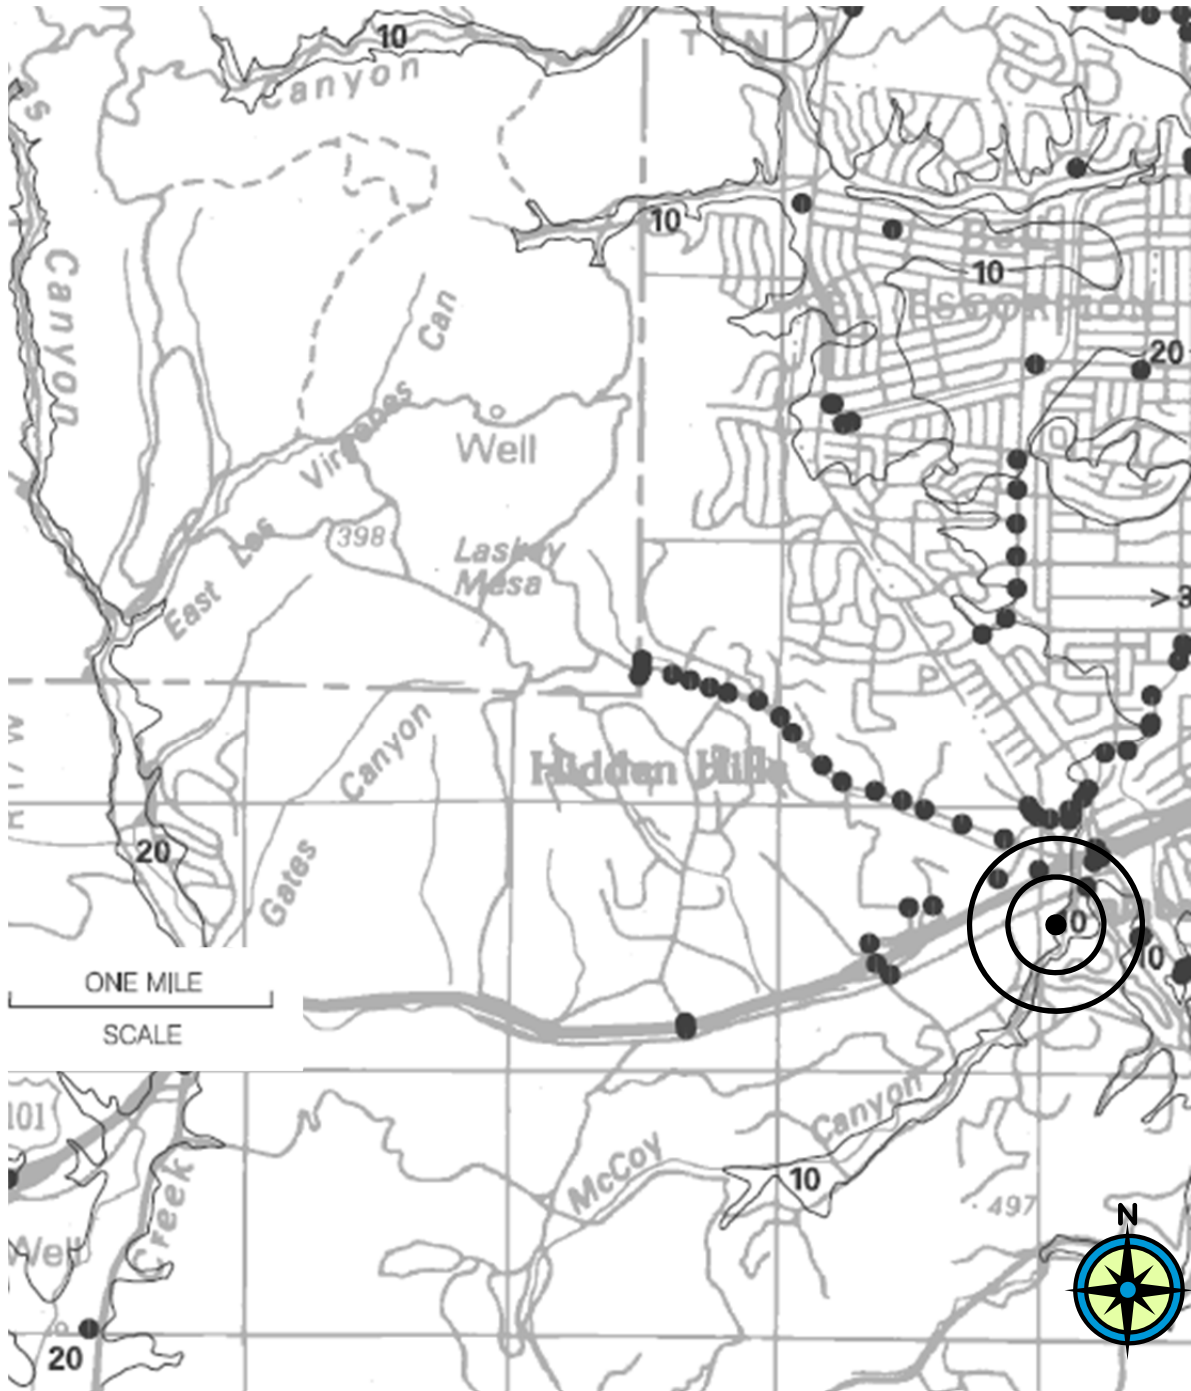
GROUNDWATER MAP

● Borehole Site

— 30 — Depth to ground water in feet

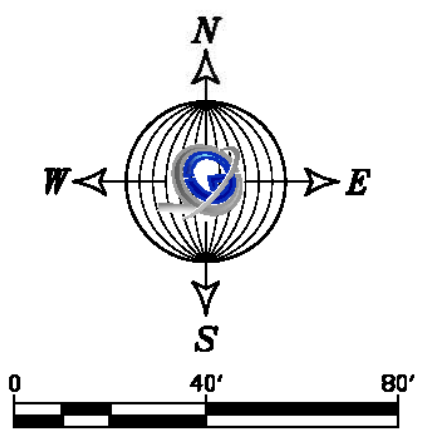
Explanation	
Af	Fill
Caf	Certified Fill (1973)
Qal	Alluvium
Mmu	BEDROCK (Modelo Formation)
B-7	Location of Borings
EB-3	Location of Borings by: L.T. Evans (1973)
C-C'	Line of Cross Section

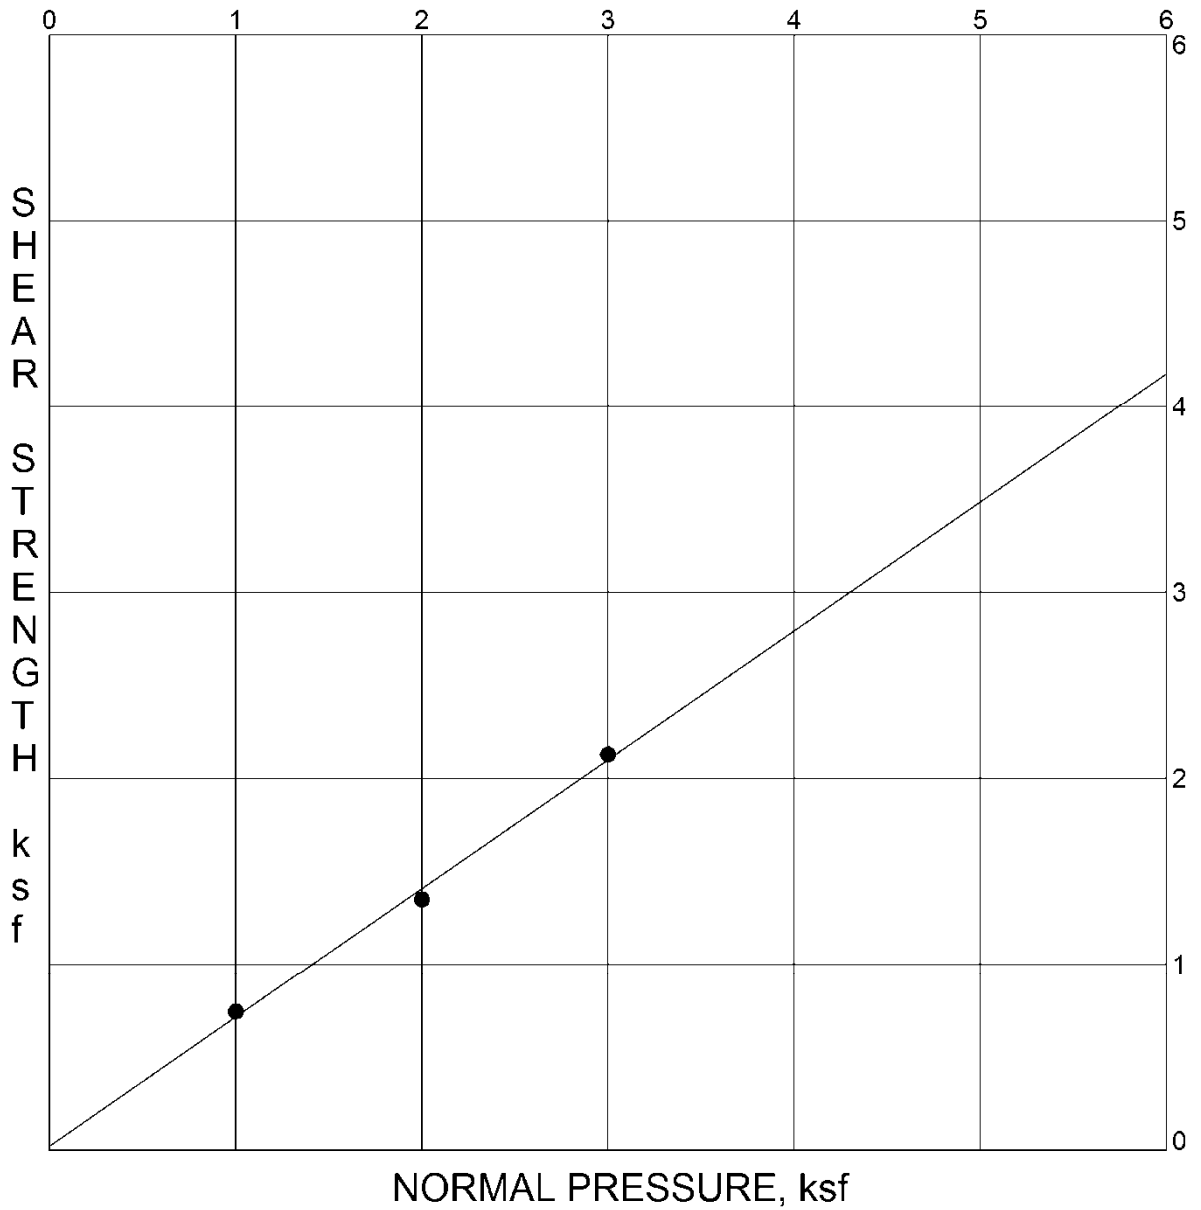
DESCRIPTION: Qa1

Test Results

Moisture Content (%)	Density (pcf)	Ultimate Strength
In situ: 8.0	Dry Density: 117.5	Phi (deg): 35.0
Saturated: 16.0		Cohesion (ksf): 0.025
