## EXHIBIT G

September 21, 2016

**Subject: Oak Trees at 23604 Dry Canyon Cold Creek Road, Calabasas, California 91302**

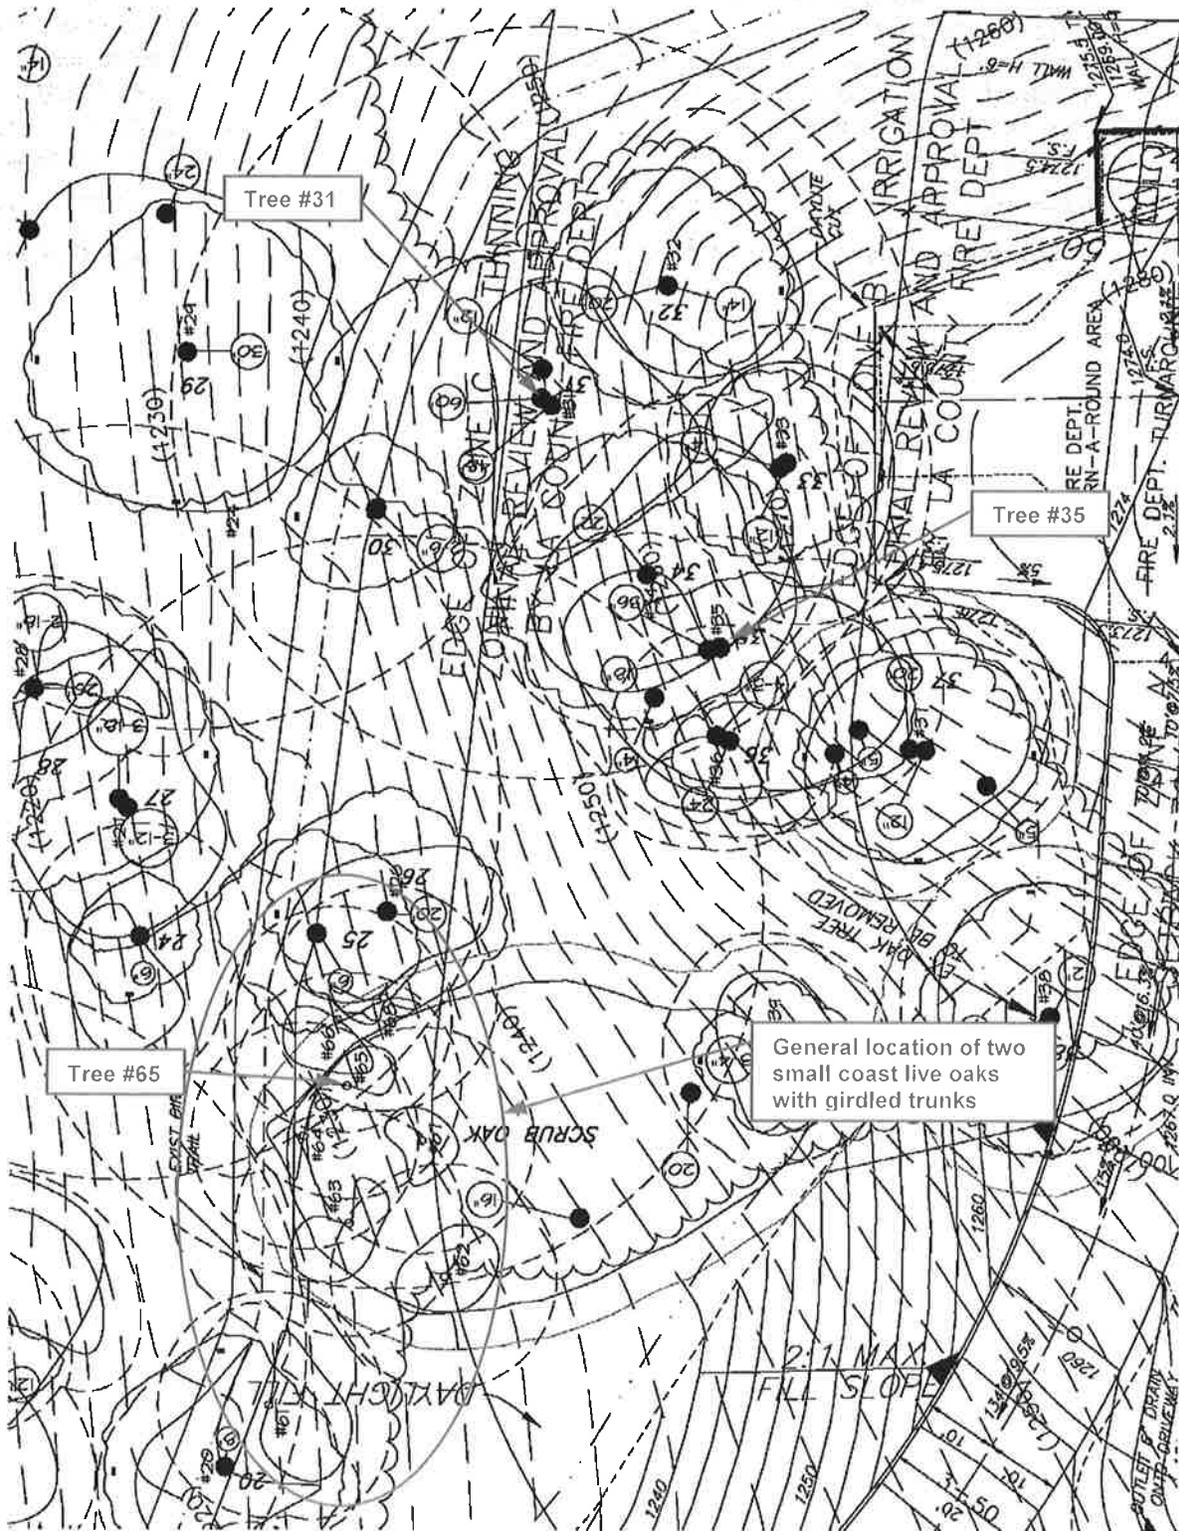
Enlarged Tree Location Map

A burned-out, hollow stump stood on this east-facing slope. Sections of oak limbs were scattered on the slope below the stump. No tag could be located on the tree but based on its location, size and a review of photographs taken during the tree inventory, we identified the tree as tree #31. Tree #31 was a senescent coast live oak tree (*Quercus agrifolia*) with a single trunk measuring 31 inches in diameter at breast height (dbH) at the time of the inventory. The tree was most likely cut down during fire-fighting operations.

Three small coast live oaks, four inches dbH to five inches dbH, located just west of the existing dirt trail on the easterly portion of the site, had been severely damaged. No tags could be located on any of the trees in this general area. Two of the trees' lower trunks were completely girdled by the fire. In the same general location, a third tree sustained severe damage to its lower trunk. Based on its general location and photos taken at the time of the inventory, we tentatively identified this tree as tree #65. Two small scrub oaks in the same general vicinity may also have been top-killed by the fire.
