**UPDATED GEOTECHNICAL EVALUATION REPORT FOR CEQA
PROPOSED RETAIL/RESTAURANT AND RESIDENTIAL BUILDINGS
THE COMMONS AT CALABASAS
4799 COMMONS WAY
CALABASAS, CALIFORNIA**

August 14, 2023

Subject: Updated Geotechnical Evaluation Report for CEQA
Proposed Retail/Restaurant and Residential Buildings
The Commons at Calabasas
4799 Commons way
Calabasas, California
GPI Project No. 3063.I

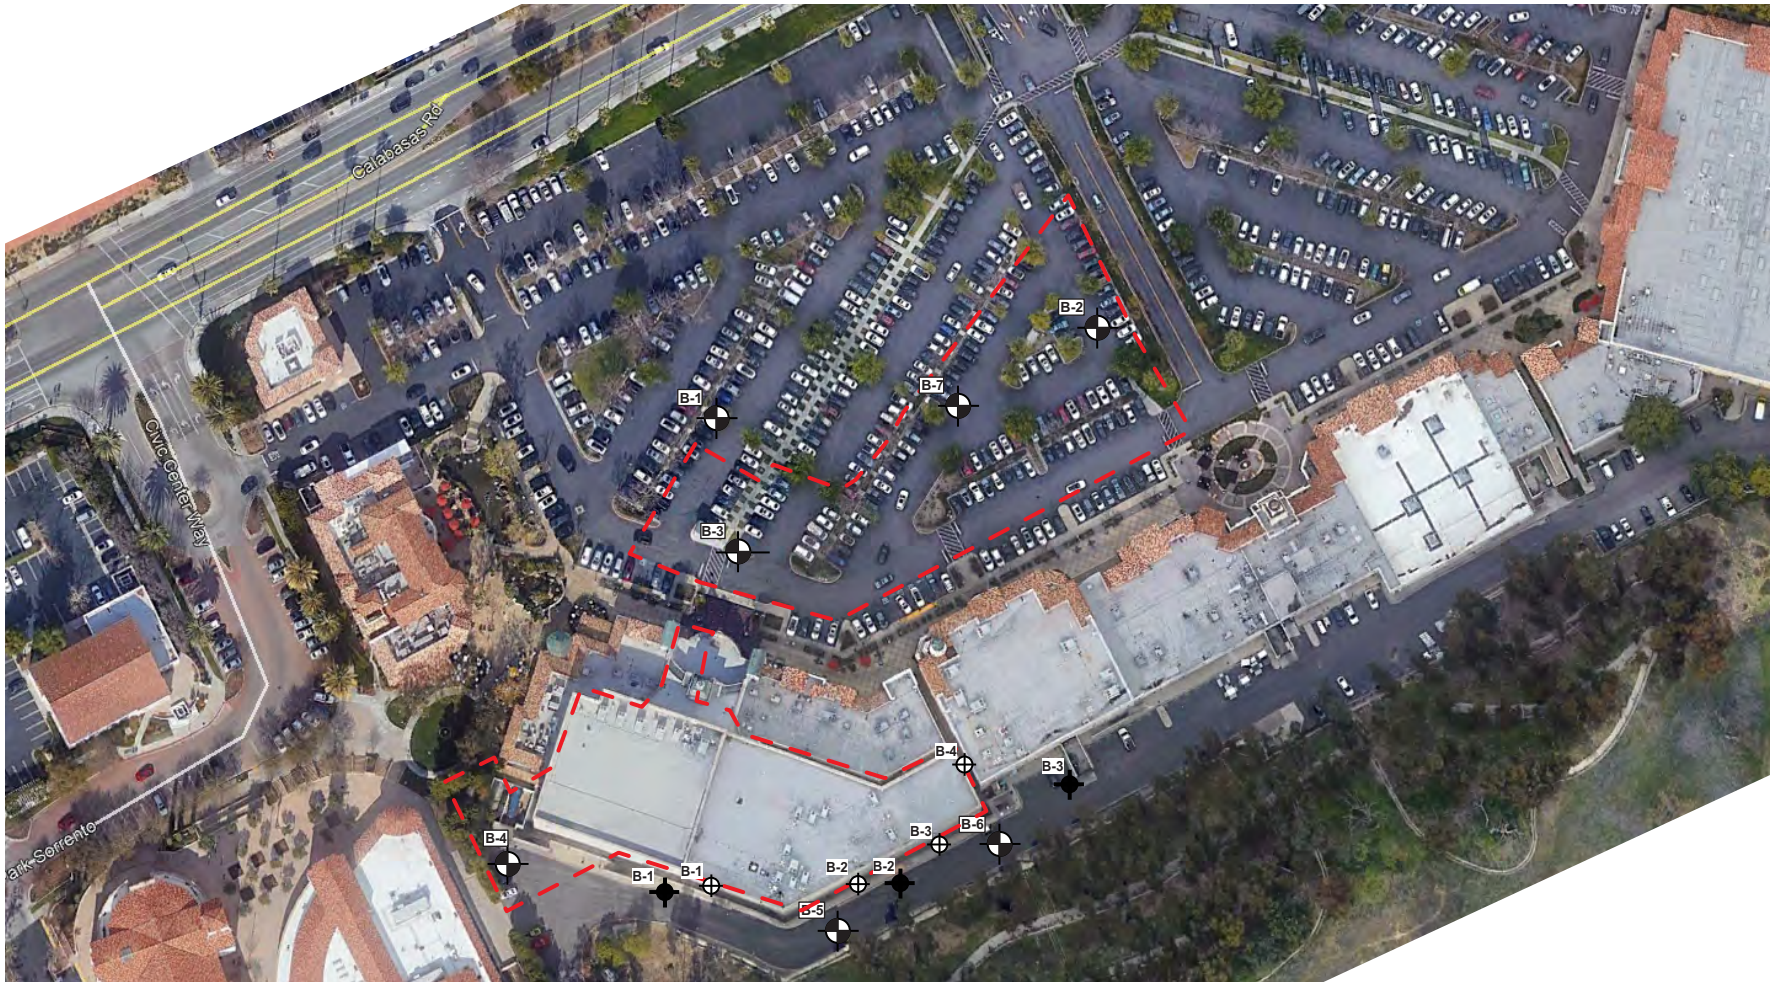
FIGURE 3

- EXPLANATION**
- B-7 APPROXIMATE LOCATION AND NUMBER OF EXPLORATORY BORING
 - B-4 APPROXIMATE LOCATION AND NUMBER OF EXPLORATORY BORING BY OTHERS (KLEINFELDER, 2017)
 - B-3 APPROXIMATE LOCATION AND NUMBER OF EXPLORATORY BORING BY OTHERS (KLEINFELDER, 2009)
 - - - APPROXIMATE LIMITS OF PROPOSED PROJECT

**SITE PLAN
(Existing Conditions)**

Our subsurface exploration program consisted of a total of seven hollow stem auger borings performed to depths of approximately 21 to 51 feet below existing grades. Borings B-1 through B-6 were drilled in August 2021 and Boring B-7 was drilled in October 2022 as part of this report update. A description of field procedures and logs of the explorations are presented in Appendix A. The approximate locations of our subsurface explorations, as well as the locations of the nearby prior subsurface explorations by others are shown on the Site Plans, Figures 2 and 3.

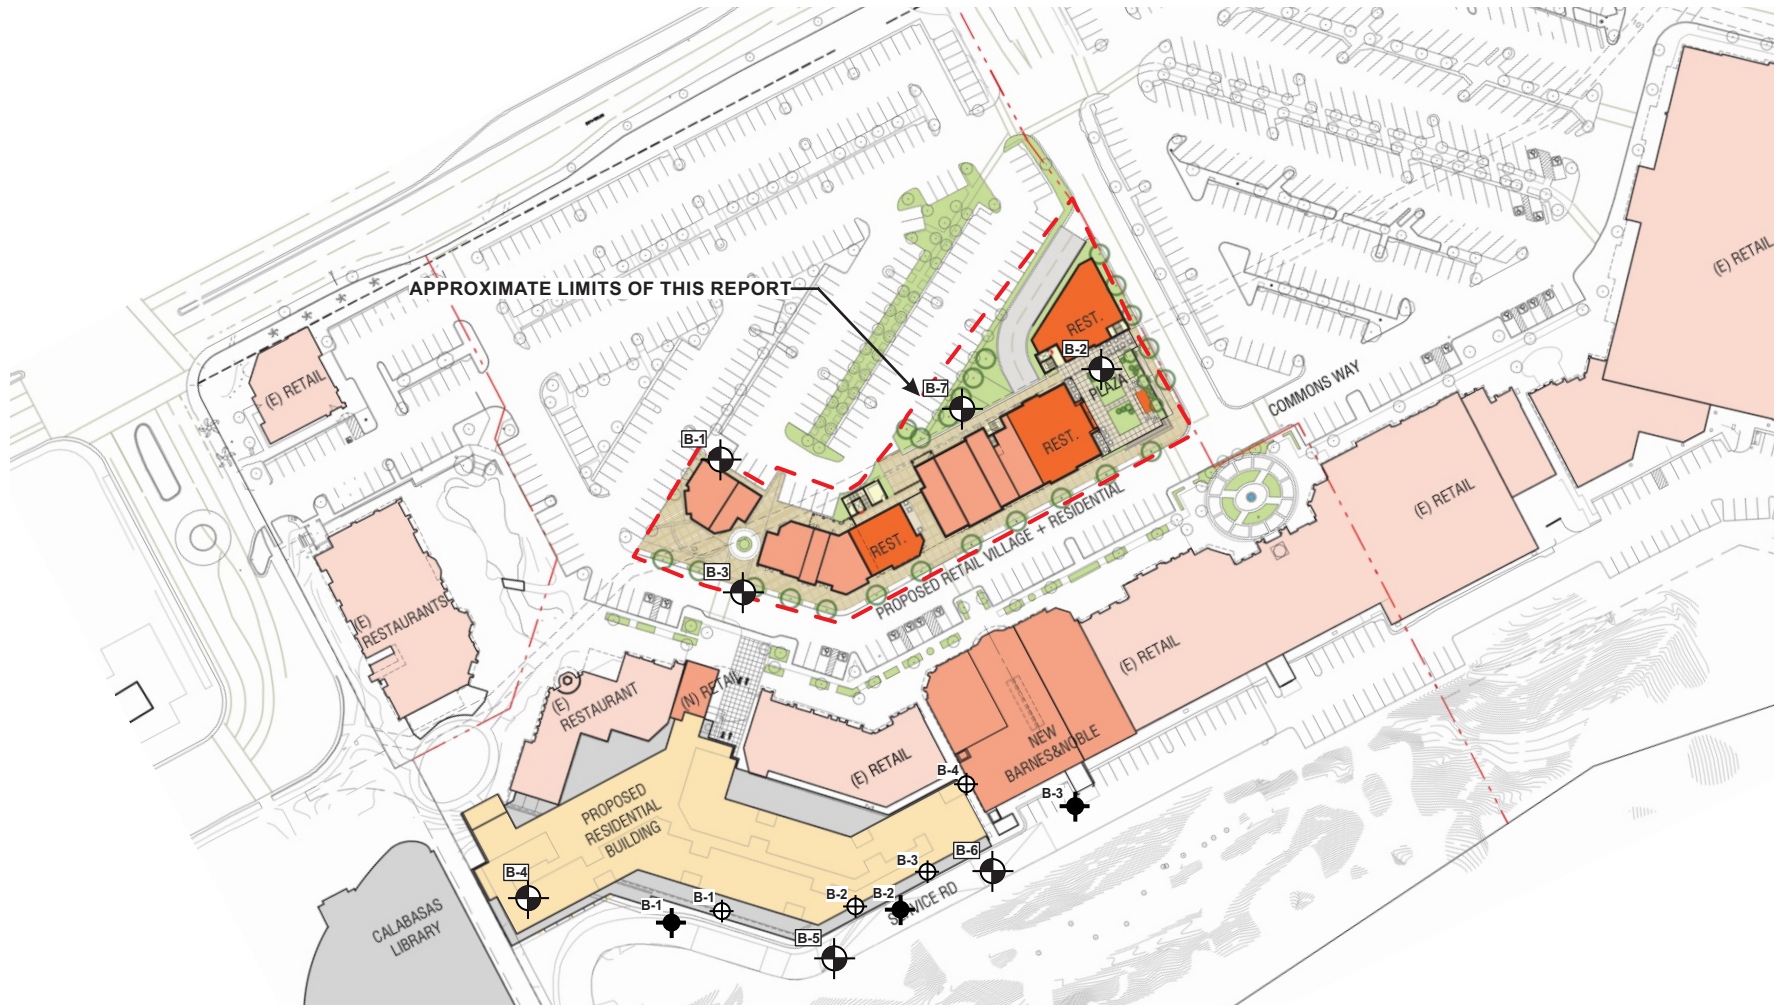
FIGURE 2

**SITE PLAN
 (Proposed Conditions)**

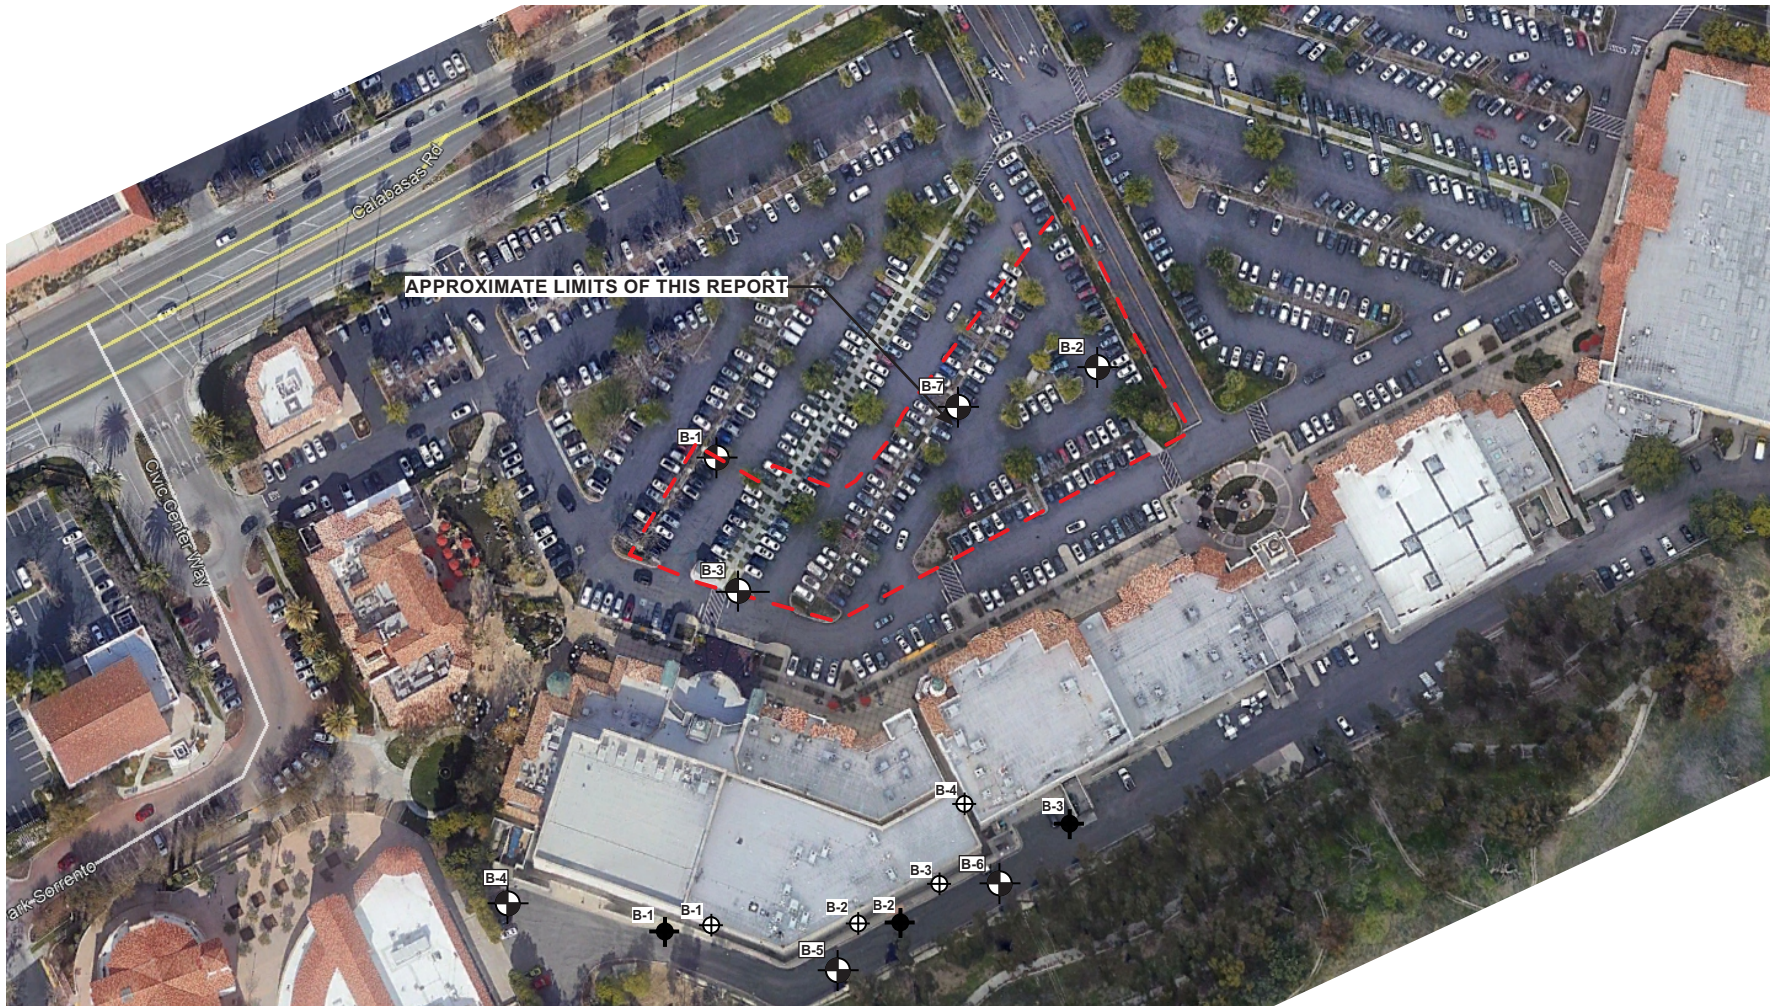
FIGURE 3

- EXPLANATION**
- B-7

The subsurface conditions at the site were investigated by drilling and sampling seven exploratory borings. Six of the borings (B-1 through B-6) were drilled in August of 2021, and one of the borings (B-7) was drilled in October of 2022. The borings were advanced to depths ranging from approximately 21 to 51 feet below the existing ground surface. The locations of the explorations are shown on Figures 2 and 3, Site Plan (Proposed Conditions and Existing Conditions).

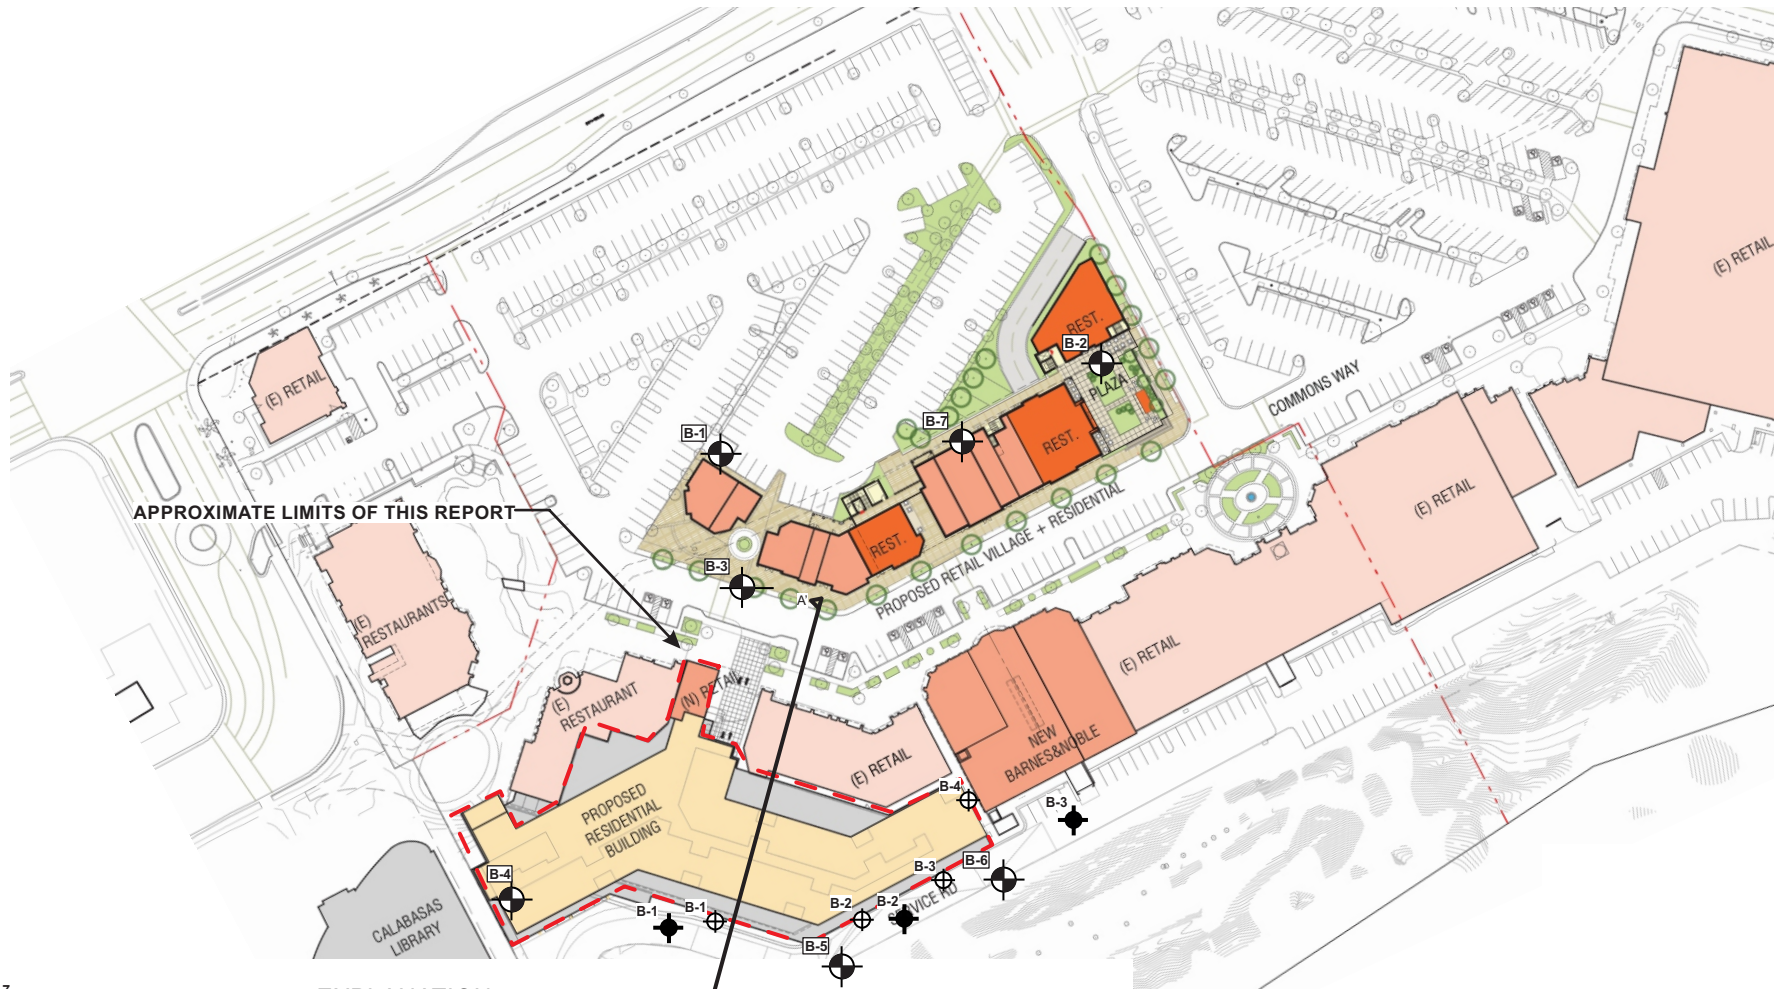
FIGURE 2

- EXPLANATION**
- B-7 APPROXIMATE LOCATION AND NUMBER OF EXPLORATORY BORING
 - B-4 APPROXIMATE LOCATION AND NUMBER OF EXPLORATORY BORING BY OTHERS (KLEINFELDER, 2017)
 - B-3 APPROXIMATE LOCATION AND NUMBER OF EXPLORATORY BORING BY OTHERS (KLEINFELDER, 2009)
 - APPROXIMATE LOCATION OF SUBSURFACE CROSS SECTION (FIGURE 4)

SITE PLAN
(Proposed Conditions)

The proposed project will consist of a new 8-story residential building approximately 43,500 feet in plan. The building will be constructed within the general location of the existing movie theatre building (Building I) in the Commons at Calabasas center. We were provided a general site layout showing the location and elevations of the proposed building in a Concept Design Package by Steinberg Hart, dated August 5, 2021 and a Conceptual Site Plan by Elkus Manfredi Architects (undated). The conceptual layout of the proposed building is shown on Figure 2.

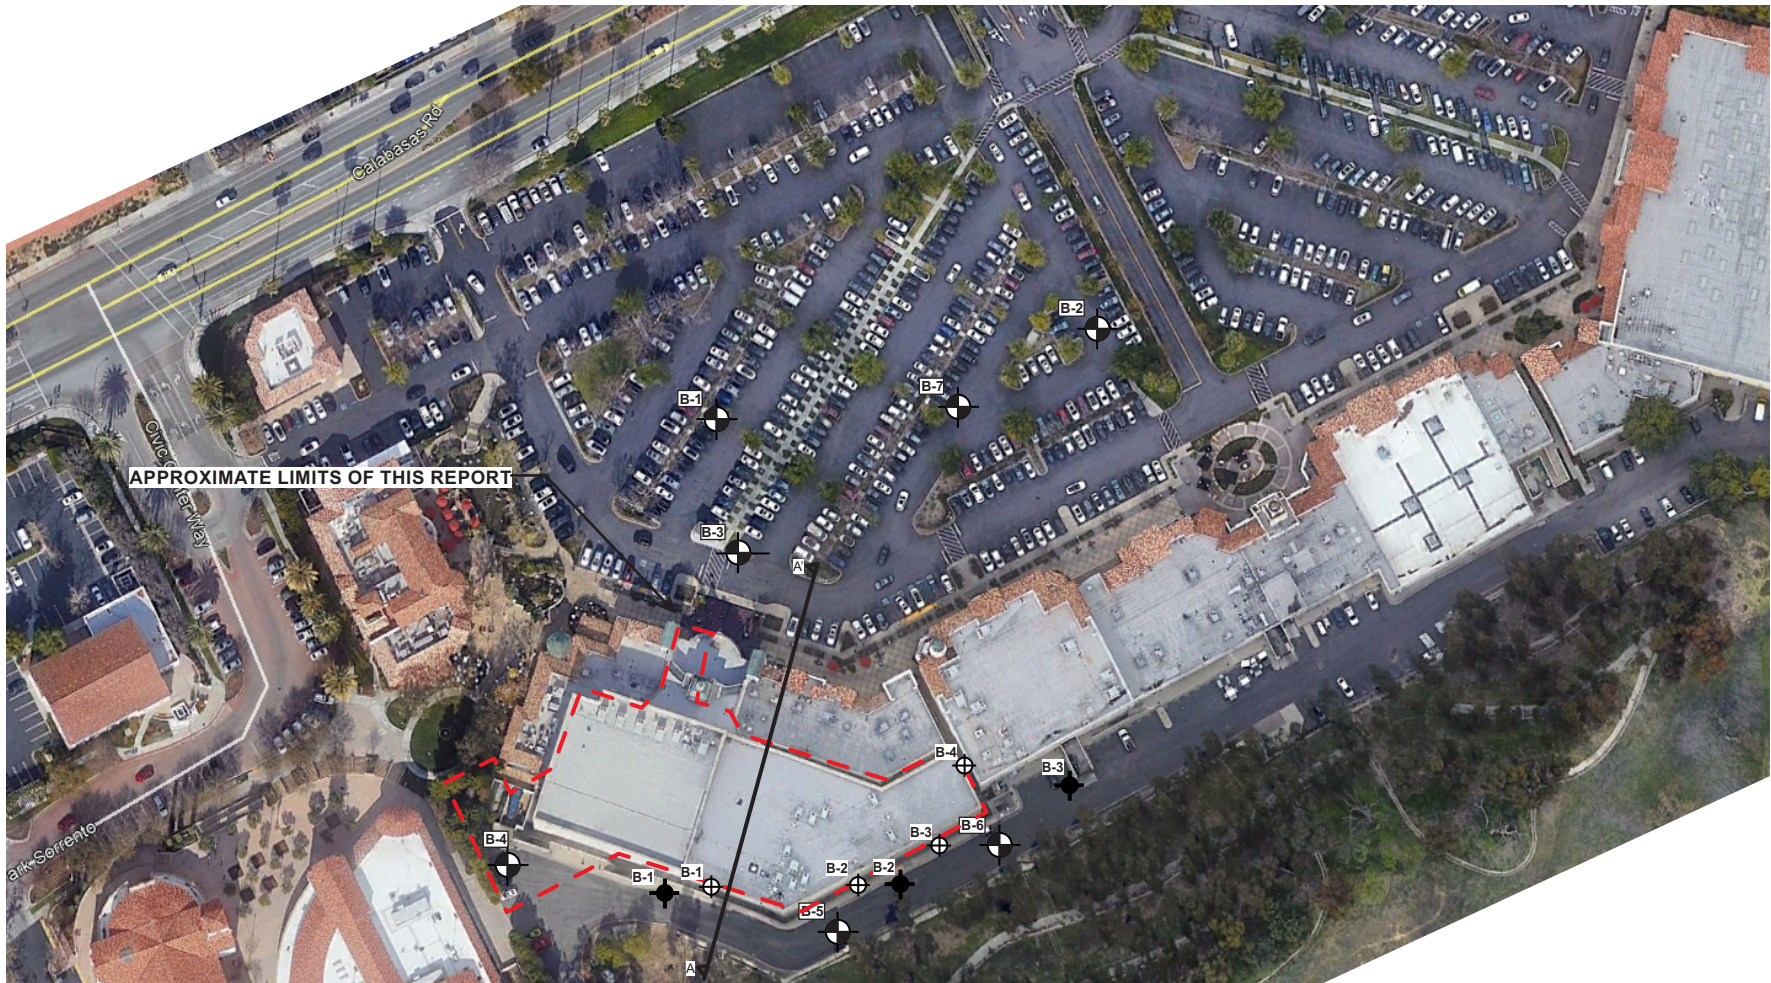
FIGURE 3

- EXPLANATION**
-

APPROXIMATE LOCATION OF SUBSURFACE CROSS SECTION (FIGURE 4)

SITE PLAN
(Existing Conditions)

Our subsurface exploration program consisted of a total of seven hollow stem auger borings performed to depths of approximately 21 to 51 feet below existing grades. Borings B-1 through B-6 were drilled in August 2021 and Boring B-7 was drilled in October 2022 as part of this report update. A description of field procedures and logs of the explorations are presented in Appendix A. The approximate locations of our subsurface explorations, as well as the locations of the nearby prior subsurface explorations by others are shown on the Site Plans, Figures 2 and 3.

The subsurface conditions at the site were investigated by drilling and sampling seven exploratory borings. Six of the borings (B-1 through B-6) were drilled in August of 2021, and one of the borings (B-7) was drilled in October of 2022. The borings were advanced to depths ranging from approximately 21 to 51 feet below the existing ground surface. The locations of the explorations are shown on Figures 2 and 3, Site Plan (Proposed Conditions and Existing Conditions).
